HSU Trinity Children's Center and Child Development Lab Project

Initial Study-Mitigated Negative Declaration

November 2021

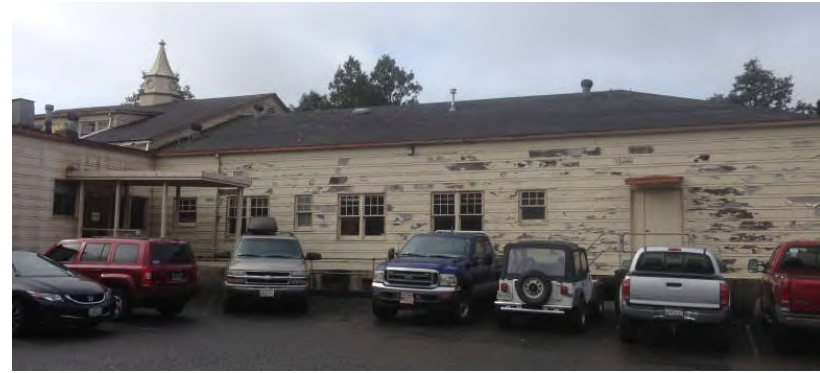
Photograph 1. View of the southernmost portion of the site across 13th St, facing north

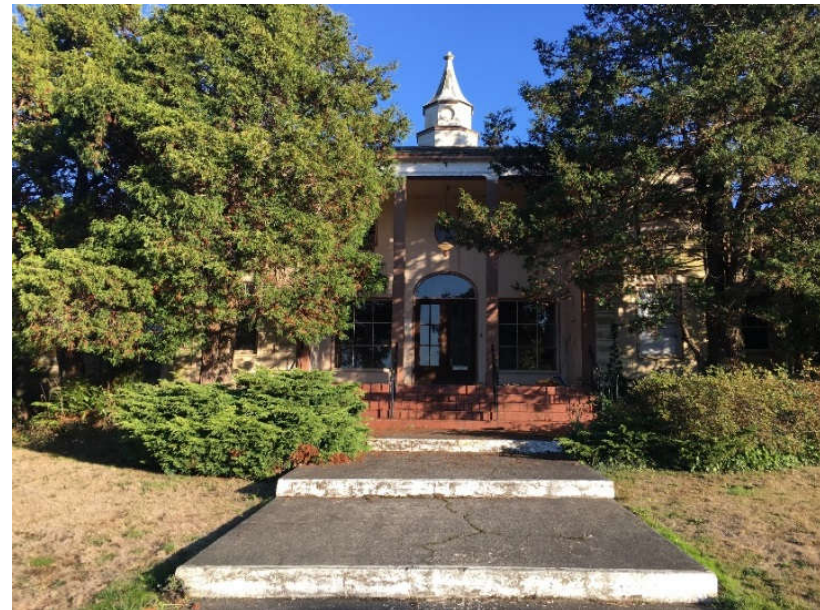
Photograph 4. View of the main entrance of the Trinity Annex along C Street, facing east

The project site is situated at an elevation of about 80 to 90 feet above mean sea level (USGS Arcata South Quadrangle, 2015). The topography of the site is generally flat, although it slopes gradually to the west in the vicinity of the project site. Vegetation consists primarily of landscaped grass lawn and low shrubs. Several conifer trees are located adjacent to the main building of the Trinity Annex. These trees appear to have been originally planted as landscaping and are partially shown on Photo 4 of Figure 4.

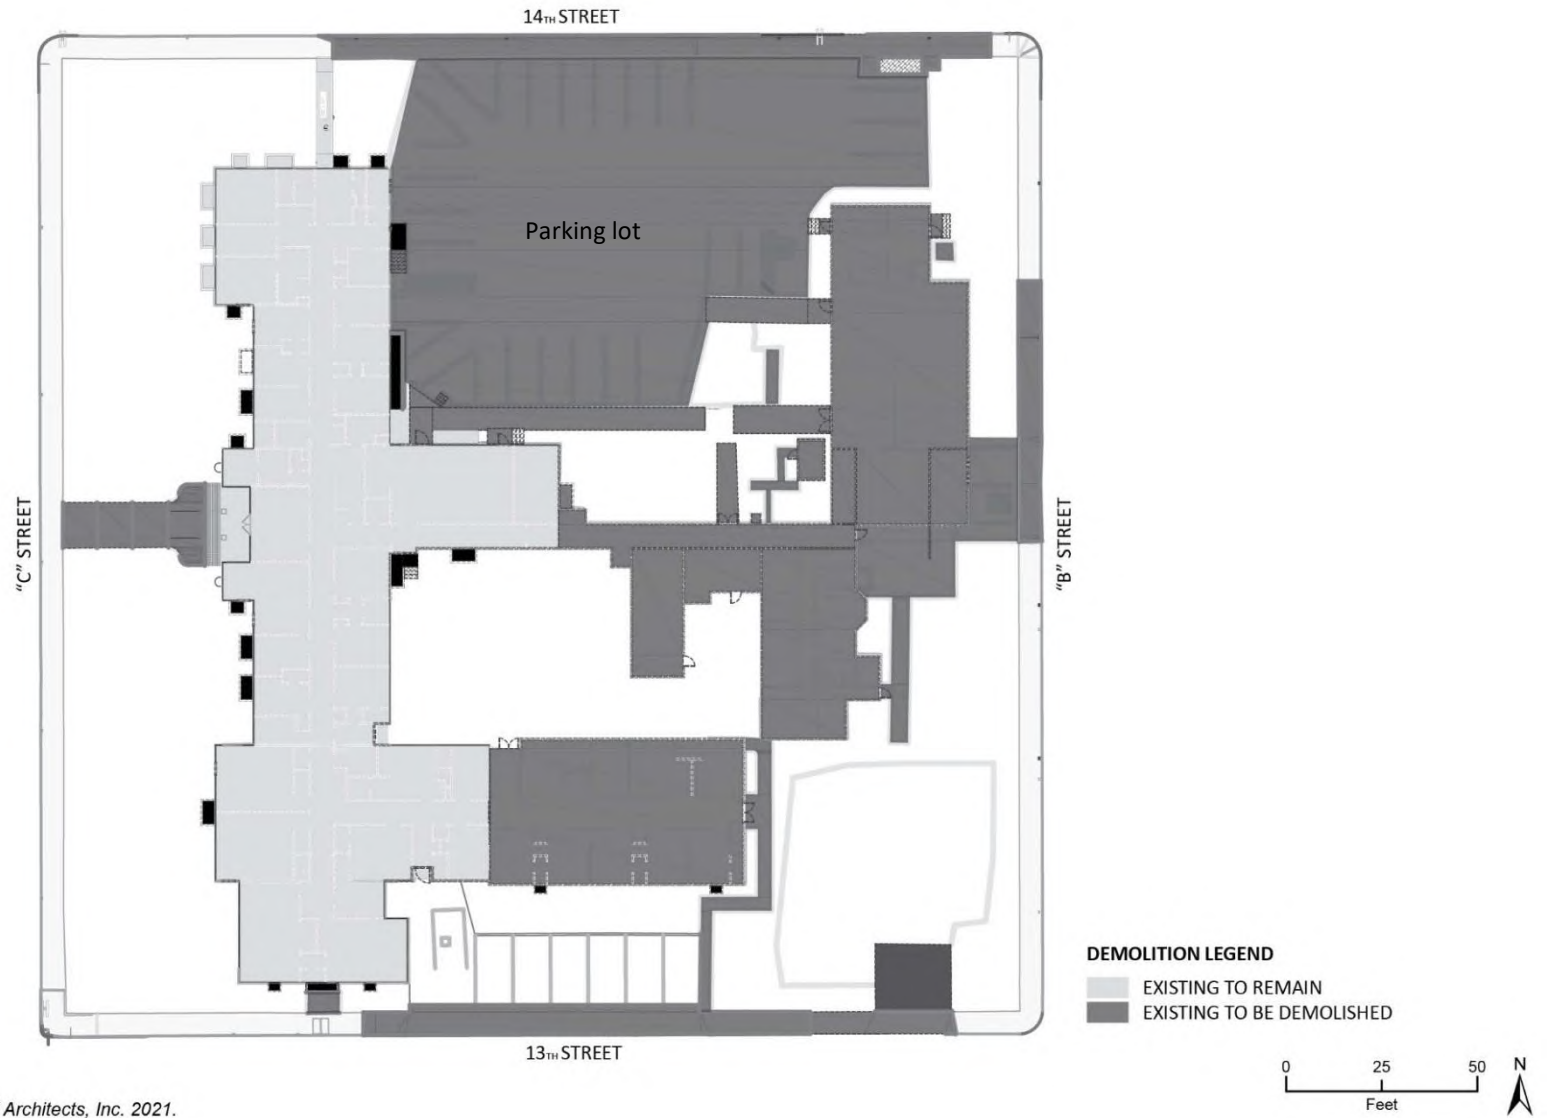
Figure 6 Demolition Site Plan

The project proposes to demolish all annexes and additions built after the original hospital was constructed in 1944. These are shown in Figure 6. All utilities would be removed from these structures and capped as appropriate. All foundations would be removed and graded as required during the demolition process. Existing utility service locations either would be preserved or modified to best serve the new facility design.

The original Main Block of the hospital building would be renovated and reused as part of the new design. Key historic character-defining features (CDF) of the building would be retained, specifically those which are representative of its Colonial Revival design. Many of the notable building features such as its wood columns, pilasters, and window surrounds would be retained and repaired, or replaced in kind as needed. Other features such as the windows and original main door would be replaced with suitable-in-kind features and the openings would not be altered. Construction would also incorporate abatement of hazardous materials. The wood siding, currently covered with lead-based paint, would be stripped and repainted. The roof of the existing hospital building would be removed and replaced with similar shingle roofing material.

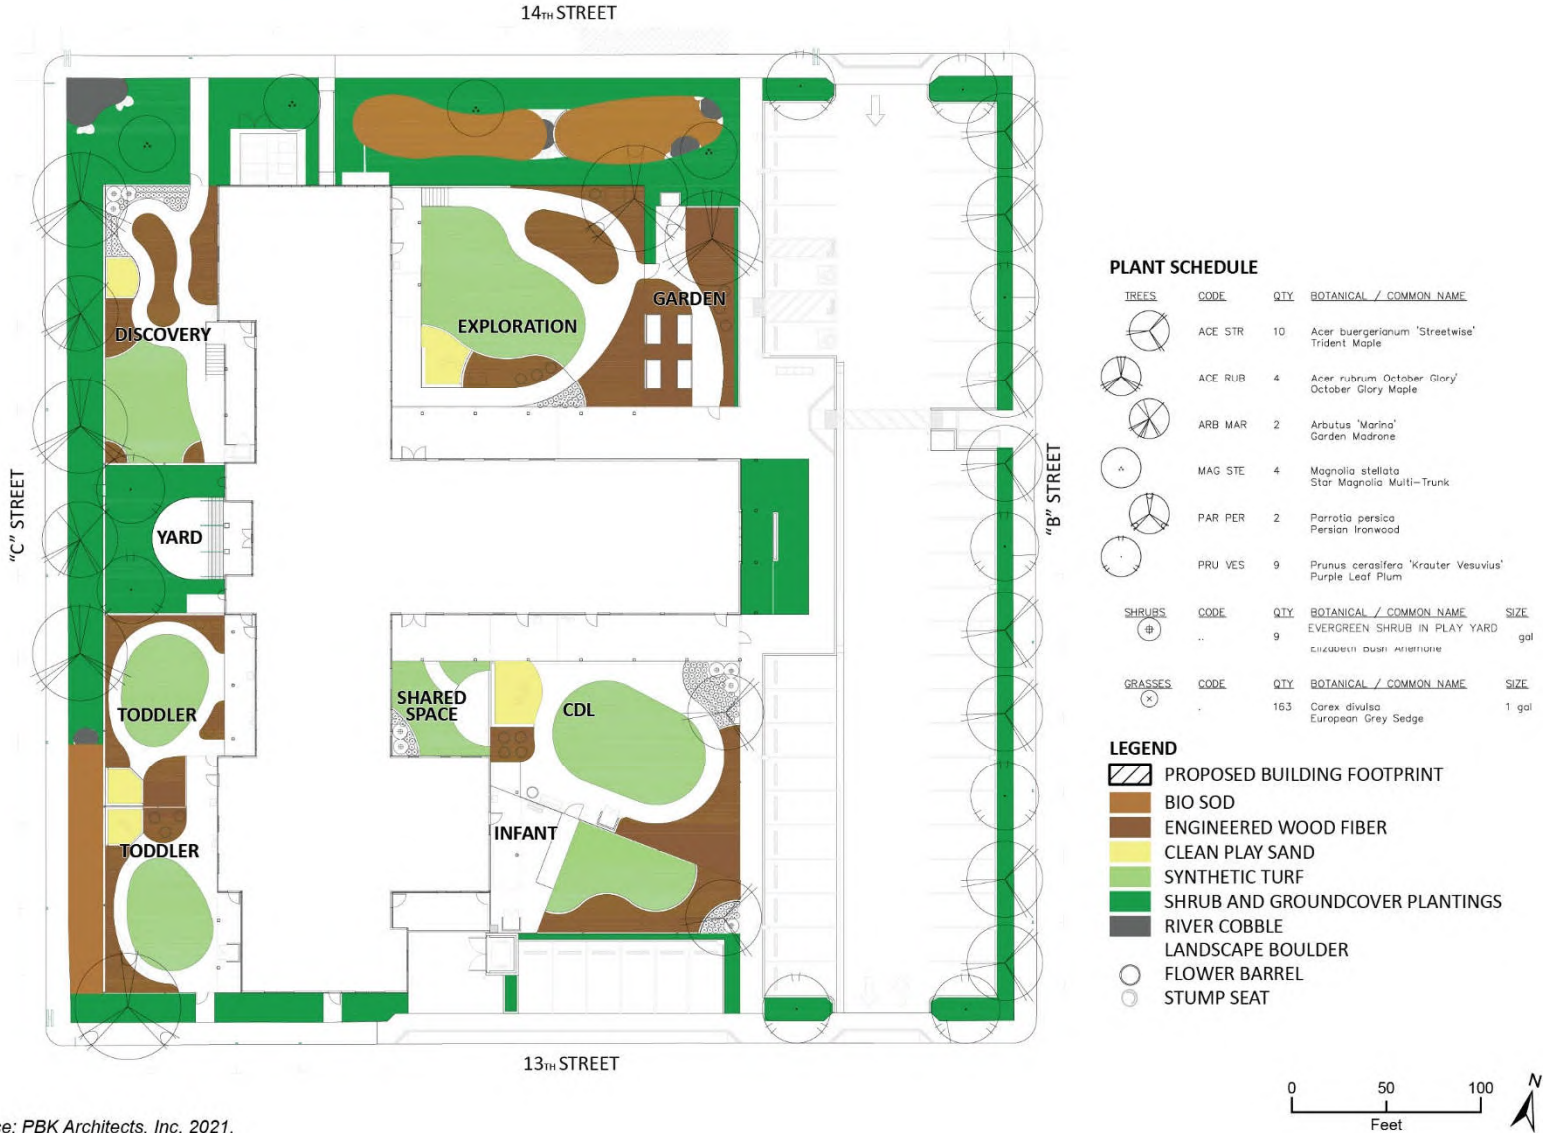
Figure 8 Landscaping Plan

On-site vegetation would be removed. The proposed landscaping plan is presented in Figure 8. As shown therein, 35 trees would be planted on site. Tree species to be planted include trident maple (*Acer buergerianum*), October glory maple (*Acer rubrum*), star magnolia (*Magnolia stellata*), Persian ironwood (*Parrotia persica*), and purple leaf plum (*Prunus cerasifera*). In addition to new trees, shrubs and groundcover would be planted, with synthetic turf, engineered wood fiber, clean play sand, and sod installed in the play areas. The majority of new trees would be planted in the perimeter of the site, partially screening views of on-site features, such as the parking lot, play areas, and remodeled building. Vegetated bioretention basins would be constructed along C Street and toward the center of the block along 14th Street.

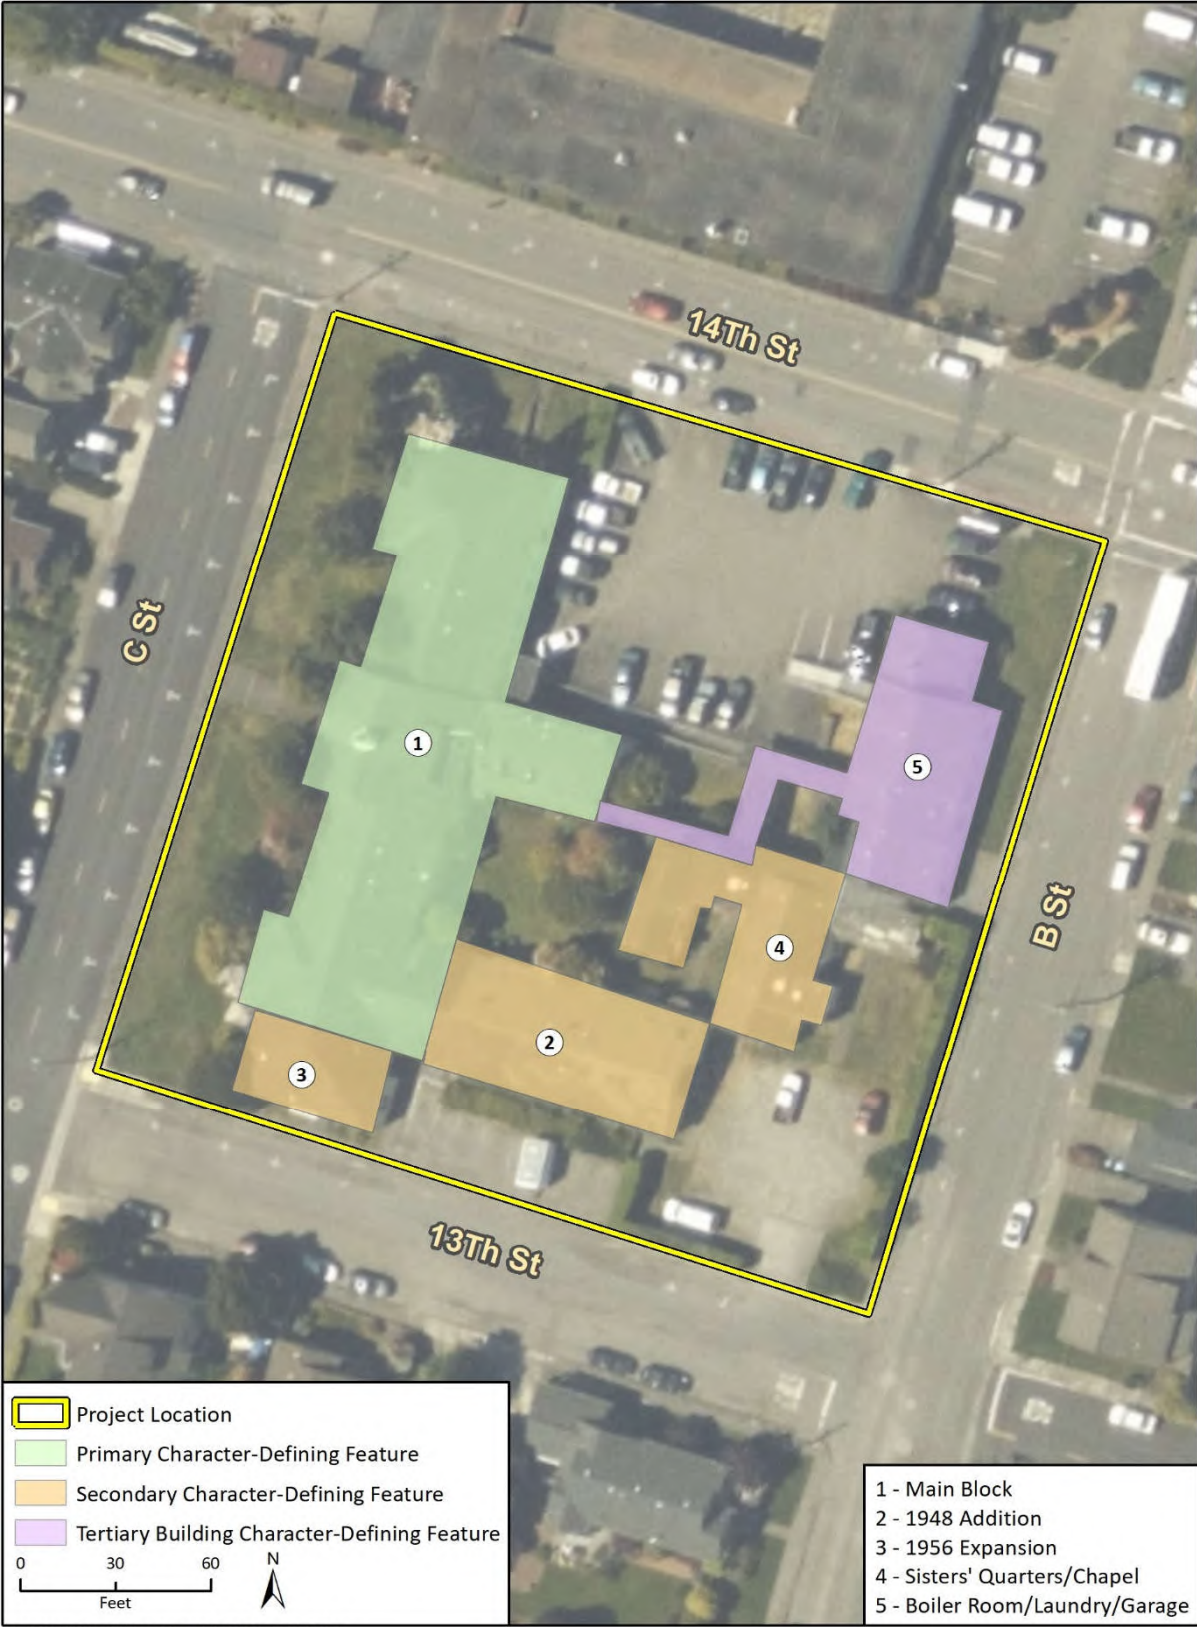
Figure 9 Contributing Components of Trinity Annex

The proposed project would retain, and/or replace in-kind where necessary due to deterioration, CDFs related to the façade of the 1944 Main Block, which is the key element conveying the property’s significance under Criteria A/1 and Criteria C/3. The Main Block would be renovated and adaptively reused. The horizontal wood siding, currently coated with lead-based paint, would be stripped according to the *Secretary’s Standards*, using the gentlest means possible, and repainted in a compatible color palette. The roof of Trinity Annex would be removed, repaired, and re-sheathed in a similar roofing material.

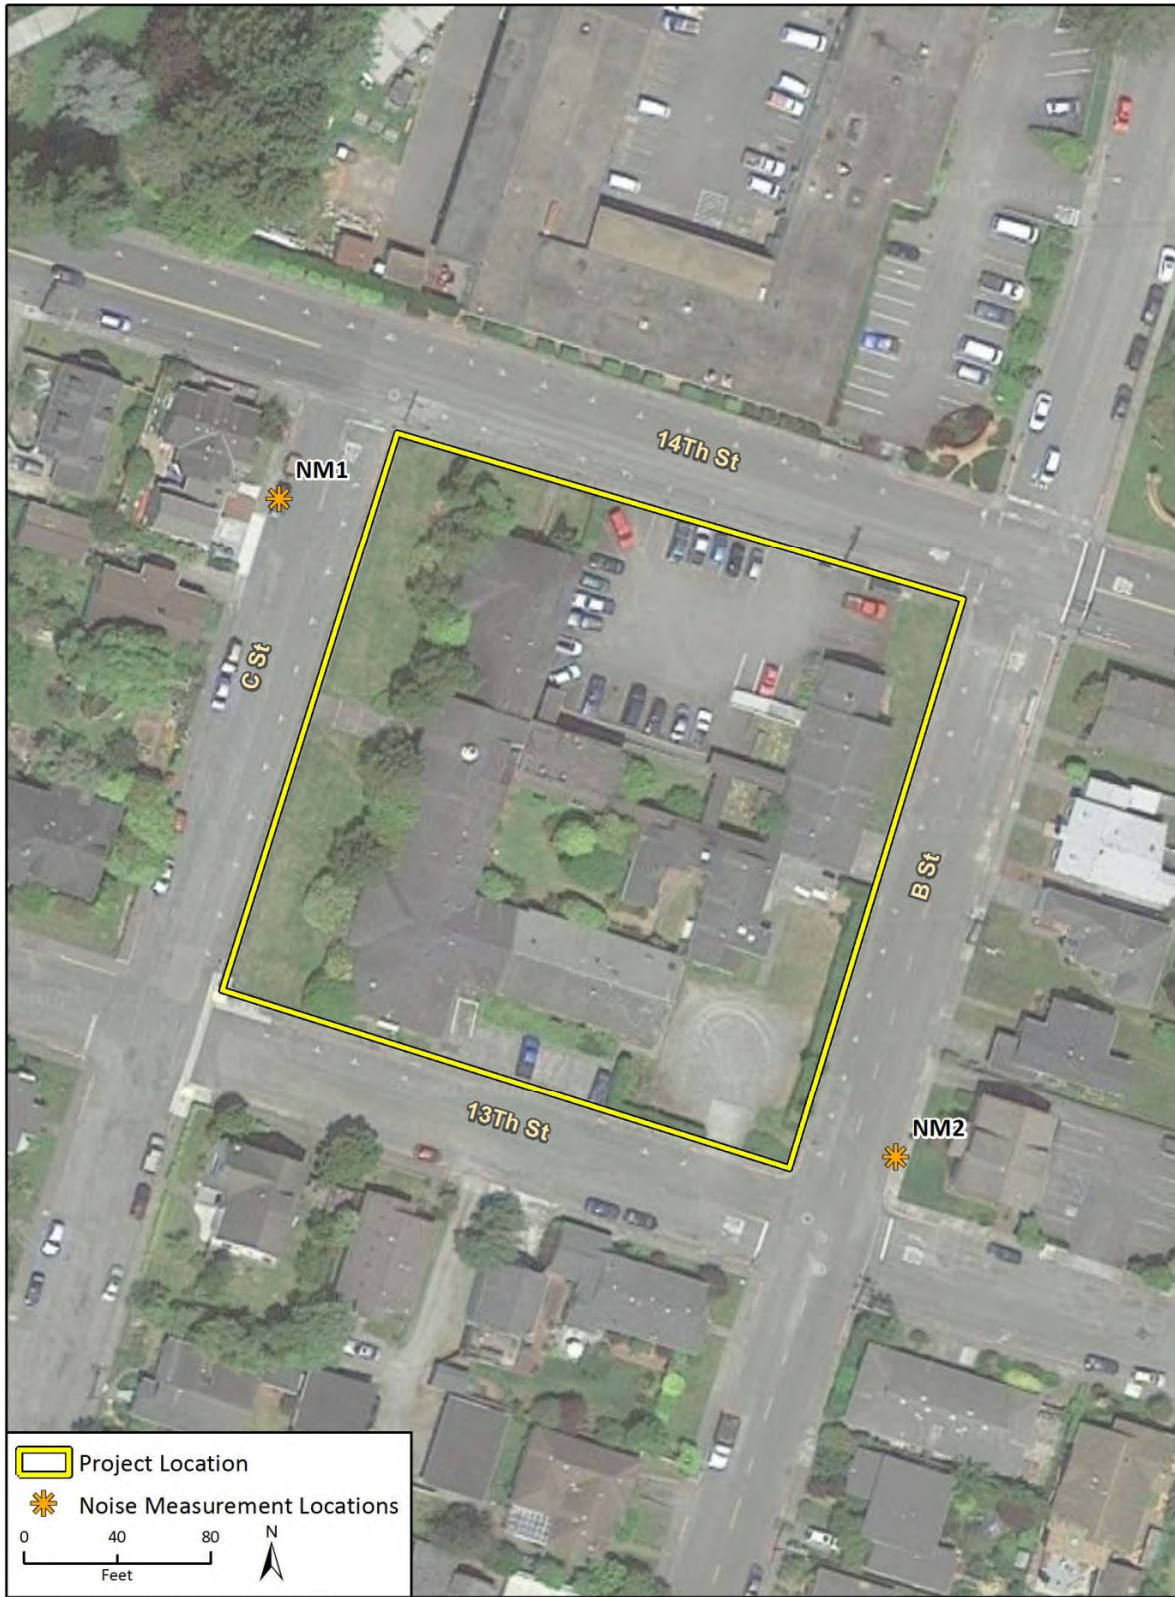
Figure 10 Noise Measurement Locations

The project site is surrounded by residences to the east, west, and south, and campus buildings and associated parking lots to the north and northeast. The most prevalent source of noise in the project site vicinity is primarily traffic noise from local roadways, although freeway traffic from US 101 can also be heard in the background. To characterize ambient sound levels at and near the project site, two 15-minute sound level measurements were conducted on May 3, 2018 during the AM peak hour traffic between 7:35 a.m. and 8:10 a.m. A Soft dB Piccolo Integrating Sound Meter and Data Logger, Model SLM-P3, meeting the requirements of the IEC 651/804 Type 2 and ANSI S1.4 Type 2, was used to conduct the measurements. Figure 10 shows the noise measurement locations, and Table 15 summarizes the results of the noise measurements. Detailed sound level measurement data are included in Appendix NOI.

Measurement Number	Measurement Location	Sample Time	Primary Noise Source	L _{eq} (dBA)	L _{min} (dBA)	L _{max} (dBA)
1	Southwest corner of C and 14 th Streets	7:35 – 7:50 a.m.	Local traffic, including several construction trucks	58.3	28.6	72.7
2	Northeast corner of B and 13 th Streets	7:55 – 8:10 a.m.	Local traffic, including two southbound buses	57.4	39.0	75.4

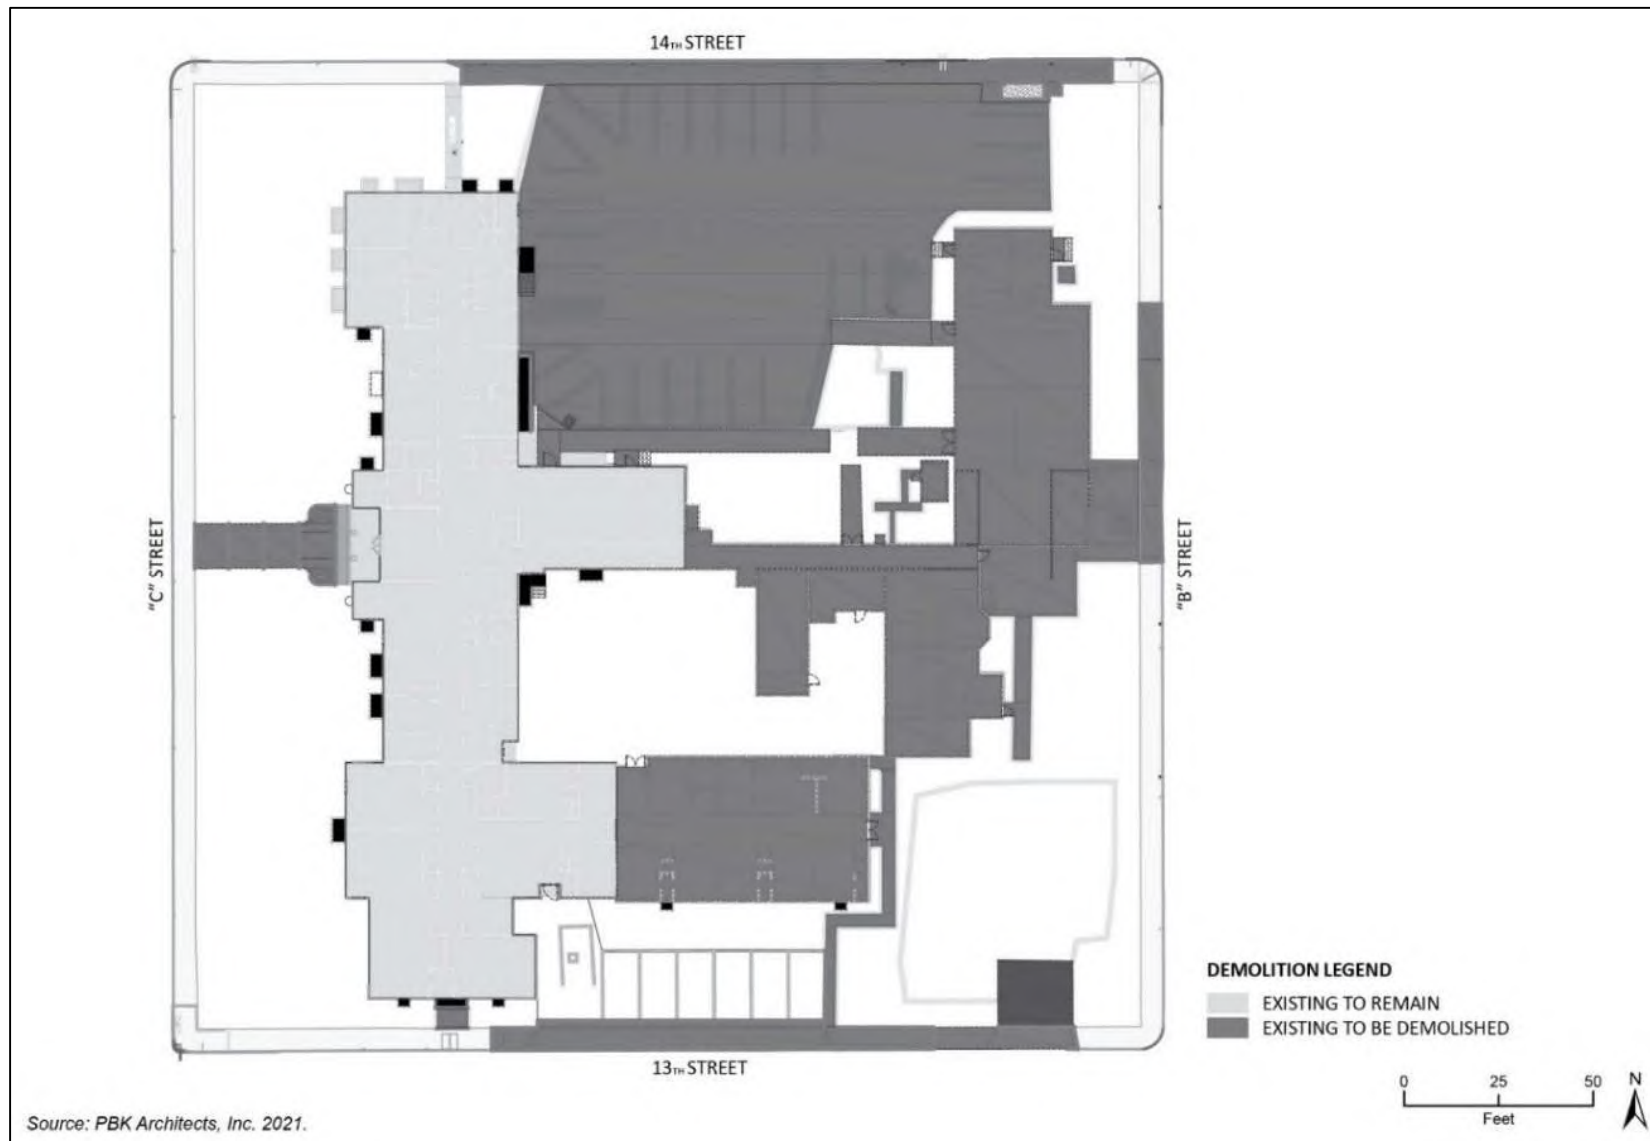
Figure 3 Proposed Site Plan, with Areas Slated for Retention and Removal

The proposed site plan is presented in Figure 3; the proposed landscaping plan is presented in Figure 4. Additional project detail and drawings are provided in Section 6 ("Project Impacts Analysis").

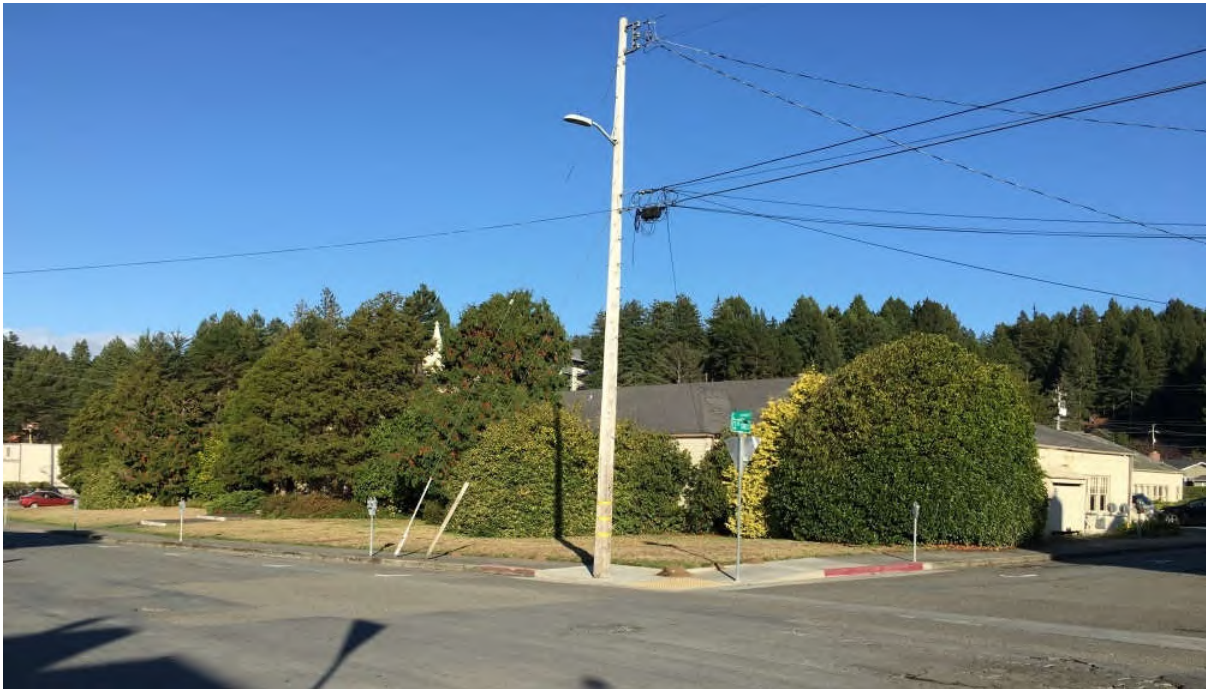
The façade of this one-story, wood-frame complex represents a distinctive, intact example of the Colonial Revival style as applied to an institutional property. Irregular in plan, the Main Block rests on a concrete slab foundation and raised basement. The building is capped with a combination gable and hip roof, sheathed in asphalt shingles. The main building faces C Street (west) and is set back on a deep grass lawn with mature trees and shrubs, which presently obscure most of the façade (Figure 7). The horizontality of the façade is expressed by a two-story central pavilion flanked by nested, adjoining wings.

Figure 7 Main Block, Trinity Hospital, with Façade Largely Concealed by Landscaping

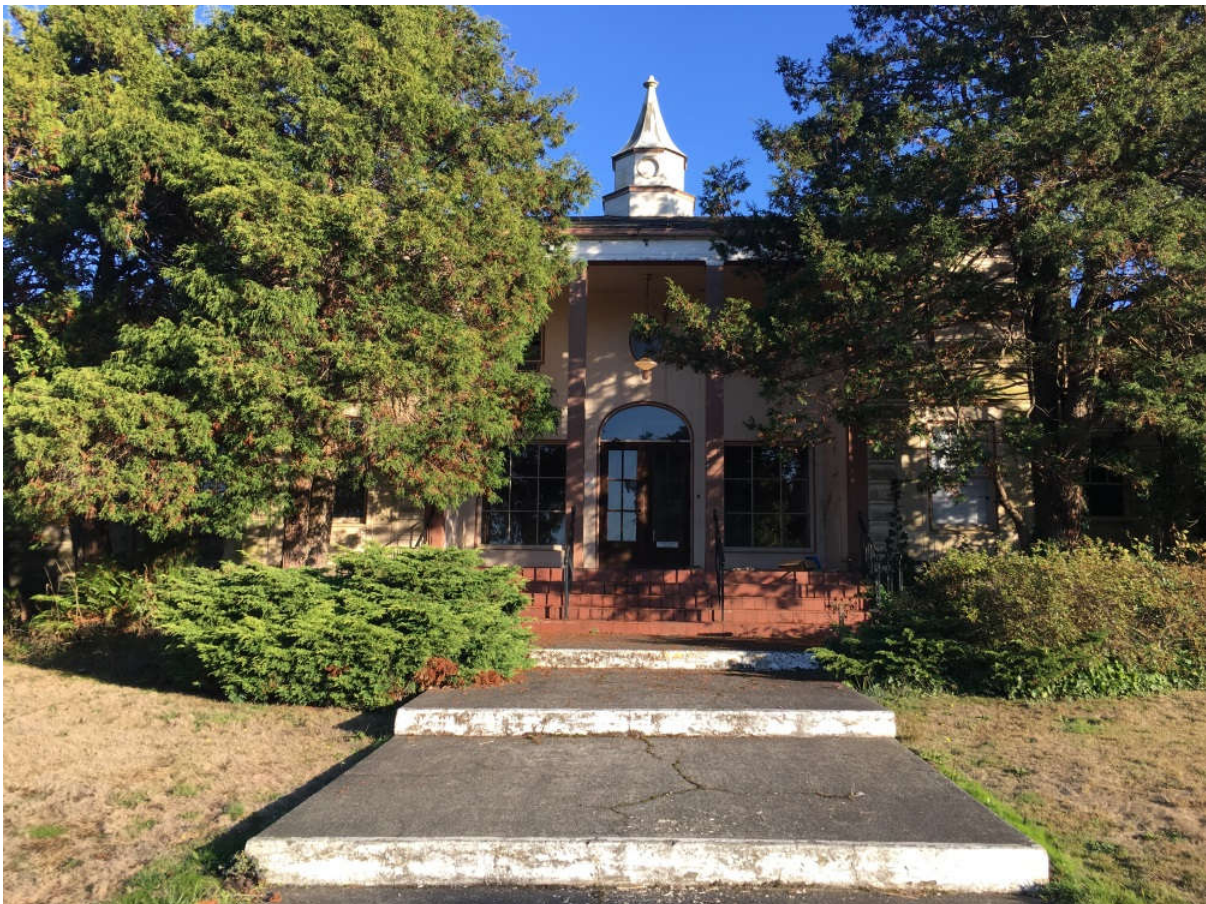
Figure 9 Main Block, Primary Elevation and Entrance

The height of the central pavilion, as well as the decorative cupola with an oculus atop the ridge of its roof, distinguishes it from the rest of the façade. It is divided into three bays and is reached by a short flight of wide concrete steps set from the sidewalk and a set of Mexican paver steps topped by metal railing. The center bay containing the entrance is recessed and features two full-height columns of wood posts supporting the extended eave and simple cornice at the roof, which shelters the pavilion. The main entrance is a wood-frame, double-hinged door with multi-pane glazing, and a fan light above, flanked by large wood-frame, multi-pane, fixed windows. Smaller fixed decorative and jalousie windows are at the clerestory level. A drop light hangs from the pavilion ceiling. Pilasters similar to the post columns cap the edges of the flanking wood bays of the central pavilion. The pavilion walls are sheathed in vertical flush board siding (Figure 8; Figure 9).

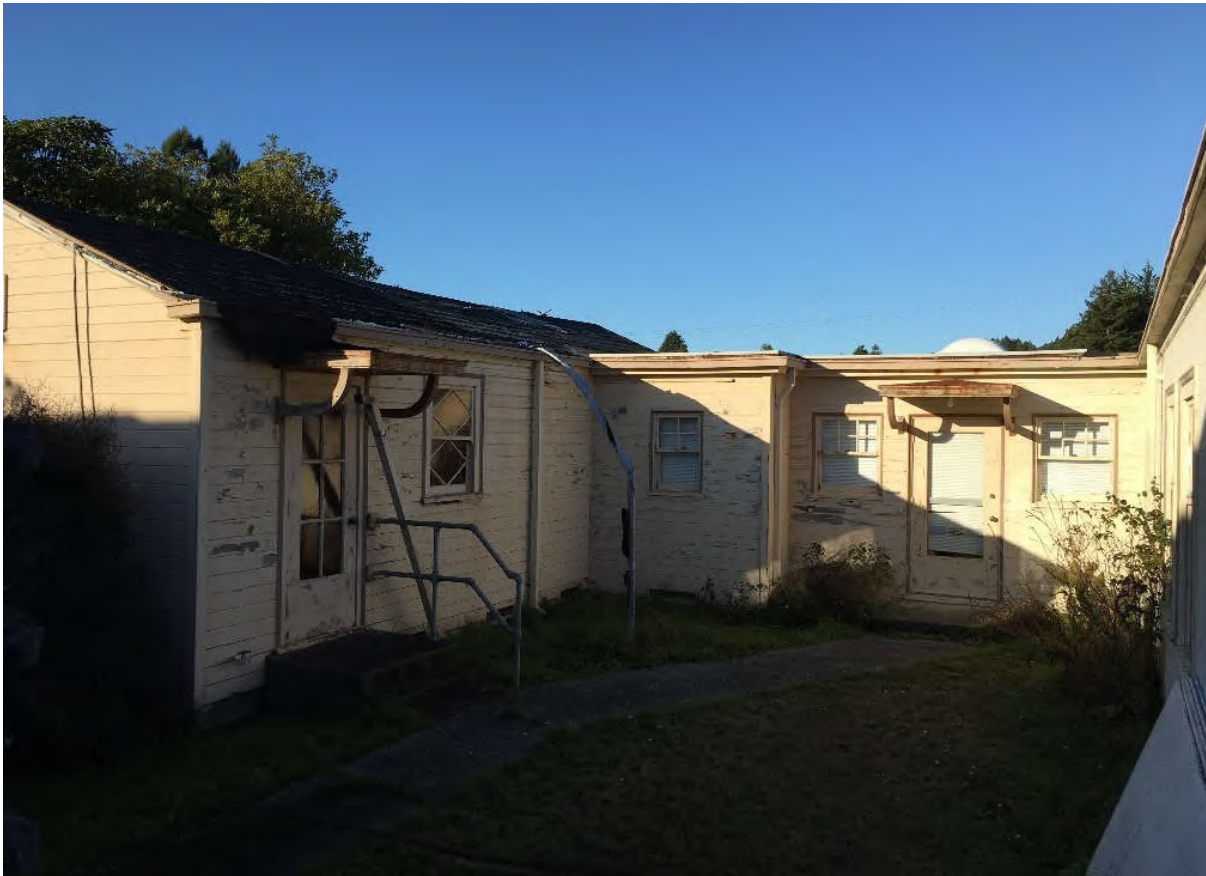
Figure 10 Main Block, Chapel (left), with Flat-roof Segment Connecting to Sisters' Quarters (right); Both Buildings were Relocated to the Site in 1944 and Incorporated into the Footprint of Trinity Hospital

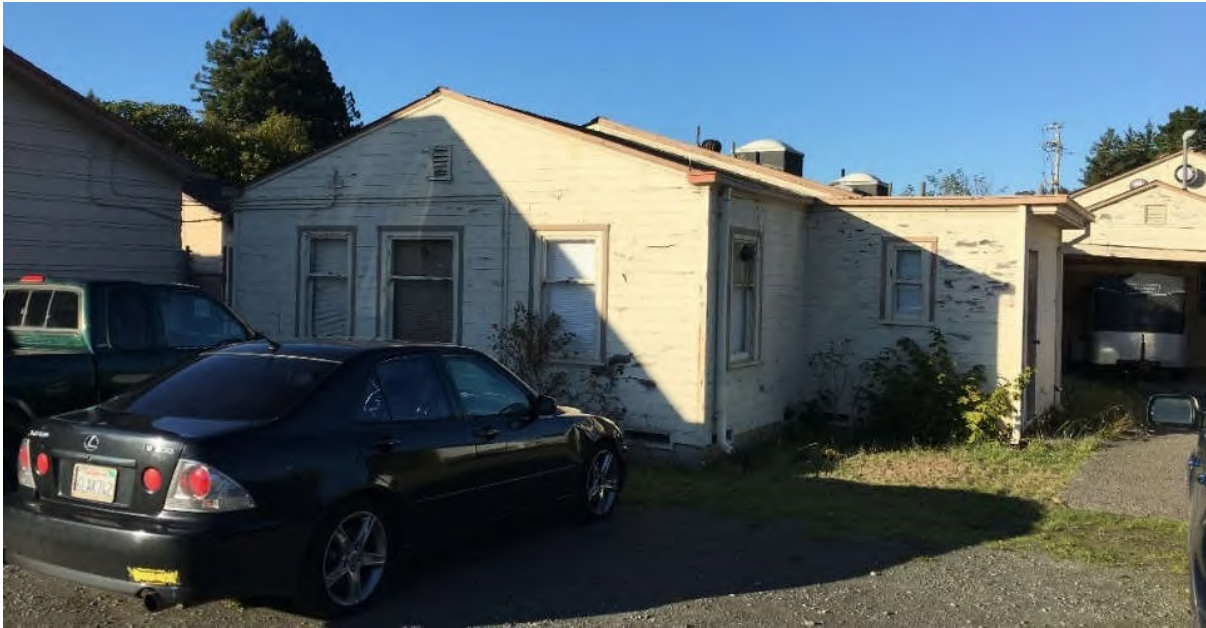
The Chapel and Sisters' Quarters are adjacent to the kitchen, facing the complex's central courtyard (Figure 10 and Figure 11). Both segments of the building display the same wood siding and fenestration patterns/materials observed elsewhere in the complex. The Chapel displays a single diamond-paned, wood-framed window on its east wall. A flat-roof segment with multi-pane, wood-hung windows connects the Chapel and Sisters' Quarters. The Chapel and Sisters' Quarters are accessed via single-entry doors sheltered beneath an unadorned pent roof resting on curved brackets (Figure 10). Located adjacent to the 1948 Addition, the Sisters' Quarters displays one-over-one, wood-frame windows and a shed roof extension with a single-entry door.

Figure 11 Main Block, Sisters' Quarters

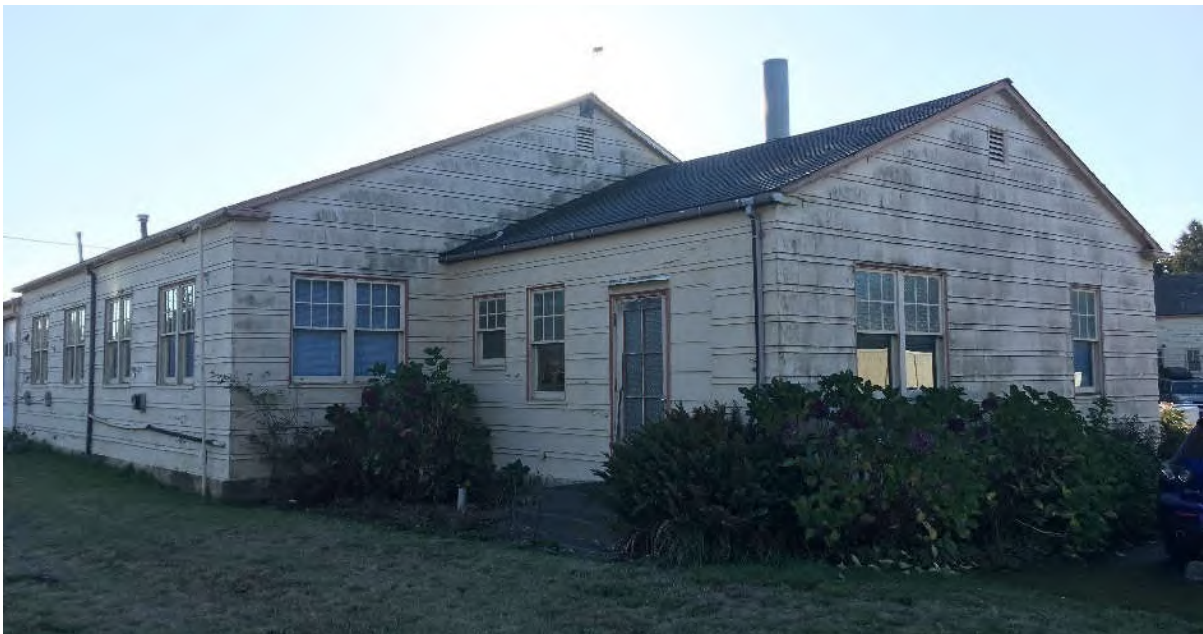
Figure 12 Main Block, Boiler Room and Laundry

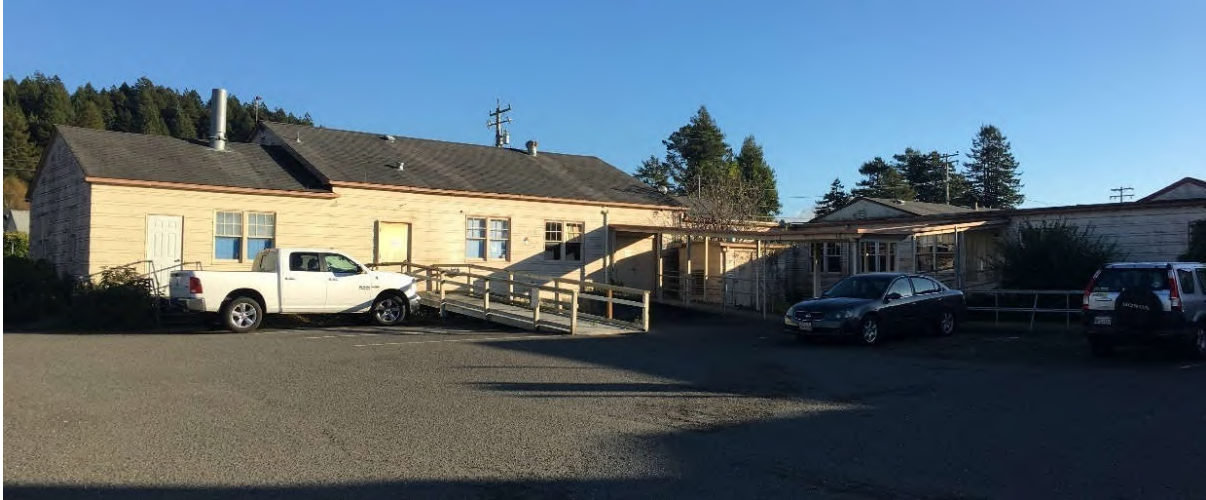
The west elevation facing the parking lot displays two replacement doors and a wheelchair-access ramp extending from the replacement door at the center of the elevation. A sheltered breezeway connects this building to the Main Block's Chapel, Sisters' Quarters, and Kitchen (Figure 13). The east elevation of the former boiler room/laundry/garage building contains various service entries, including a wood porch, a replacement wood door with raised wood steps, and a concrete ramp which leads to the basement (Figure 14).

Figure 13 West Elevation of Former Laundry/Boiler Room with Connecting Breezeway

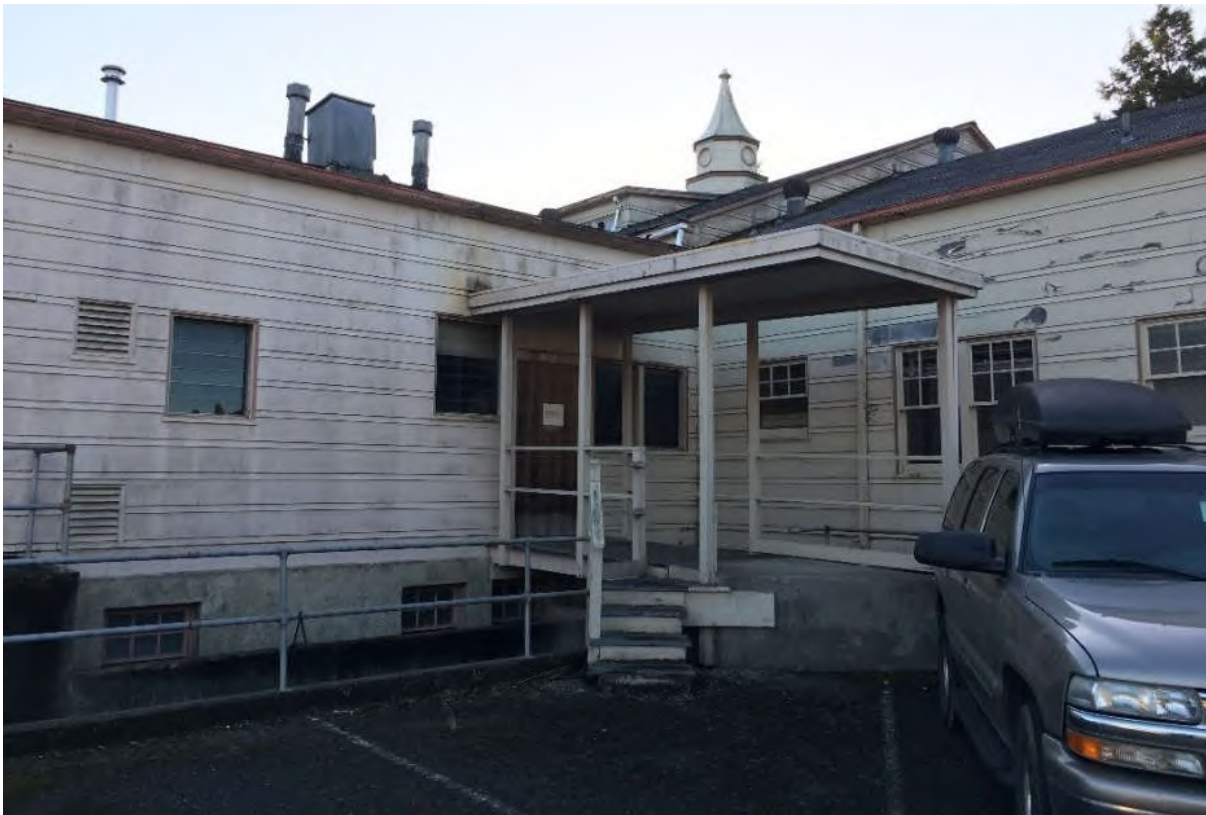
Figure 14 Entrance at Northeast Portion of North Wing, Looking Southwest

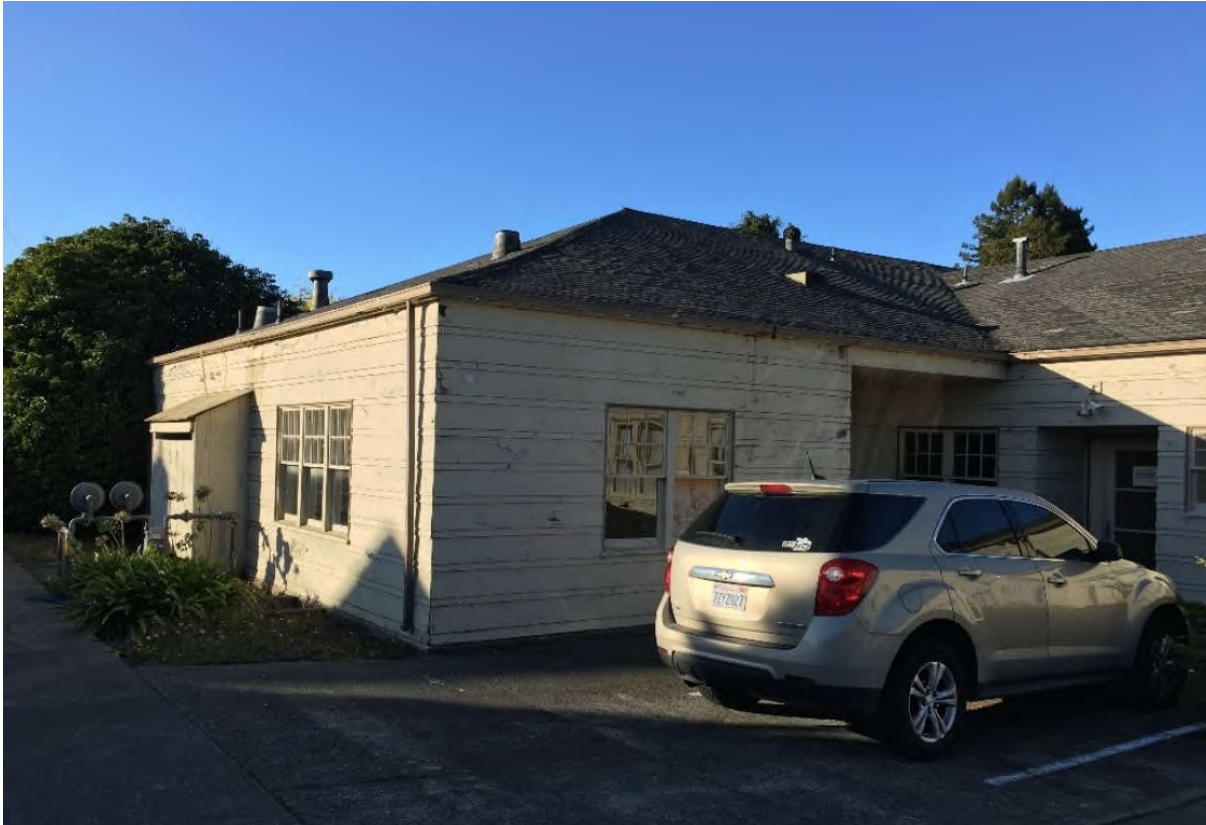
In 1956, the Main Block was extended at the southern edge (Figure 15). This 1956 Extension displays the same wood siding, and double and triple set multi-pane, wood-hung windows seen throughout the complex. A small utility shed capped with a shed roof projects from the south façade. The 1948 Addition and 1956 Extension are set back and separated from the street by a parking lot (Figure 16).

Figure 15 1956 Extension, South Wing

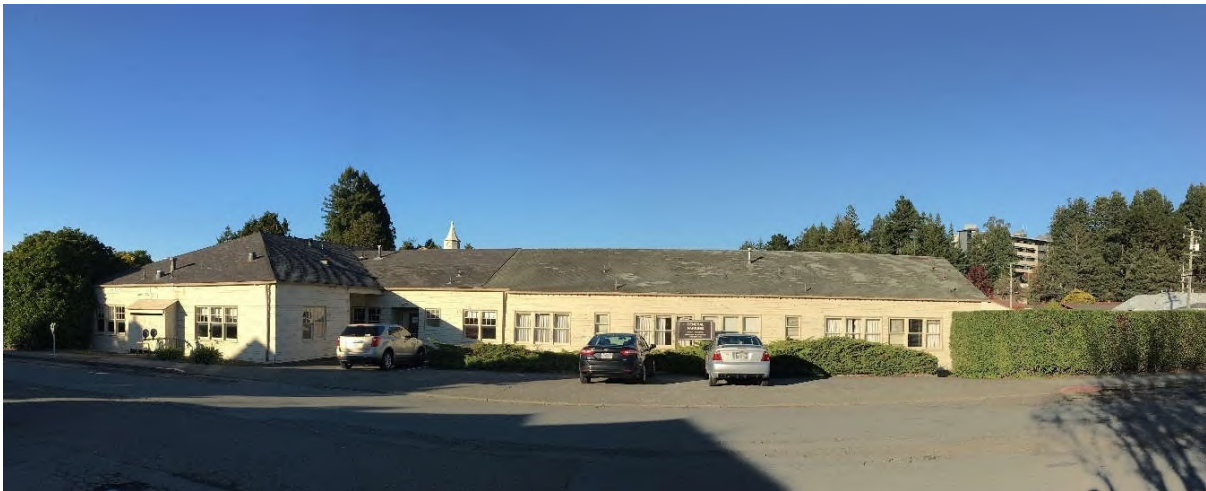
Figure 16 Overview of 1956 Extension (Left) and 1948 Addition (Right)

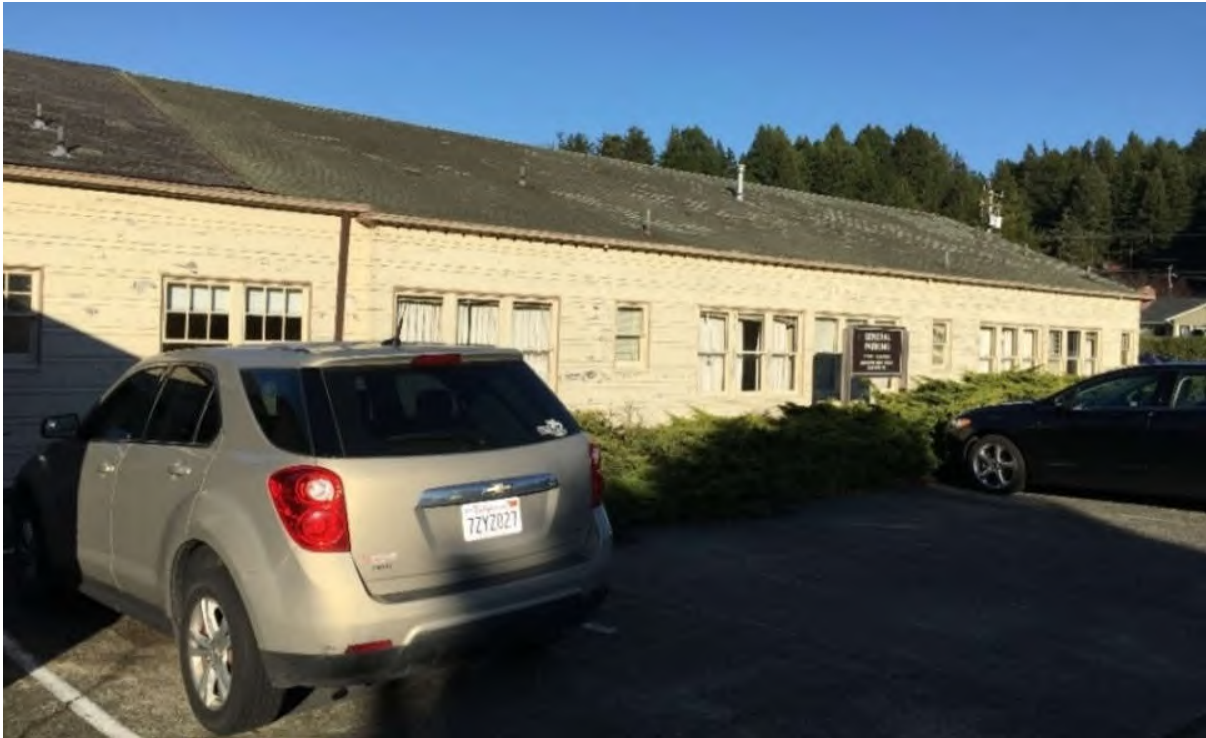
The wing extending east was added in 1948 to accommodate 14 additional hospital beds. As shown in Figure 17, the addition mirrors the mass/scale, roof form and features, and wall cladding and general window patterns seen on the Main Block. In a departure from the Main Block, the 1948 Addition has single-pane, double-hung windows (whereas the Main Block on this elevation exhibits grouped six-over-one sashes). The north elevation faces a landscaped central courtyard; the east elevation features a central entry accessed from a gravel parking lot. The entry contains a simple wood door with the glazing painted, sheltered beneath a small gable roof.

Figure 17 1948 Addition, with New Wards and Beds

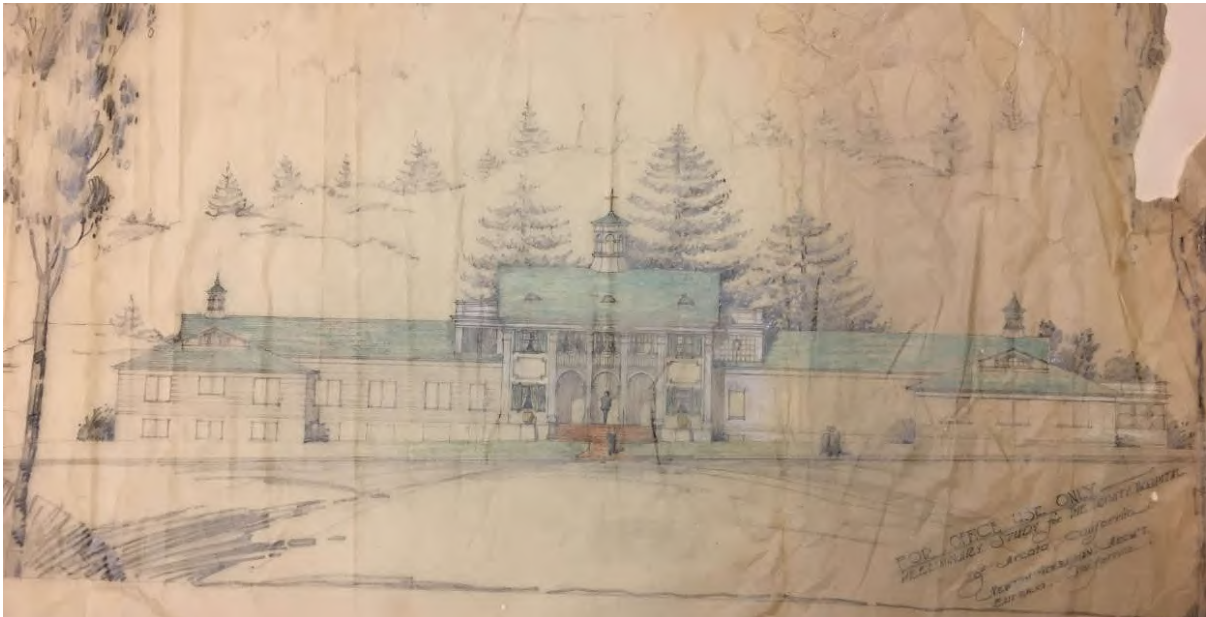
The plans for the new hospital were drafted by local Eureka architect, Newton Ackerman in July 1943. These early plans show the footprint of the complex largely in its current form except for the boiler room/laundry/garage building at the rear of the complex. The west and east elevation plans were revised by architect Gene Verge of Los Angeles in 1944, prior to the building's construction. The early drawings also show that Ackerman envisioned a more ornate building with additional decorative cupolas at each wing of the main building and a grand two-story central pavilion (Figure 22) (Ackerman 1943a, 1943b; Verge c.1944).

Figure 22 Drawing by Ackerman of Trinity Hospital Primary View, 1943 (Ackerman, 1943)
