HSU Trinity Children's Center and Child Development Lab Project

Initial Study-Mitigated Negative Declaration

November 2021

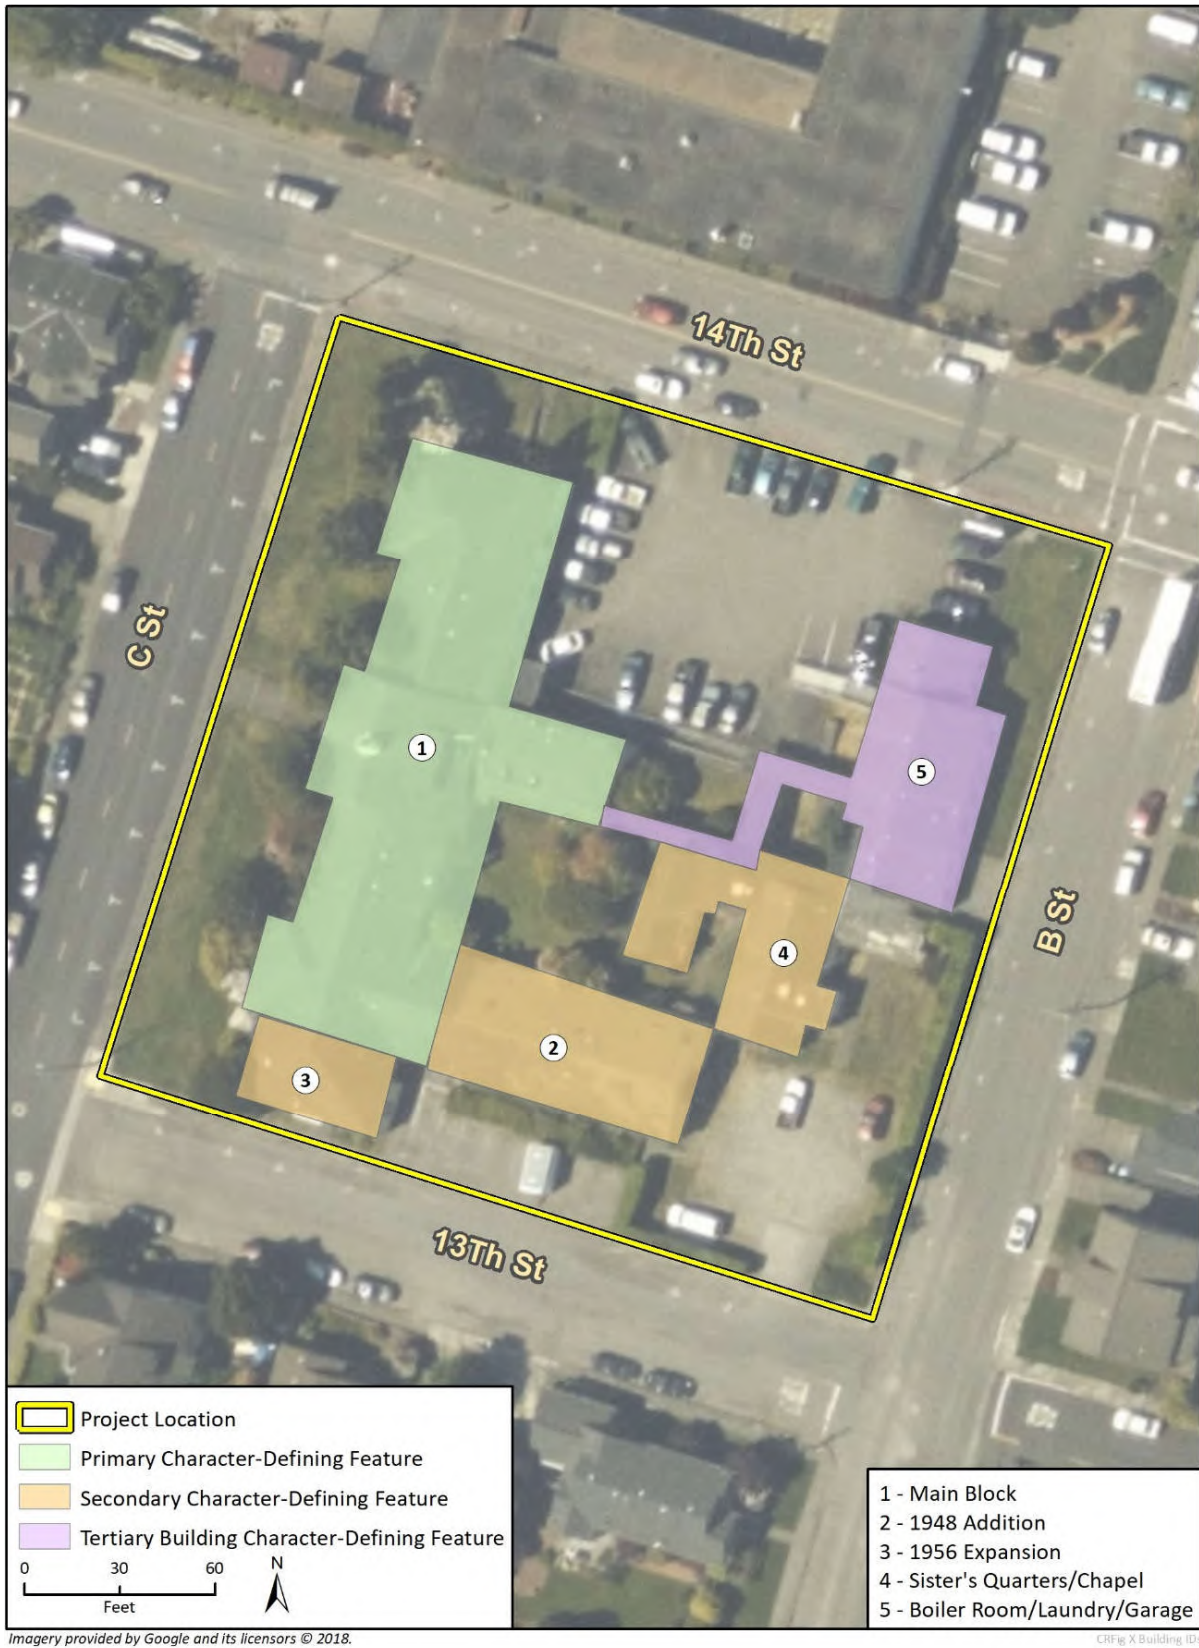
Figure 23 Contributing Components of Trinity Annex

Figure 23 provides an overview of the Trinity Annex site plan and the locations of the Main Block, 1948 Addition, and 1956 Expansion. Descriptions of character-defining features for each of the three contributors follow below.

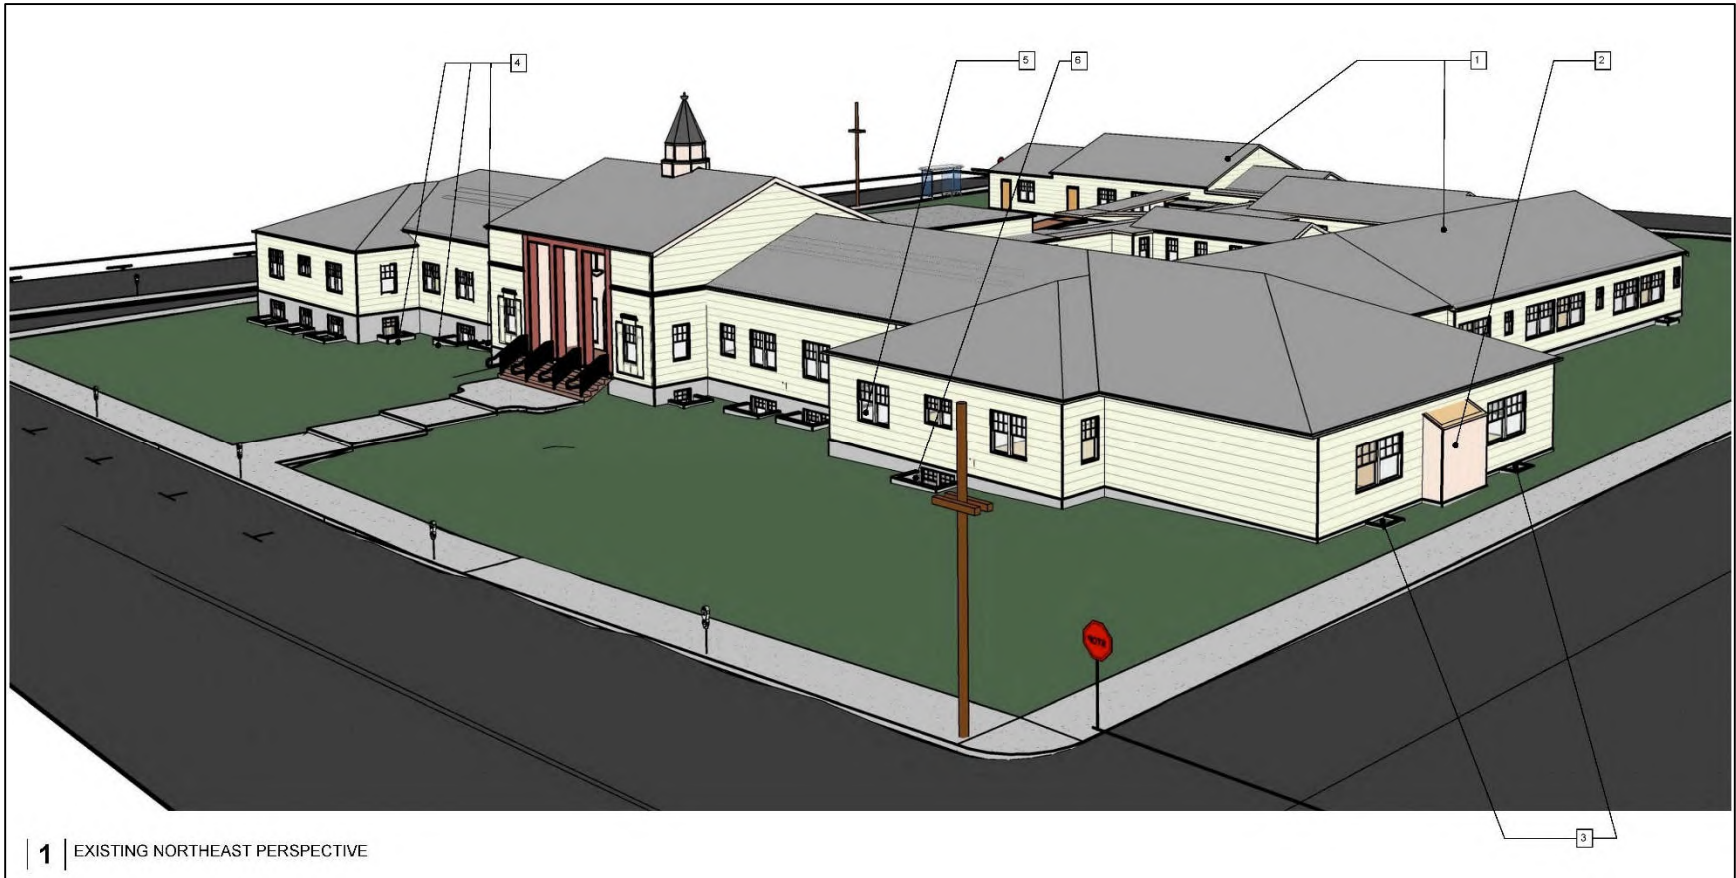
Figure 24 Existing Conditions, Main Block, Façade, Northeast Perspective; Image shows the Colonial Revival-style Features on Main Block Façade and Additions and Sheltered Breezeways on Rear Elevation

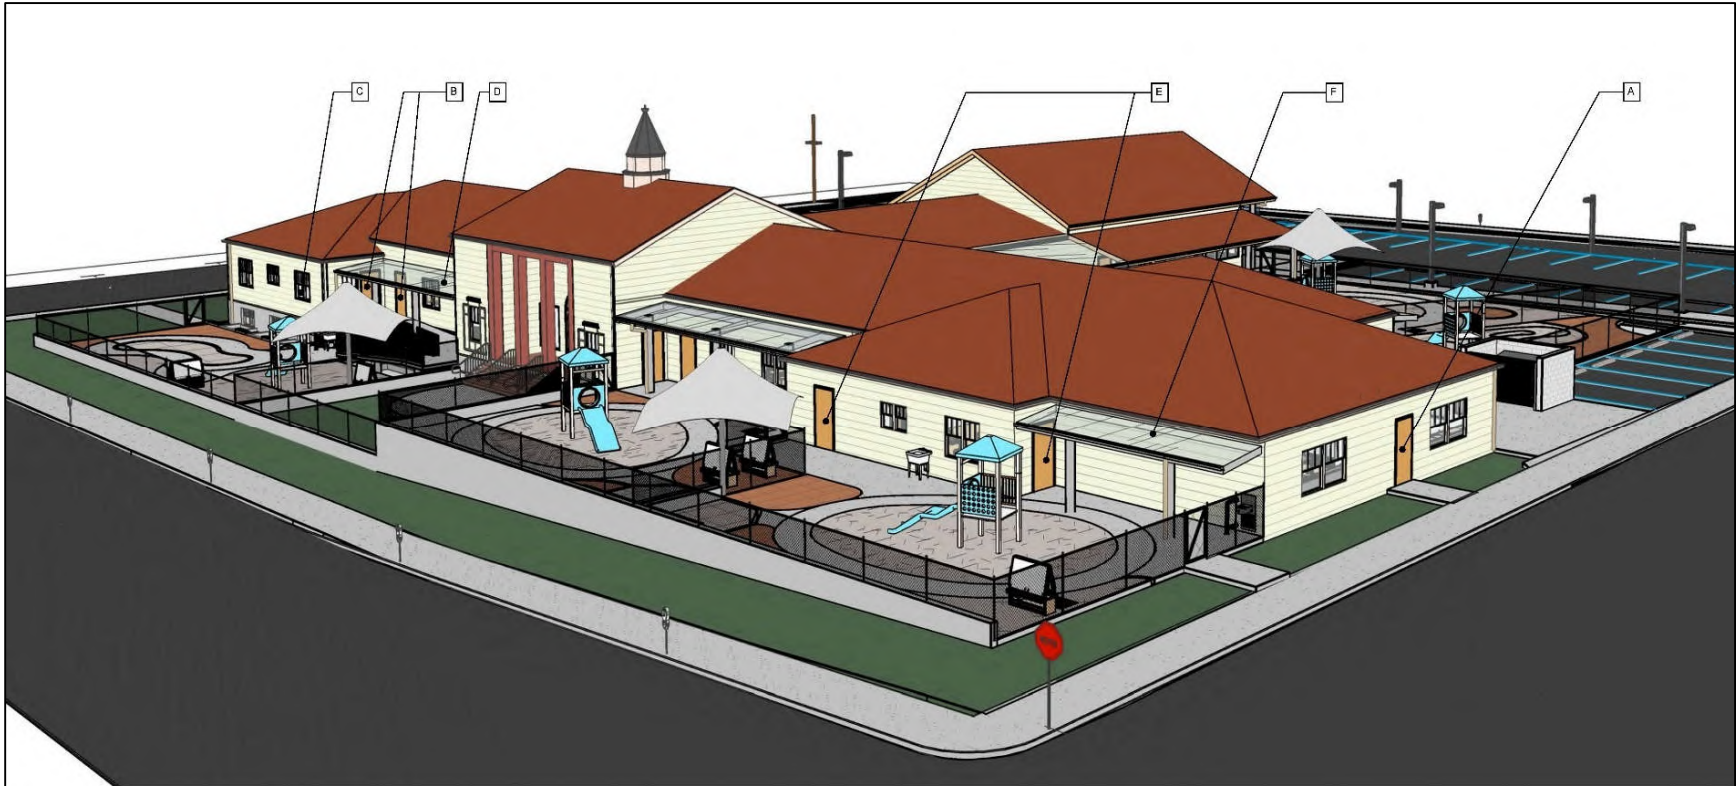
Figure 25 Proposed Northeast Perspective; in Adaptive Reuse, the Main Entrance Would Shift to the Rear Elevation; Arrows Indicate Areas Slated for New Elements, including Code-compliant Egress Doors, Windows, and Sun Canopies

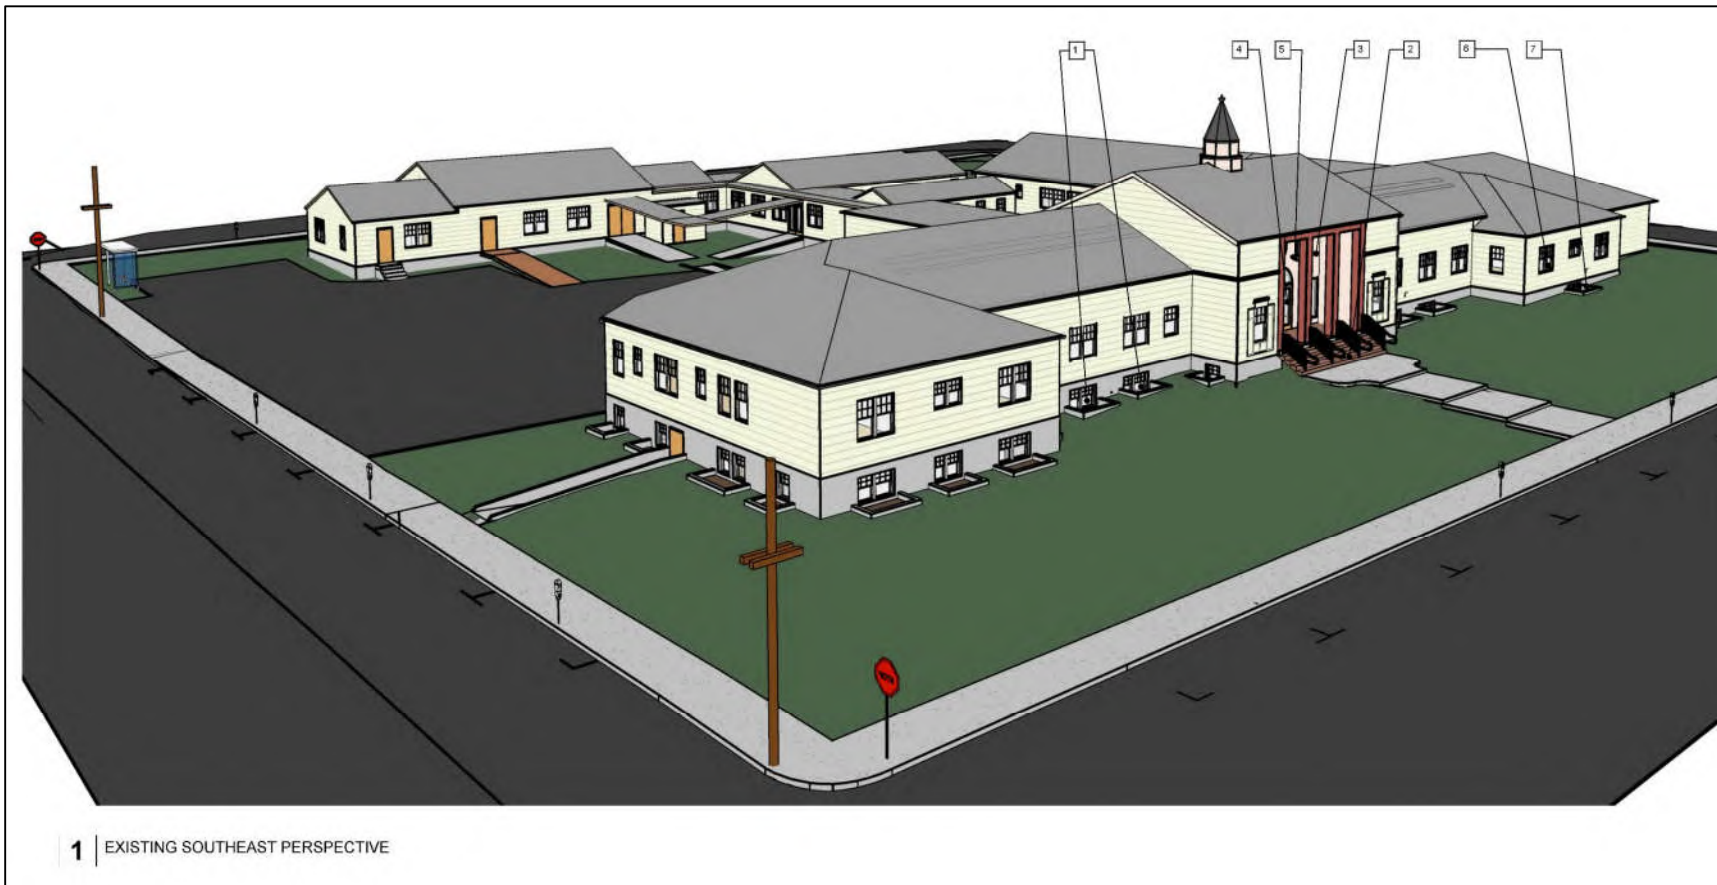
Figure 26 Existing Southeast Perspective, Showing Colonial Revival-style Features on Main Block Façade and Additions and Sheltered Breezeways on Rear Elevation; Arrows Indicate Areas Slated for Alteration, In-kind Replacement, Limited Demolition/Removal

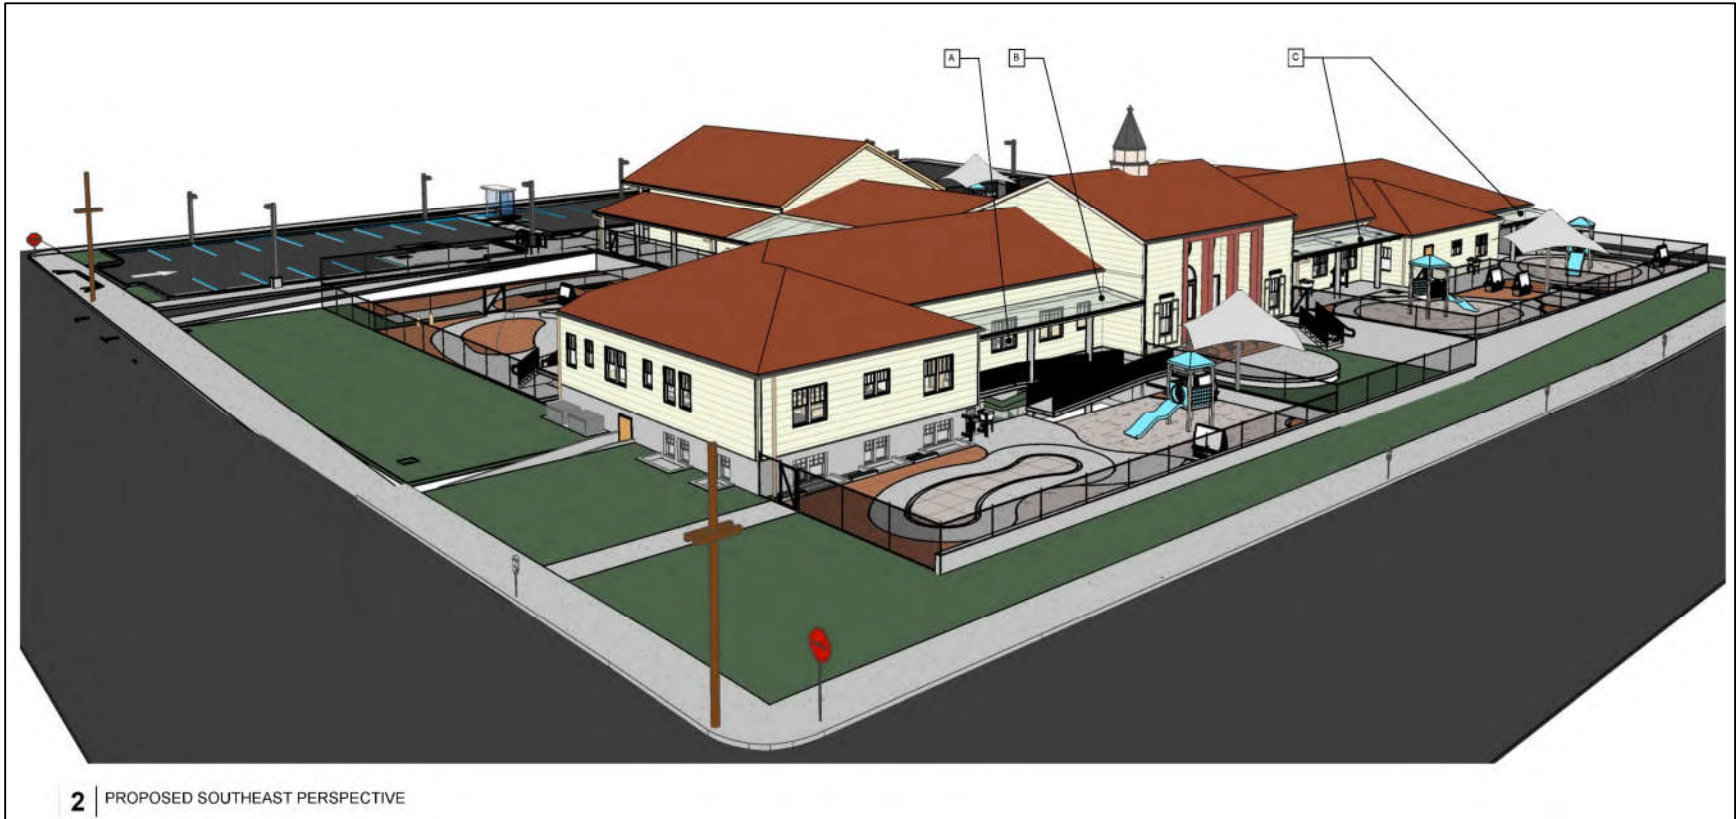
Figure 27 Proposed Southeast Perspective, with Mass/Scale and Colonial Revival-style Features Retained and Adapted for re-use as Childcare Center and Child Development Lab; Arrows Indicate Areas Slated for New Elements, Including Code-compliant Egress Doors, Windows, and Sun Canopies

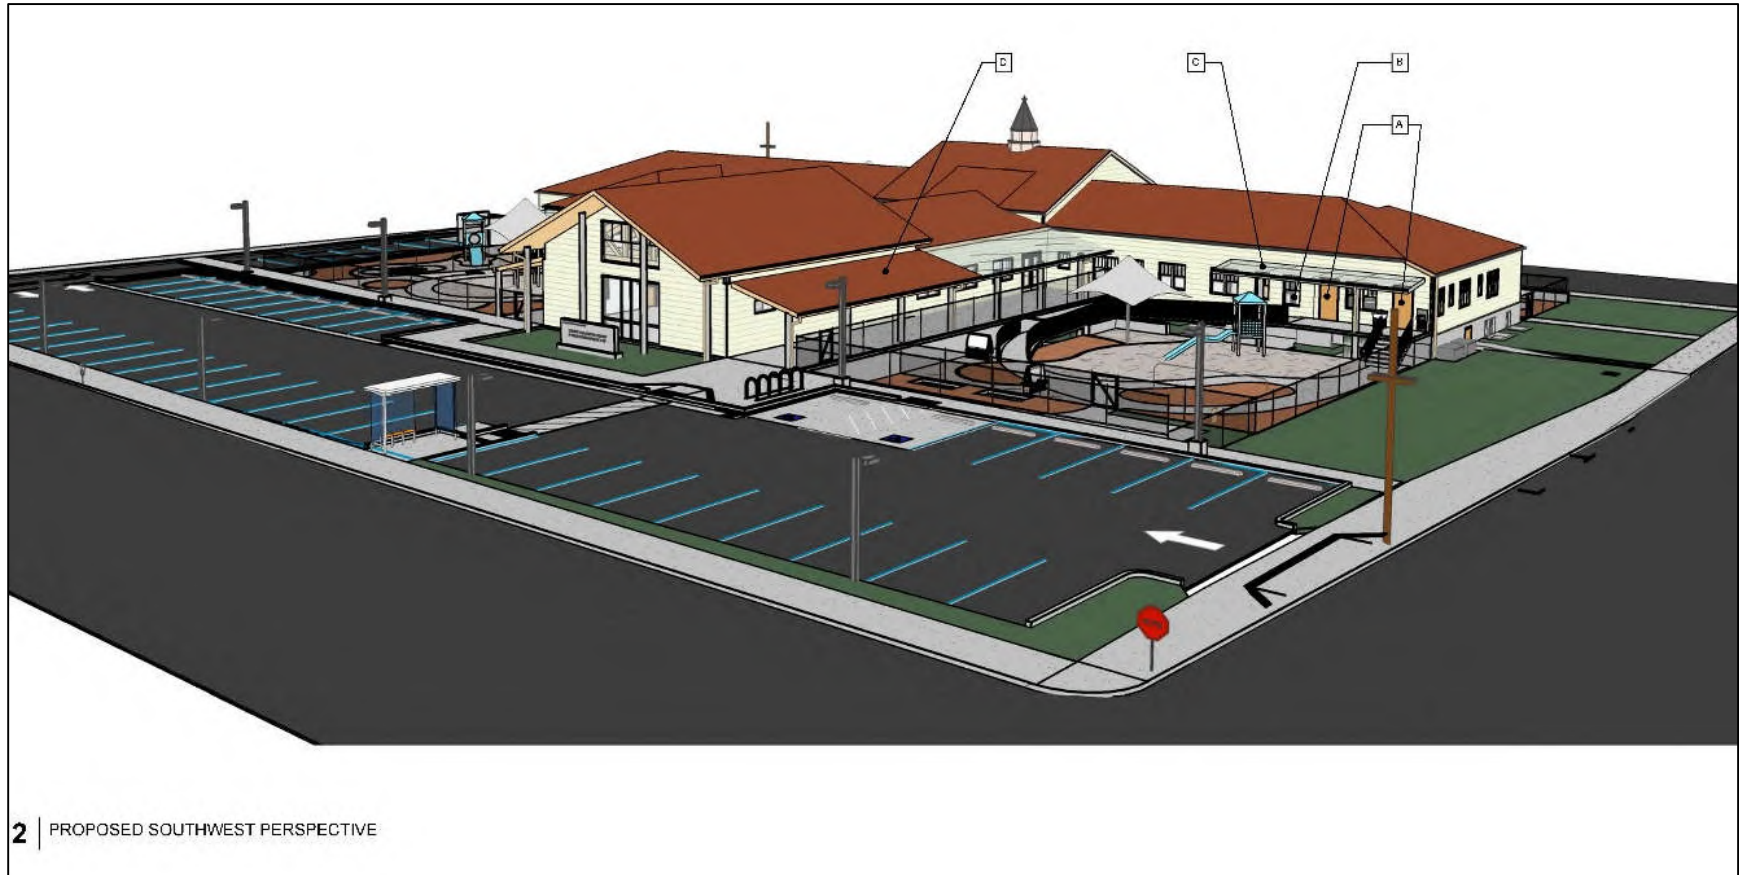
Figure 29 Proposed Southwest Perspective, Showing Proposed, More Compact Site Plan and Compatible New Construction; Arrows Indicate Areas Slated for New Elements, Including Code-compliant Egress Doors, Windows, and Sun Canopies

Hello, the relocated bus stop will be situated adjacent to the existing B Street sidewalk about halfway between 13th Street and 14th Street, in front of the new addition. If you look at page 53 of the Cultural Resources Technical Report, Figure 29, the bus stop is visible. I have also added the preliminary design drawings to our website under Project Documents titled 'Preliminary Drawings (100%)' <https://facilitymgmt.humboldt.edu/trinity-annex-project>. The bus stop is identified on several plan sheets, including the cover sheet G0.00 and site plan sheet C3.0 (called out as #25 in the legend). Please let me know if you have further questions.

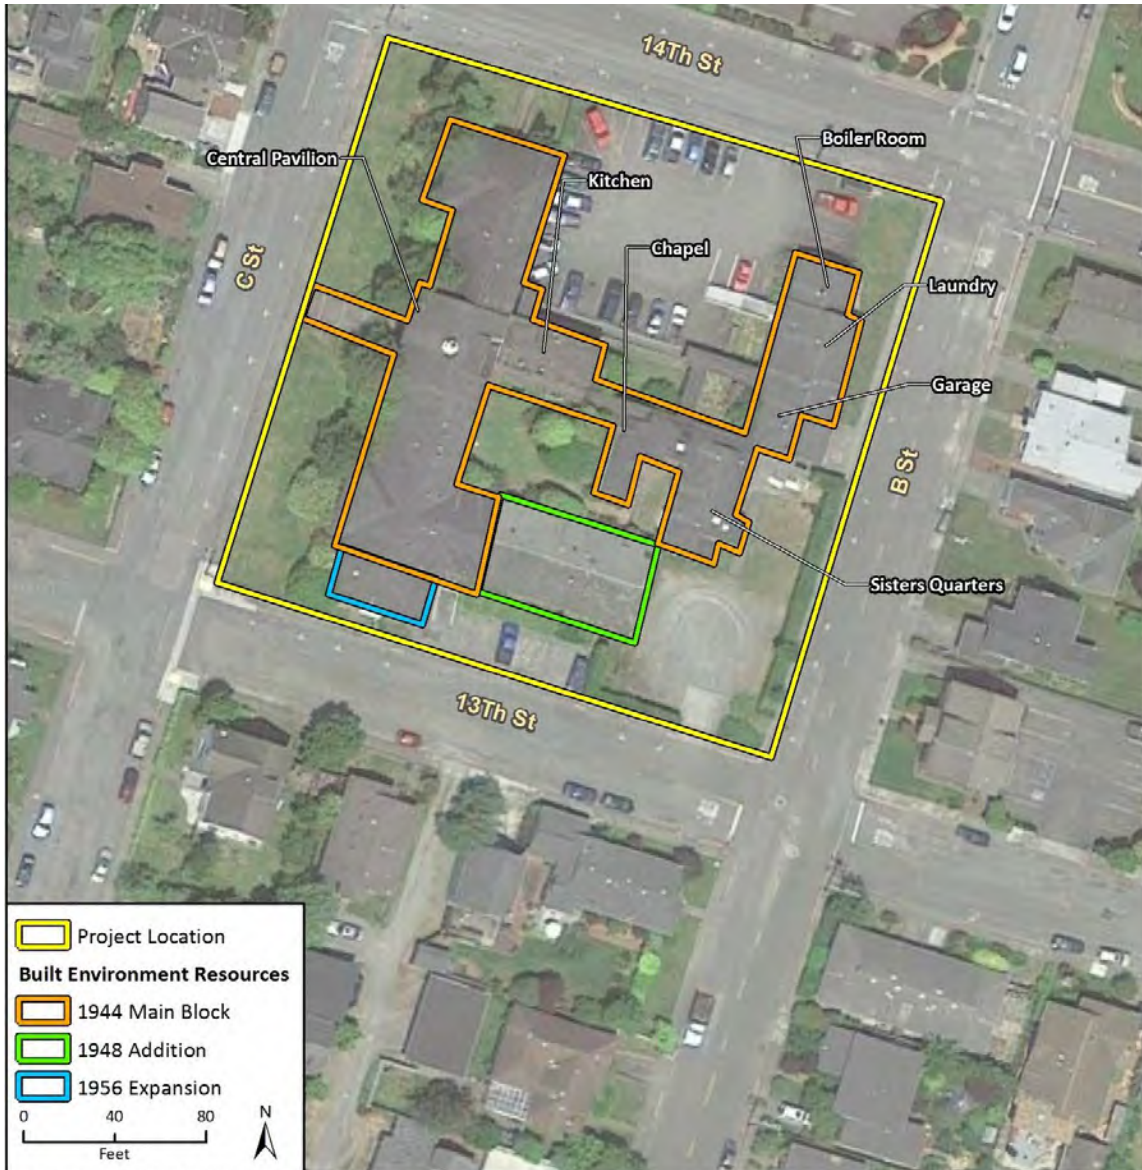
Fig 9. Built Environment Resources

Overall, Trinity Annex consists of the three connected components: (1) Main Block, 1943-1944; (2) 1948 Addition; and (3) 1956 Expansion. The Main Block represents the hospital's signature elevation along the façade, with its Colonial Revival-style architecture. The rear elevation, which lacks the Colonial Revival styling and presents a more utilitarian design, contains all the functional spaces of the facility, including the kitchen, laundry room, boiler room, and garage, as well as a Chapel and Sisters' Quarters, which were relocated to the rear elevation of the hospital at the time of its construction. Many of these facilities are stand-alone buildings, connected to the Main Block through covered breezeways and connection points. The Main Block occupies the western portion of the parcel. The figure below provides a visual overview of the complex.

Trinity Annex, Overview of Construction Chronology and Components

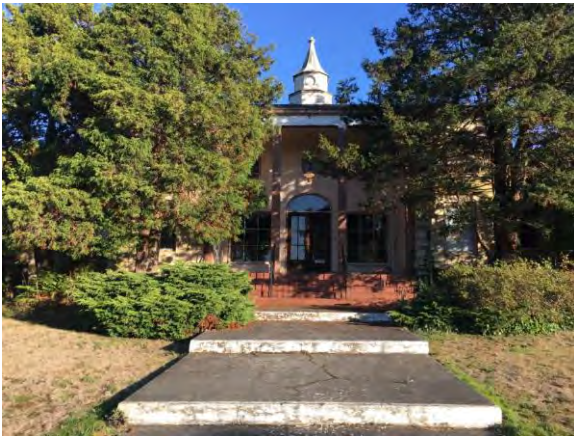
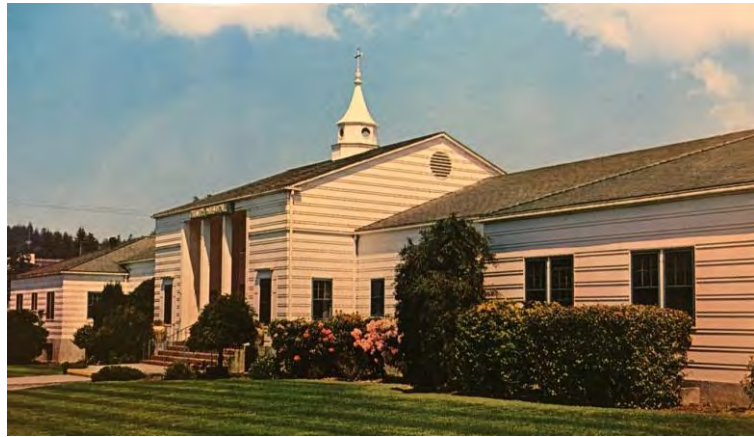
Main Block, Trinity Hospital, current and historic views of Façade

The height of the central pavilion, as well as the decorative cupola with an oculus atop the ridge of its roof, distinguishes it from the rest of the façade. It is divided into three bays and is reached by a short flight of wide concrete steps set from the sidewalk and a set of Mexican paver steps topped by metal railing. The center bay containing the entrance is recessed and features two full-height columns of wood posts supporting the extended eave and simple cornice at the roof, which shelters the pavilion. The main entrance is a wood-frame, double-hinged door with multi-pane glazing, and a fan light above, flanked by large wood-frame, multi-pane, fixed windows. Smaller fixed decorative and jalousie windows are at the clerestory level. A drop light hangs from the pavilion ceiling. Pilasters similar to the post columns cap the edges of the flanking wood bays of the central pavilion. The pavilion walls are sheathed in vertical flush board siding.

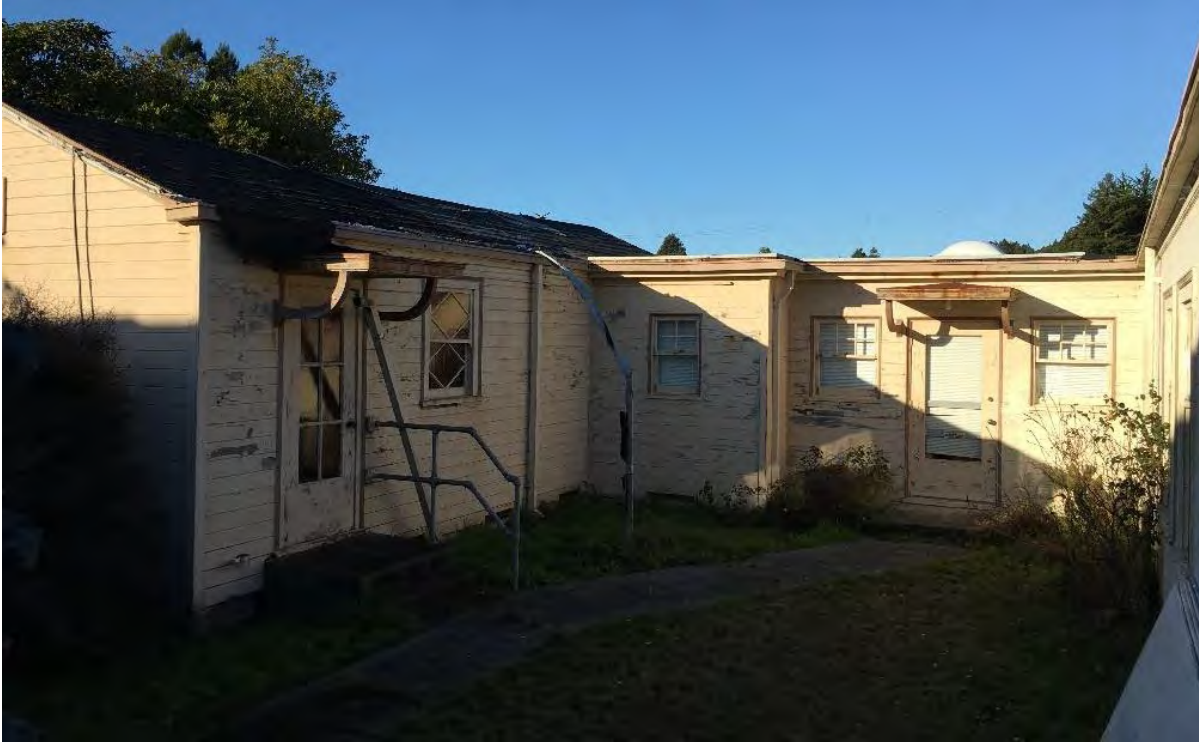
Main Block, Chapel (left), with Flat-roof Segment Connecting to Sisters' Quarters (right); Both Buildings were Relocated to the Site in 1944 and Incorporated into Trinity Hospital Footprint

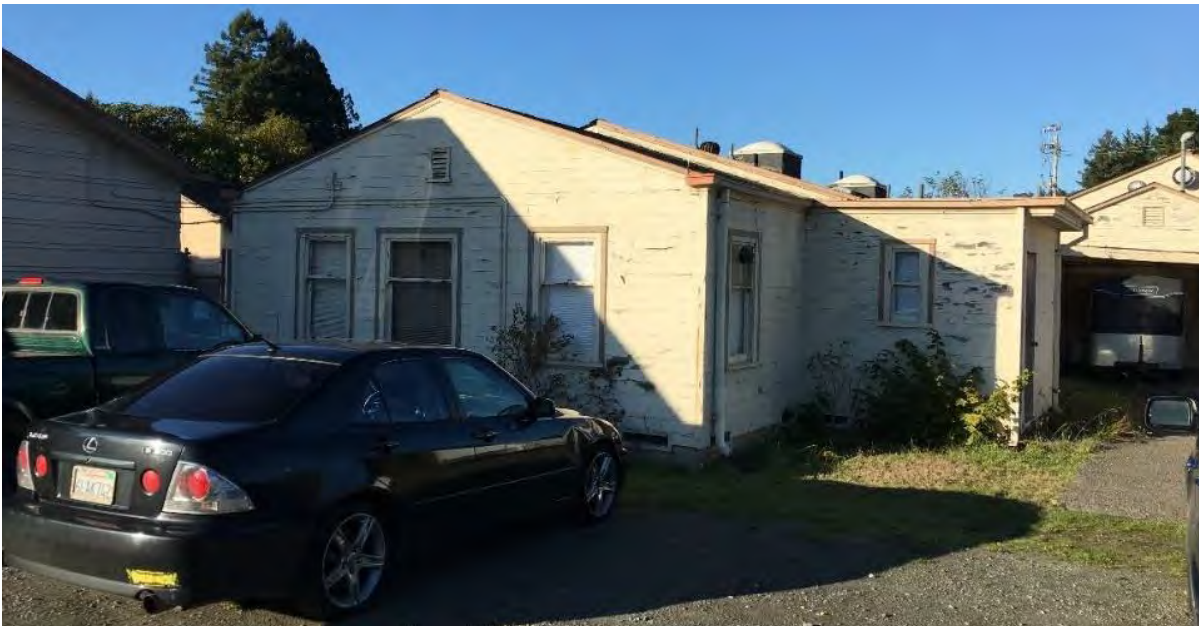
Main Block, Sisters' Quarters

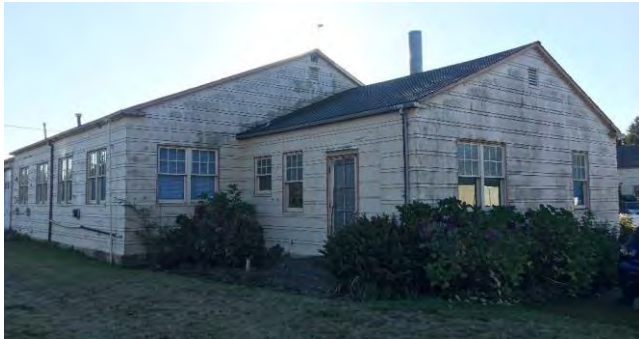
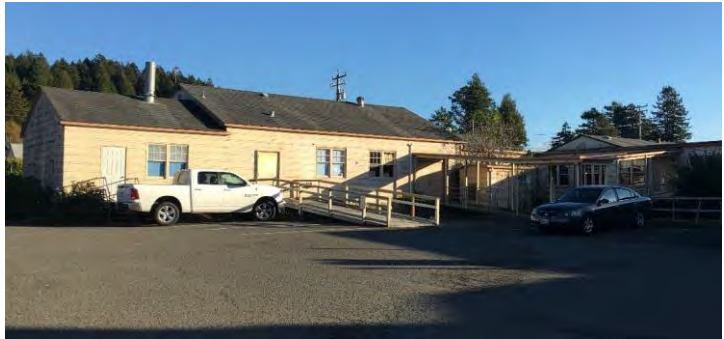
Main Block, Boiler Room and Laundry (left); West Elevation, Laundry/Boiler Room (right)

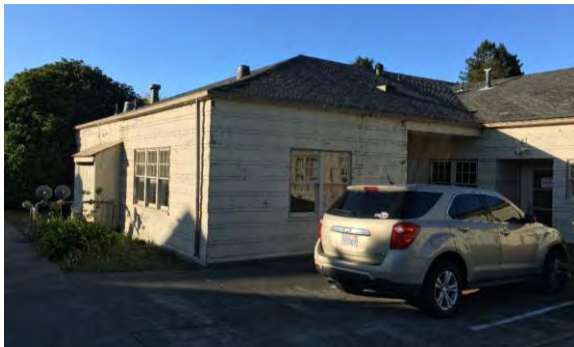
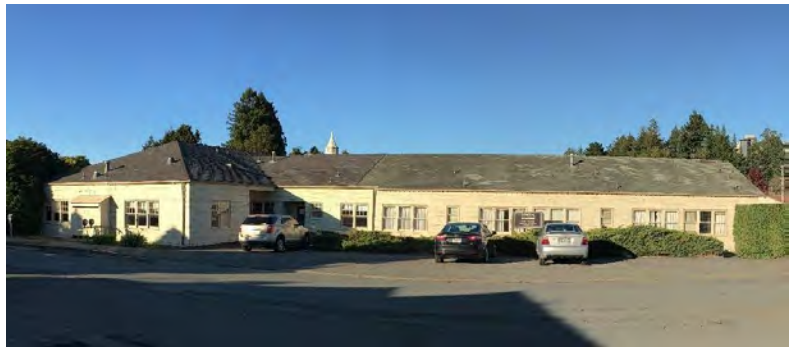
The wing extending east was added in 1948 to accommodate 14 additional hospital beds. The addition mirrors the mass/scale, roof form and features, and wall cladding and general window patterns seen on the Main Block. In a departure from the Main Block, the 1948 Addition has single-pane, double-hung windows (whereas the Main Block on this elevation exhibits grouped six-over-one sashes). The north elevation faces a landscaped central courtyard; the east elevation features a central entry accessed from a gravel parking lot. The entry contains a simple wood door with the glazing painted, sheltered beneath a small gable roof.

1956 Extension, South Wing (left); 1948 Addition (Right)

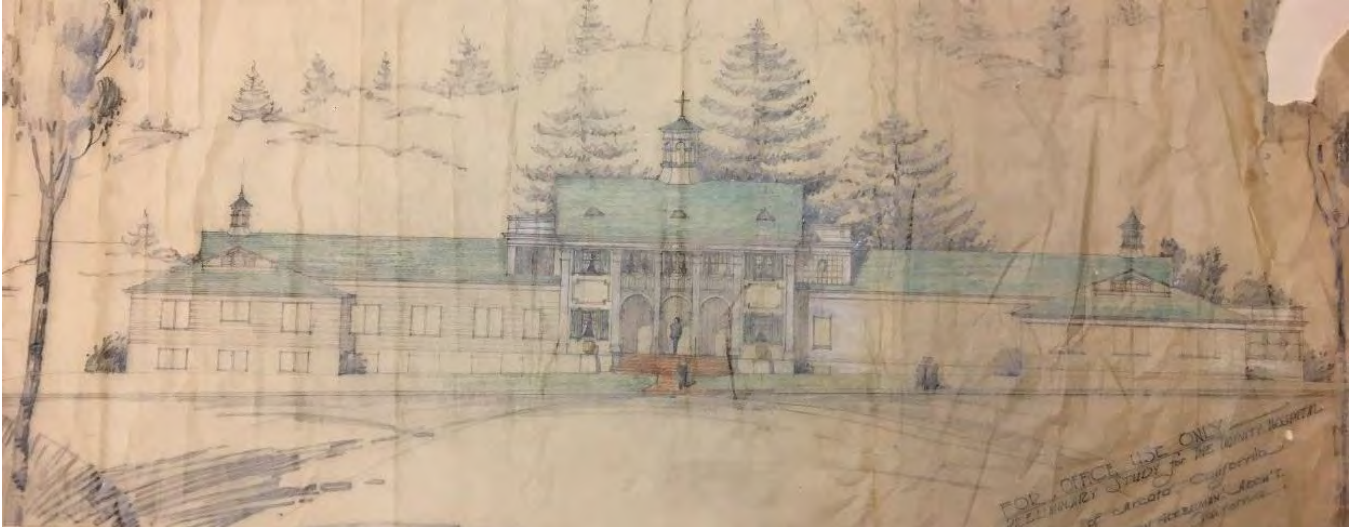
The plans for the new hospital were drafted by local Eureka architect, Newton Ackerman in July 1943. These early plans show the footprint of the complex largely in its current form except for the boiler room/laundry/garage building at the rear of the complex. The west and east elevation plans were revised by architect Gene Verge of Los Angeles in 1944, prior to the building’s construction. The early drawings also show that Ackerman envisioned a more ornate building with additional decorative cupolas at each wing of the main building and a grand two-story central pavilion (Figure 21) (Ackerman 1943a, 1943b; Verge c.1944).

Drawing by Ackerman of Trinity Hospital Primary View, 1943

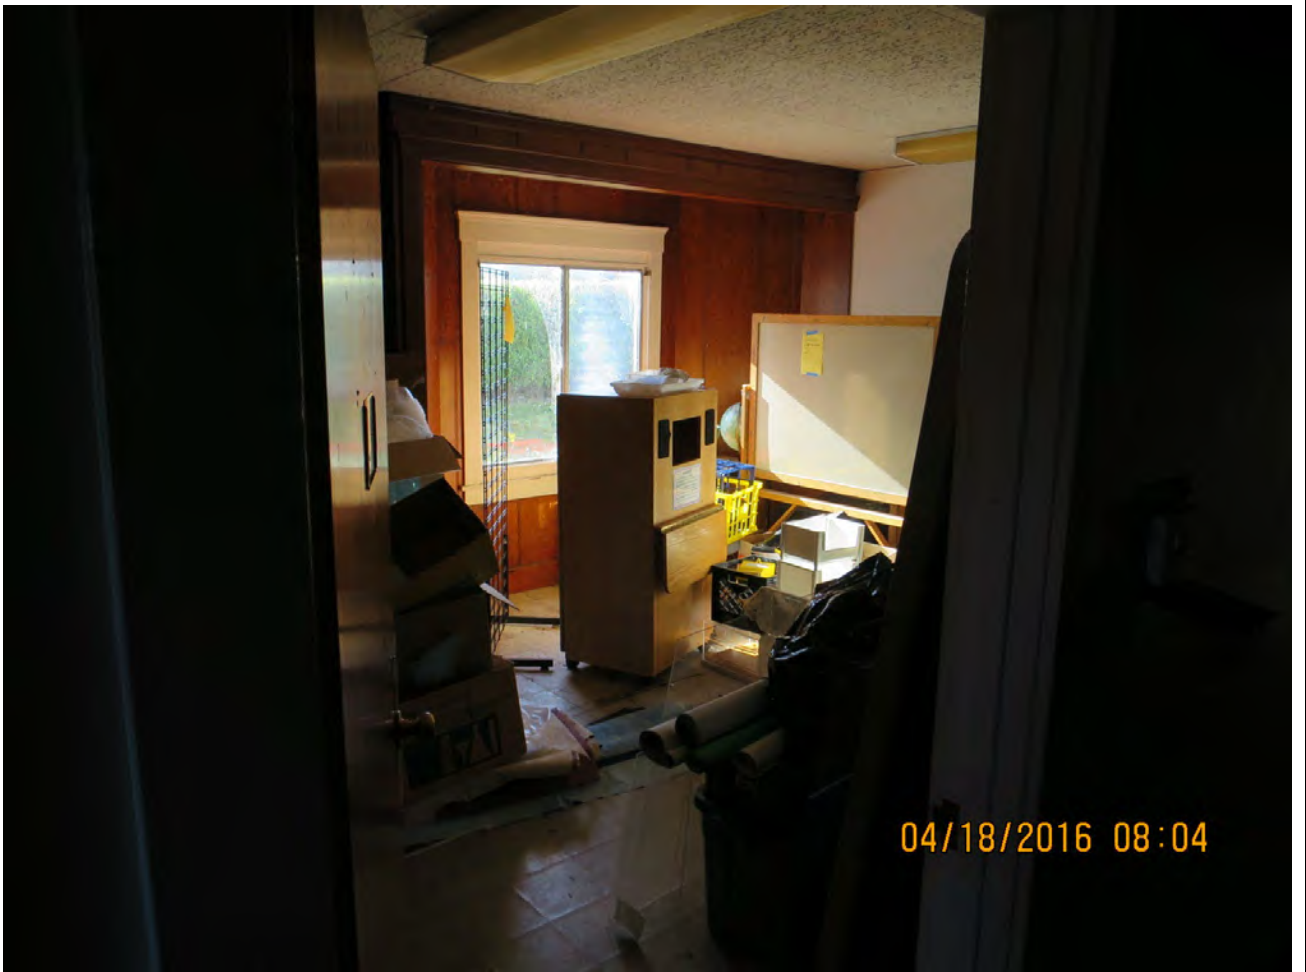
TA-56	corridor at Room 133	ND		
bluish 1x1 ceiling tile above the boiler	TA-94	basement boiler room	ND		
1x2 ceiling tile on drywall ceiling in the addition	TA-114	in Room 156A	ND		
	TA-116	in Room 160	ND		
mastic adhering the 1x2 ceiling tile in Rooms 156A and 160, Photo 12, roughly 250 square feet	TA-115	in Room 156A	2	1	NF
	TA-117	in Room 160	2		
large hole pattern 1x1 ceiling tile	TA-120	in Room 161	ND		
	TA-121	in Room 159	ND		
cove base	TA-29	in Room 116	ND		
	TA-36	in Room 118	ND		
	TA-60	in Room 135	ND		
	TA-105	in Room 139	ND		
cove base mastic	TA-30	in Room 116	ND		
	TA-37	in Room 118	ND		
	TA-61	in Room 135	ND

Photo 12: Room 160 with asbestos floor tile and 1' x 2' ceiling tile adhered with asbestos mastic

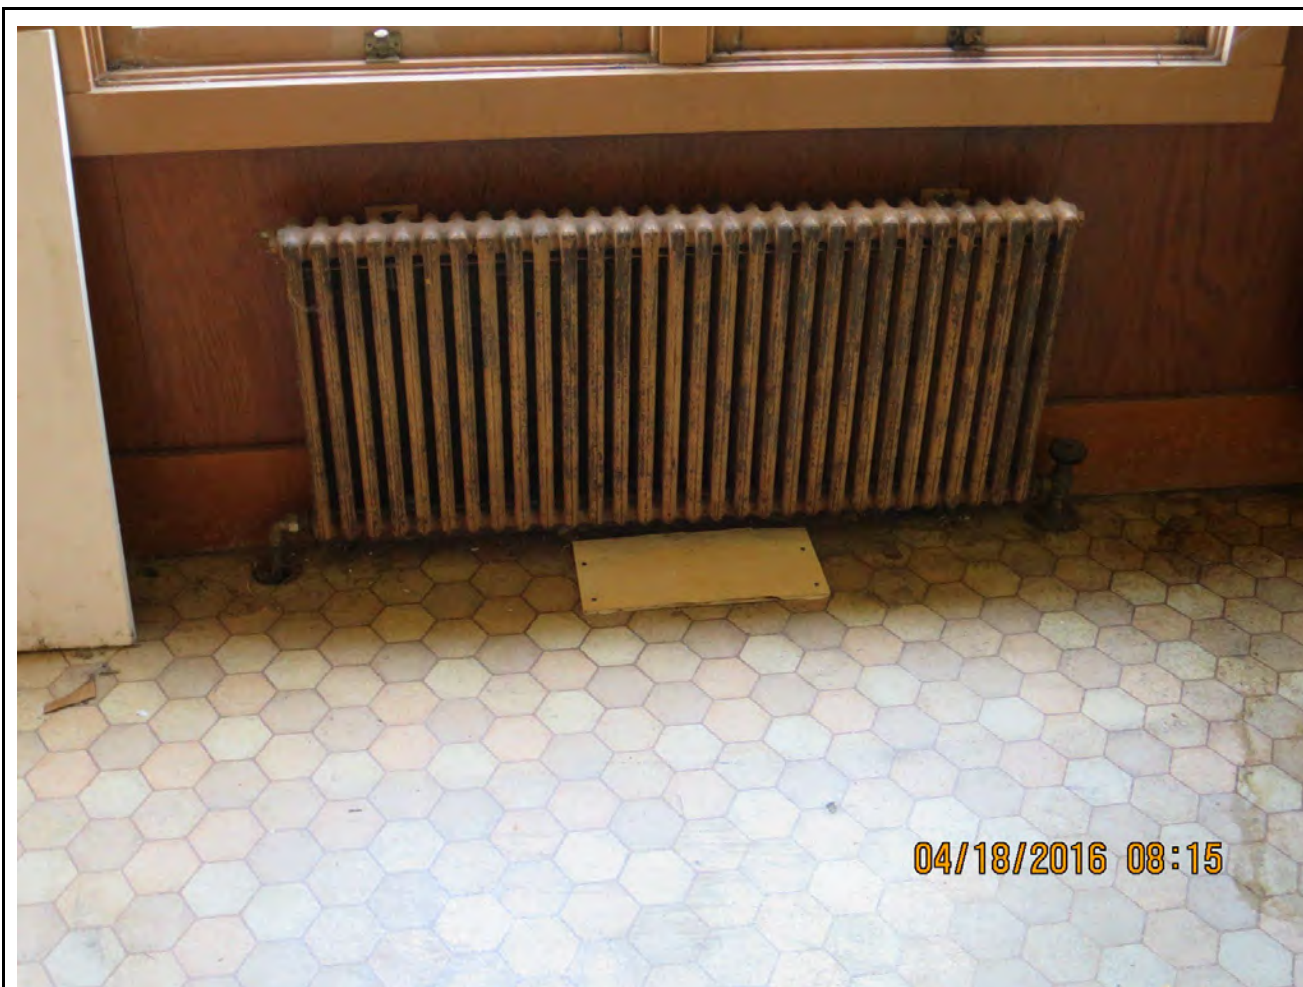
apparently ground or crushed redwood bark. We observed newer HVAC ducts insulated with fiberglass and several newer gas furnaces, but the original heating system is a boiler with asbestos insulation on the pipes and flue. We observed one asbestos-cement electrical conduit, as well as a small quantity of asbestos-cement sheets. The boiler is insulated with fiberglass.

Photo 16: A typical original radiator, this one in Room 158, a corridor

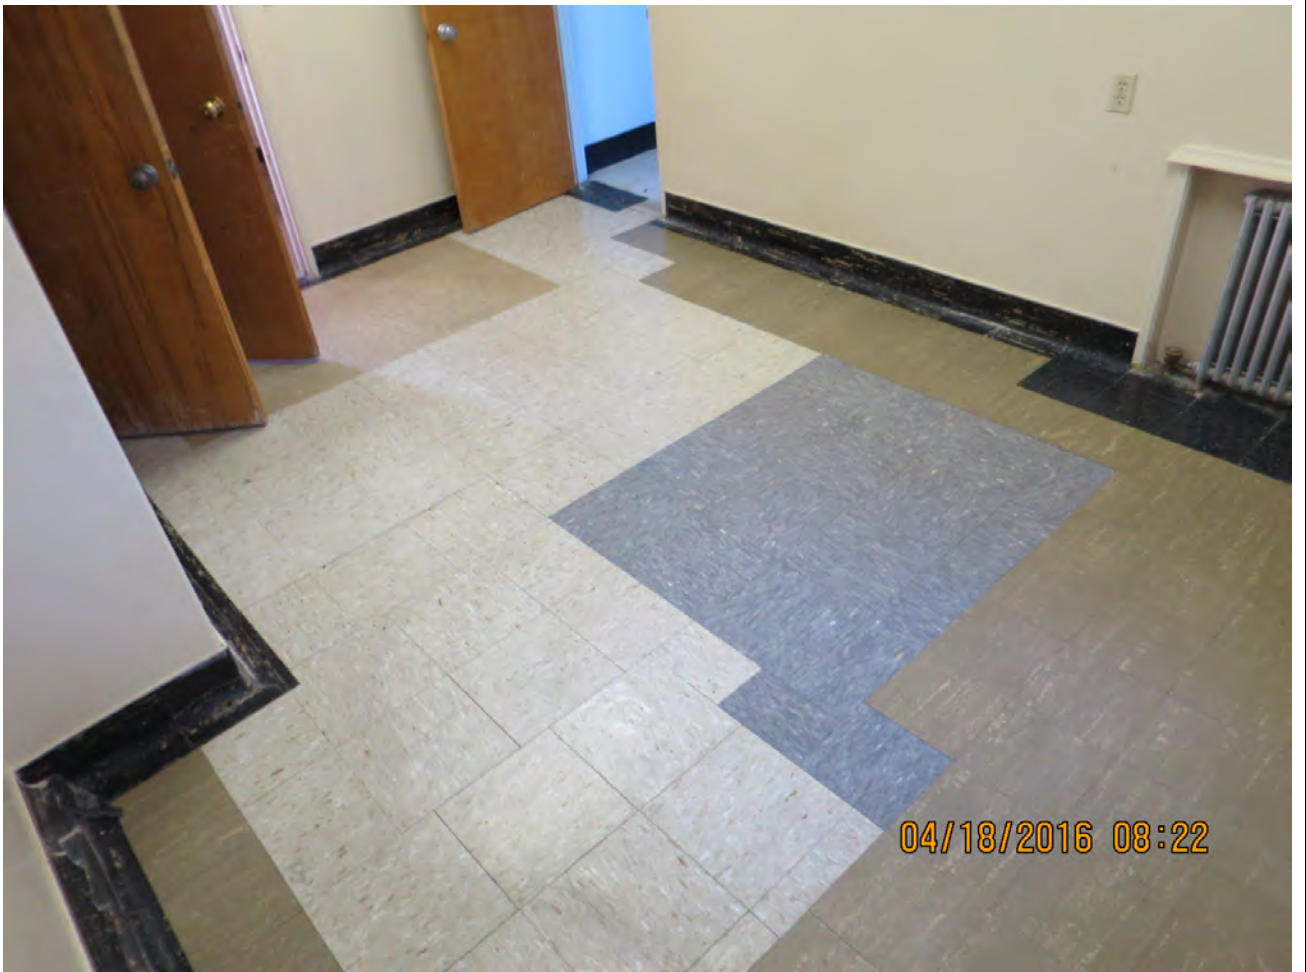
Photo 20: Various flooring in Room107, black and greenish floor tile are asbestos

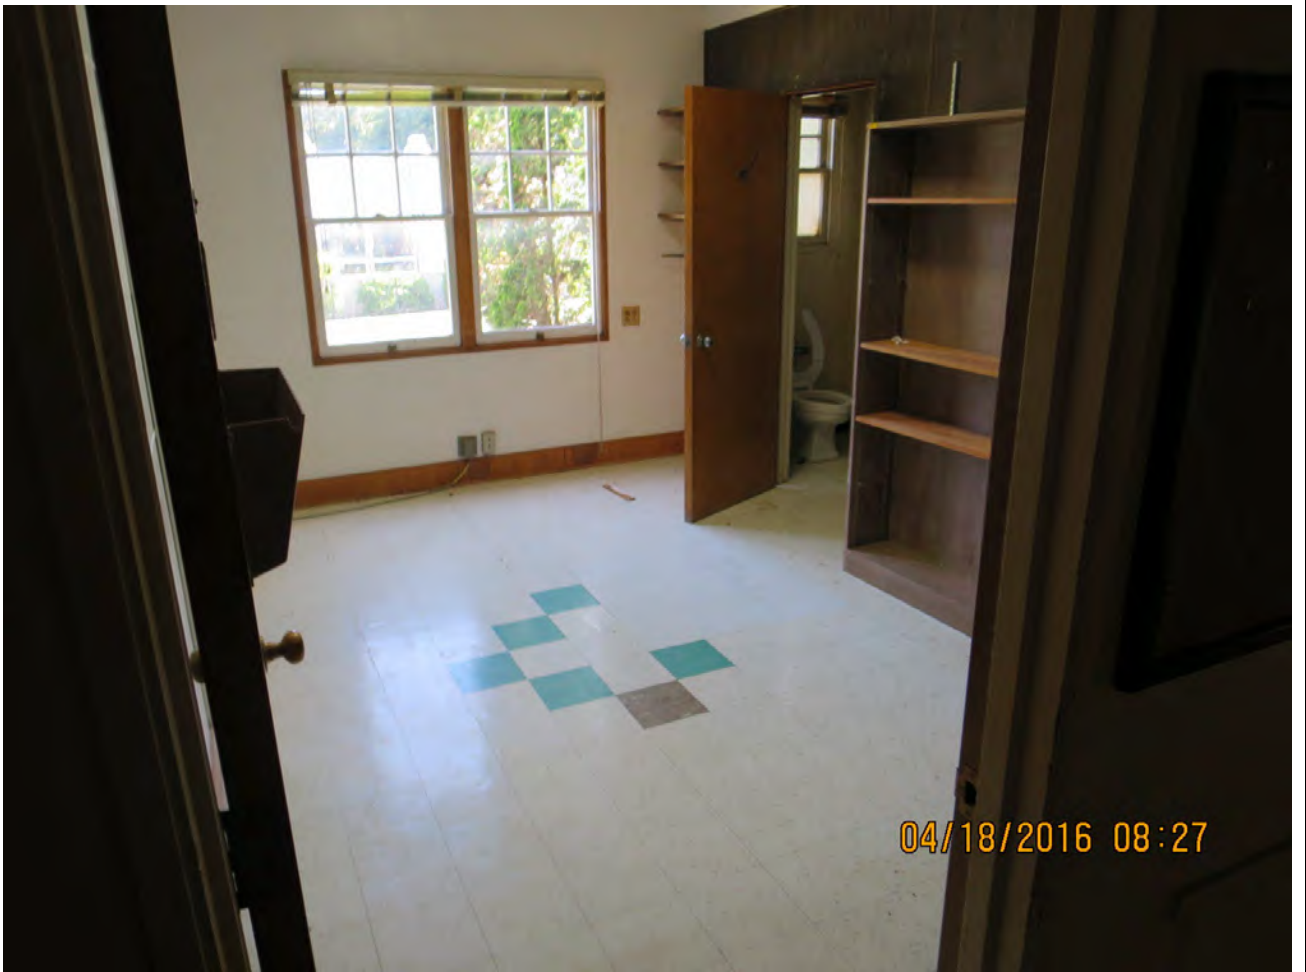
Photo 24: Room 101 with asbestos 9x9 vinyl floor tile

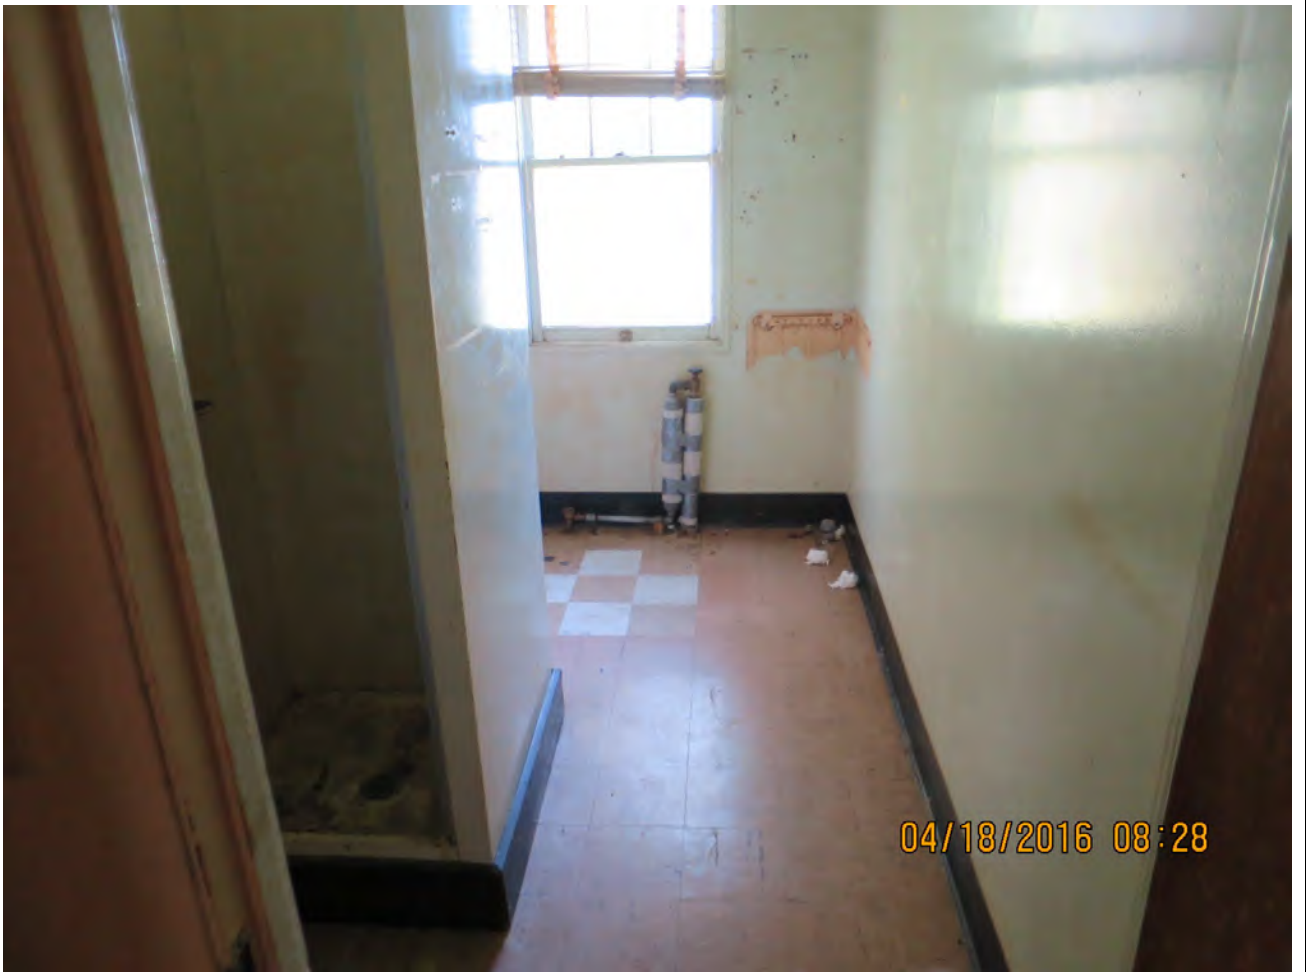
tan 9x9 vinyl floor tile in Room 116	TA-28	in Room 116 over linoleum	2		
tan with streaks 9x9 vinyl floor tile in Rooms 123A, Room 127, Room 100, Photo 25	TA-31	in Room 123A, center	3		
	TA-46	in Room 127, near the door	5		
speckled tan 9x9 vinyl floor tile in Room 118	TA-34	in Room 118, center	3		
greenish with streaks 9x9 vinyl floor tile in Room 107, Photo 20	TA-67	in Room 107, center	4		
black 9x9 vinyl floor tile installed around the room edges, Photo 20	TA-69	in Room 107	4		
whitish with sparkles 9x9 vinyl floor tile in Room 101, Photo 24,	TA-73	Room 101, corner	2		
whitish with smears 9x9 vinyl floor tile in Room 102, Photo 49	TA-76	Room 102, center	2

Photo 25: Room 100, with air-cell pipe insulation and asbestos floor tile
