HSU Trinity Children's Center and Child Development Lab Project

Initial Study-Mitigated Negative Declaration

November 2021

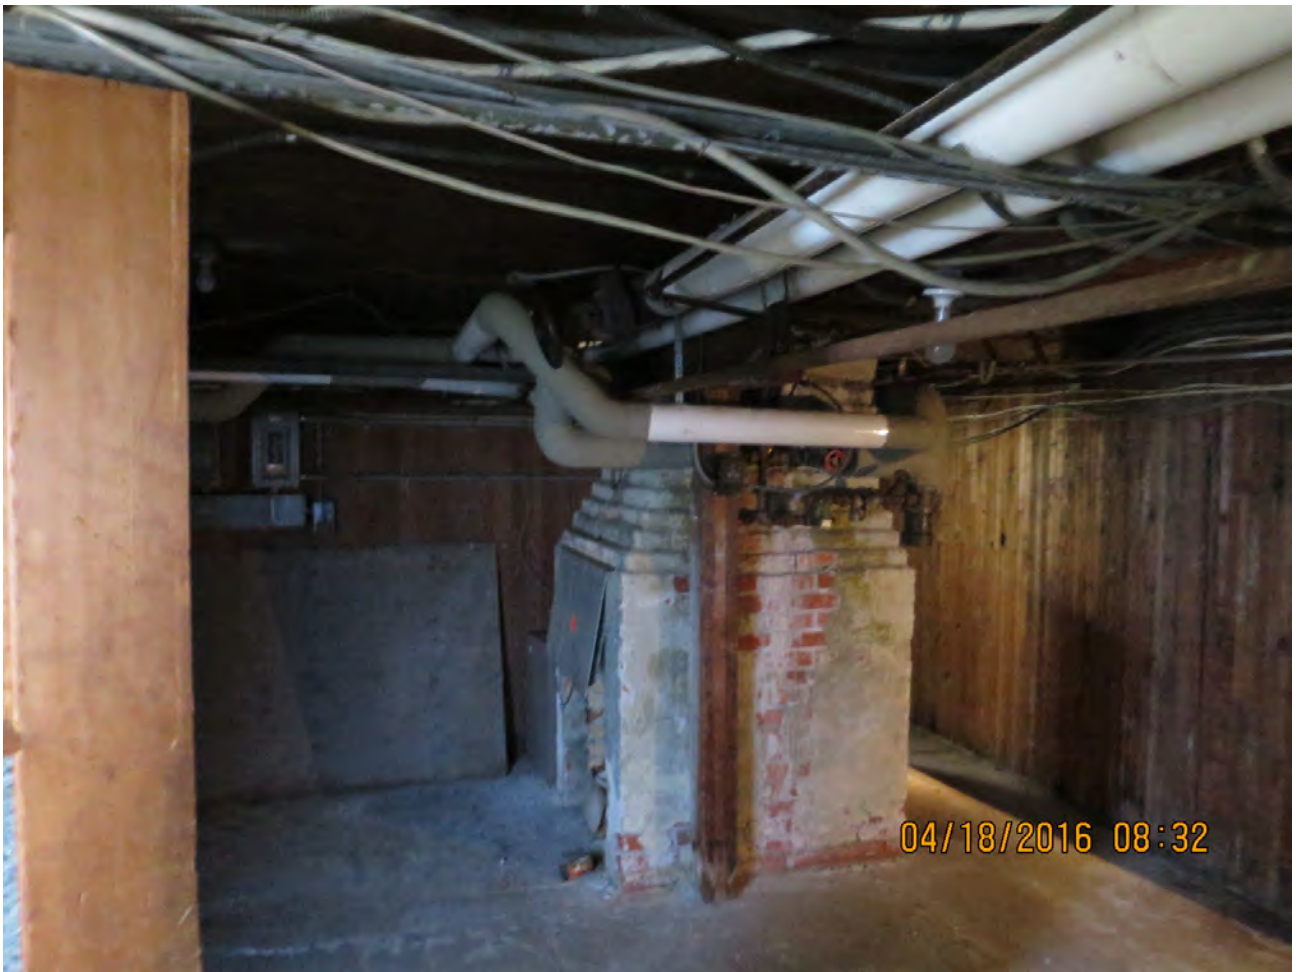
Photo 26: The incinerator and new coverings over pipes with old asbestos insulation

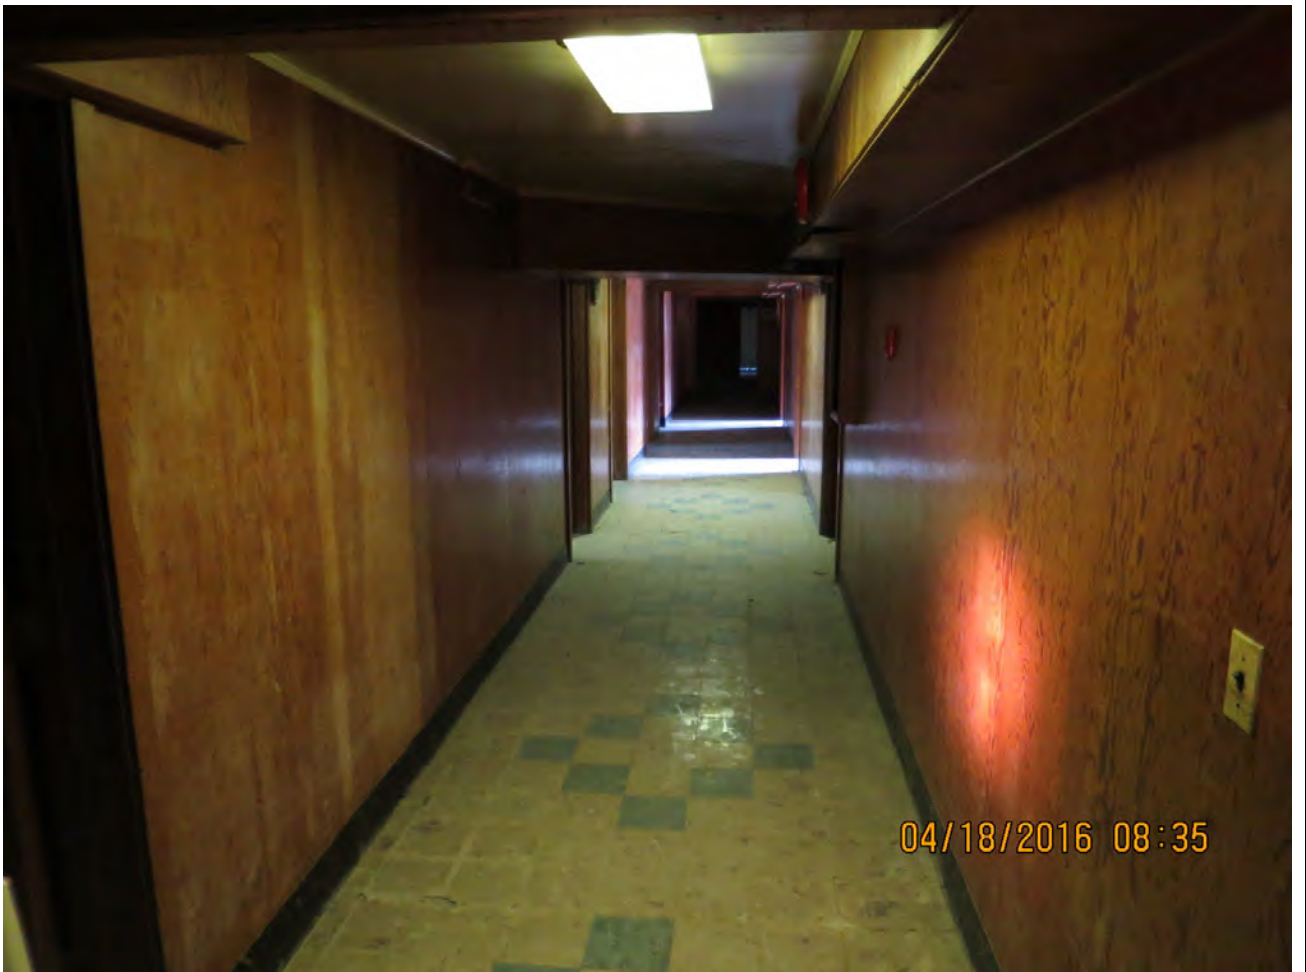
Photo 27: The portion of the basement corridor with asbestos 9" x 9" vinyl floor tile

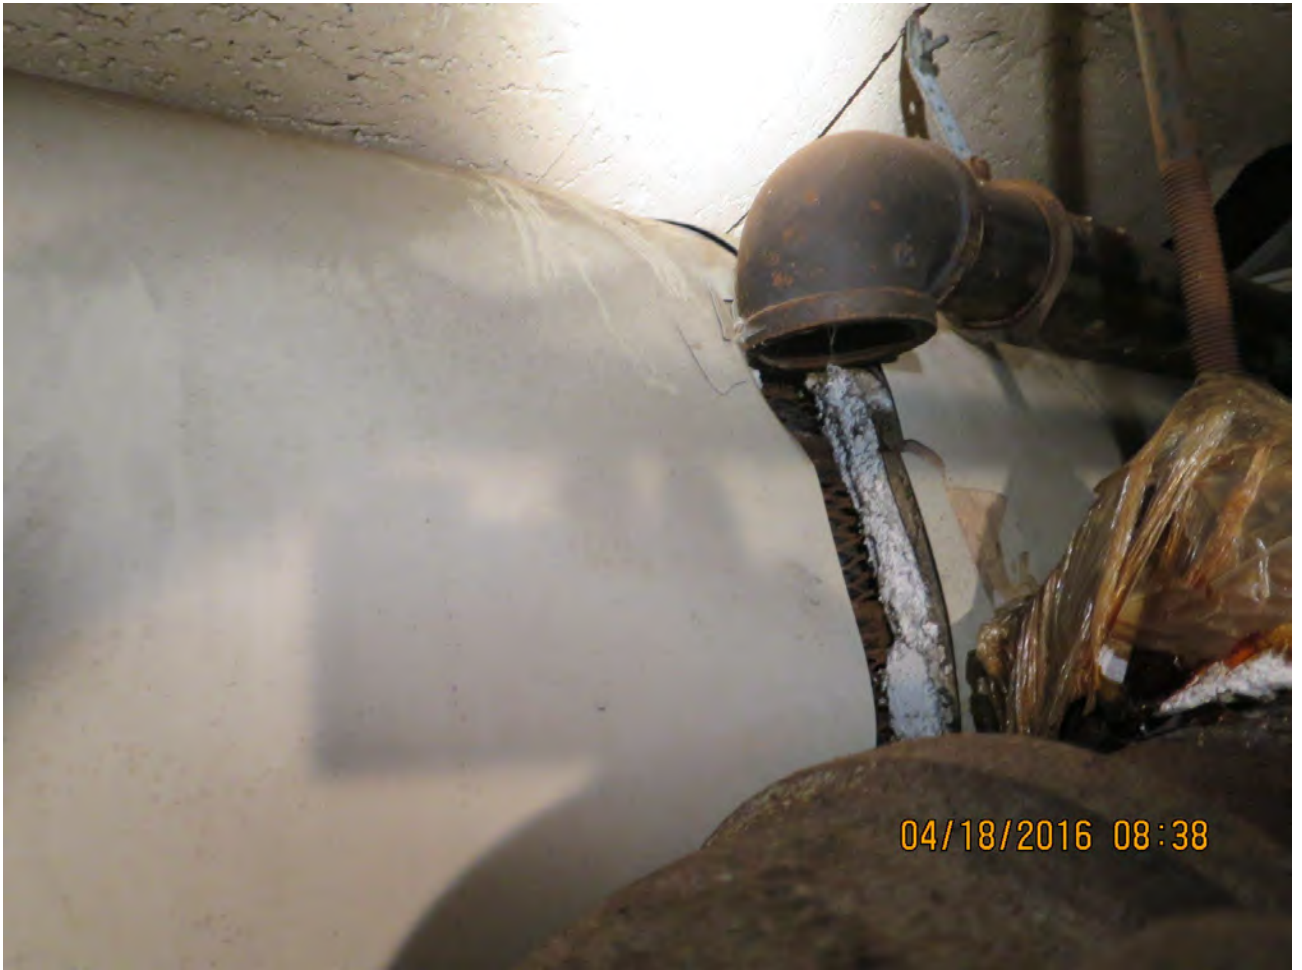
two approximately 6" diameter asbestos cement flue pipes above Room 150, roughly 15 linear feet	n/a	n/a - assumed, identified visually	n/a	1	NF
The boiler flue pipe insulation, Photo 30, roughly 200 square feet	n/a	n/a - assumed, identified visually	n/a	5d	F

apparently ground or crushed redwood bark. We observed newer HVAC ducts insulated with fiberglass and several newer gas furnaces, but the original heating system is a boiler with asbestos insulation on the pipes and flue. We observed one asbestos-cement electrical conduit, as well as a small quantity of asbestos-cement sheets. The boiler is insulated with fiberglass.

Photo 30: Old asbestos insulation under a newer covering on the boiler flue

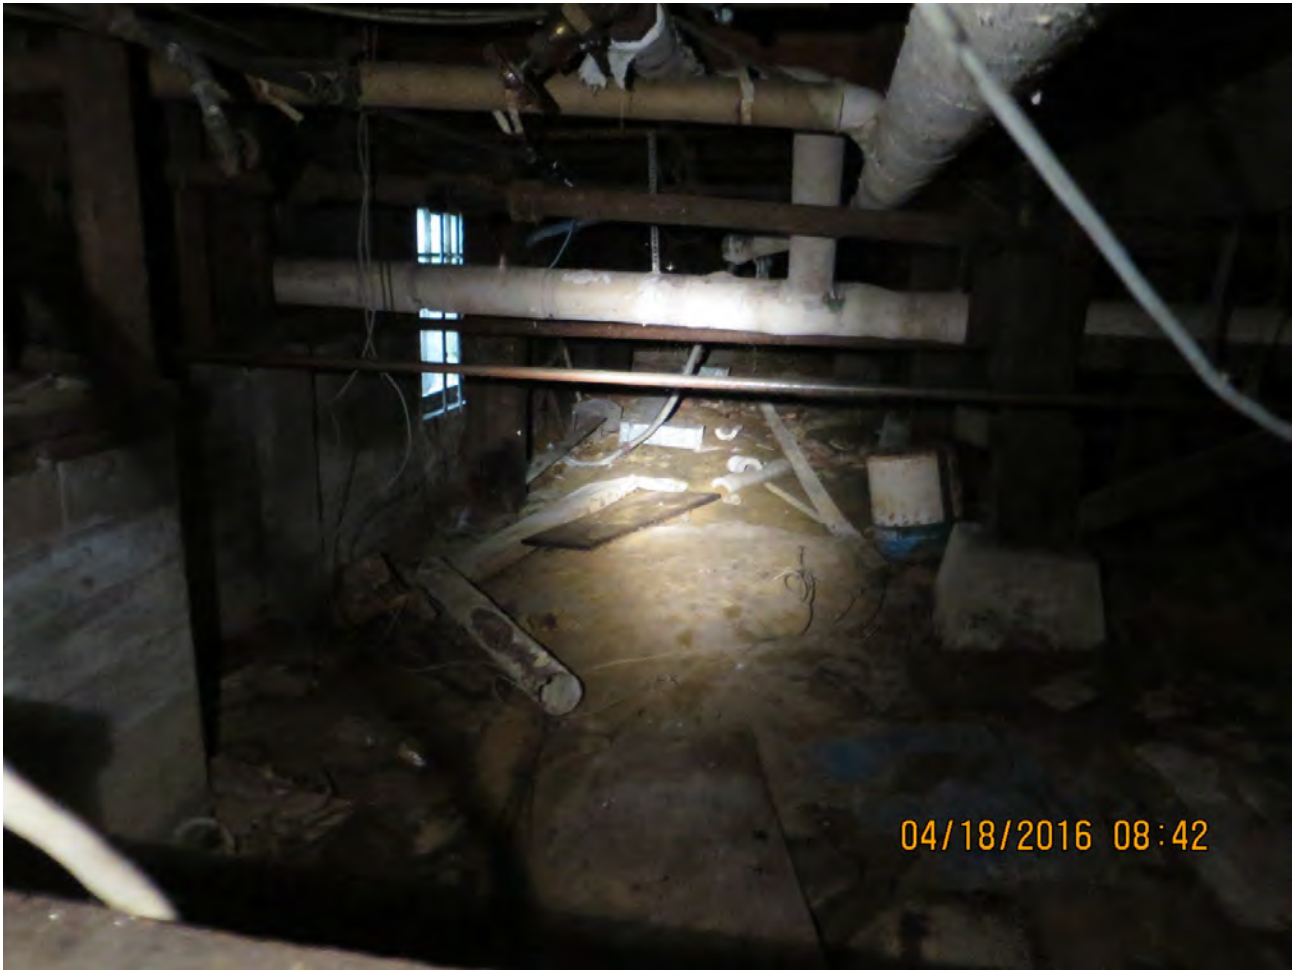
Photo 31: The old asbestos insulation on the pipes in the crawl space have not been covered with newer materials and there are pieces of pipe insulation on the soil, with some mixed into the soil

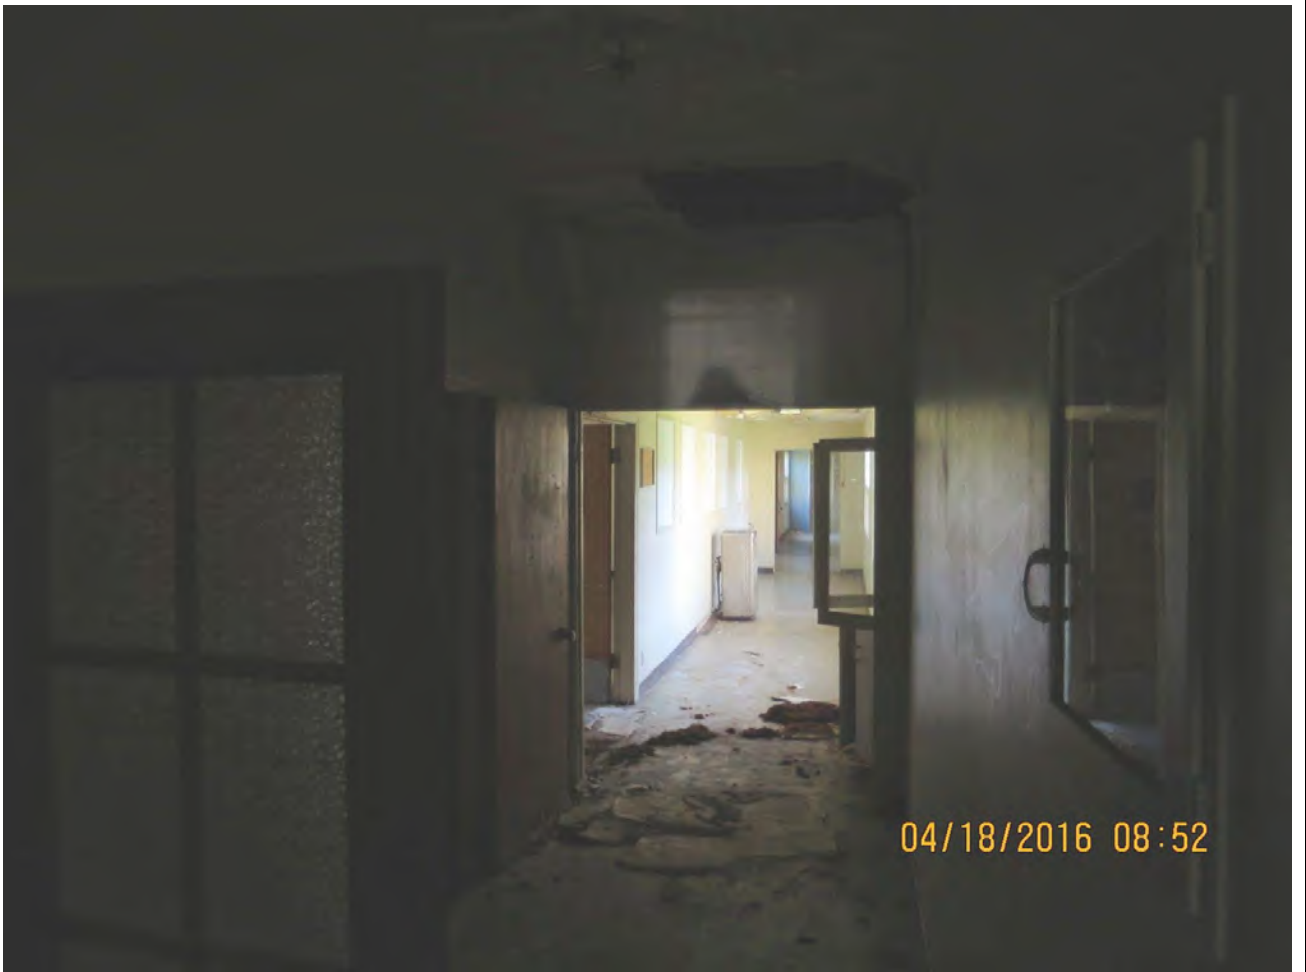
Photo 35: The corridor outside of Room 148 and 149, with a partial ceiling collapse due to water intrusion

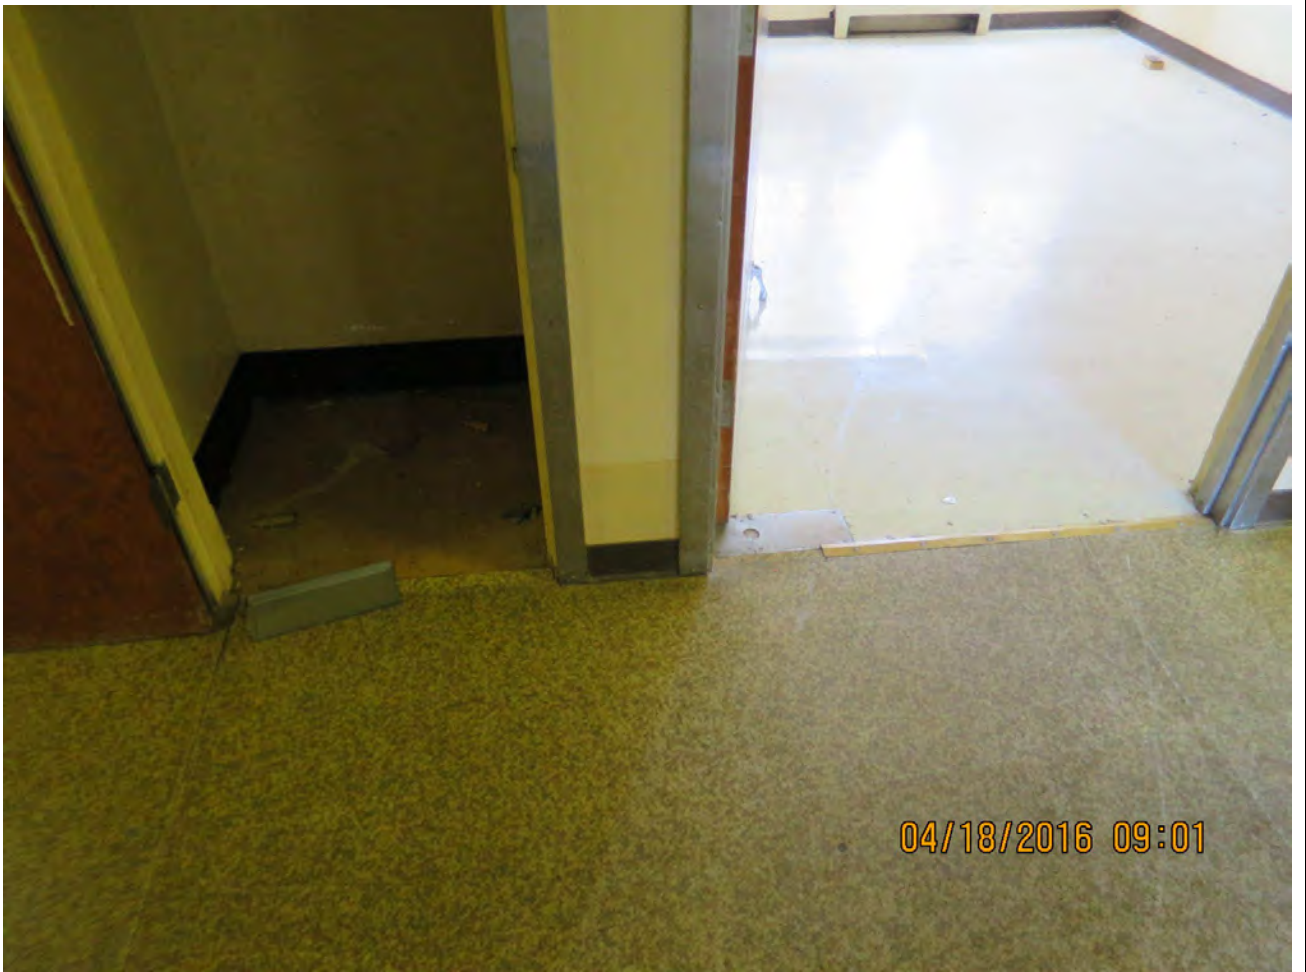
Photo 40: Room 137A and Room 137

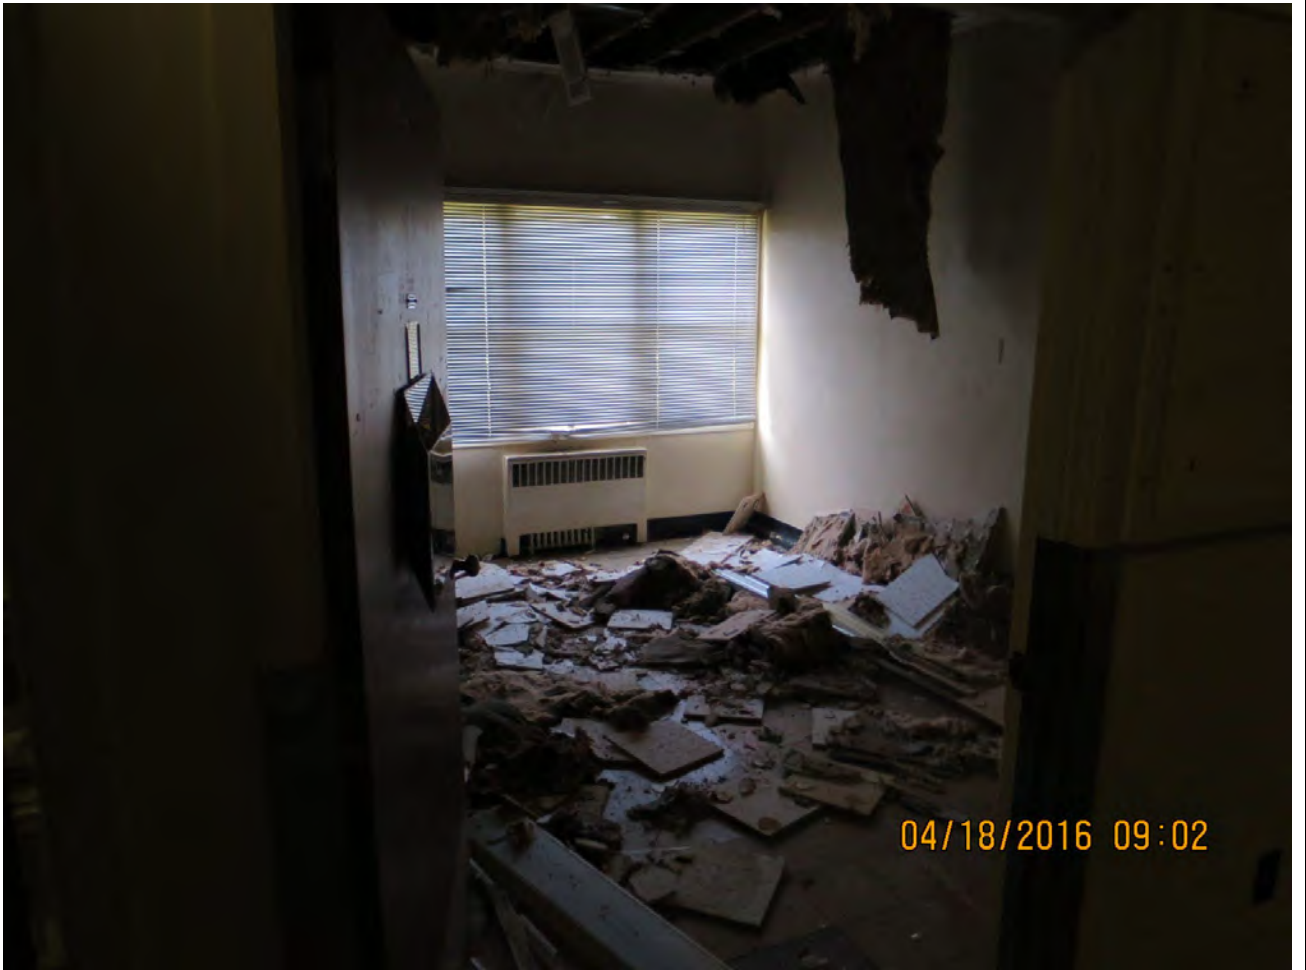
Photo 41: The collapsed ceiling in Room 141

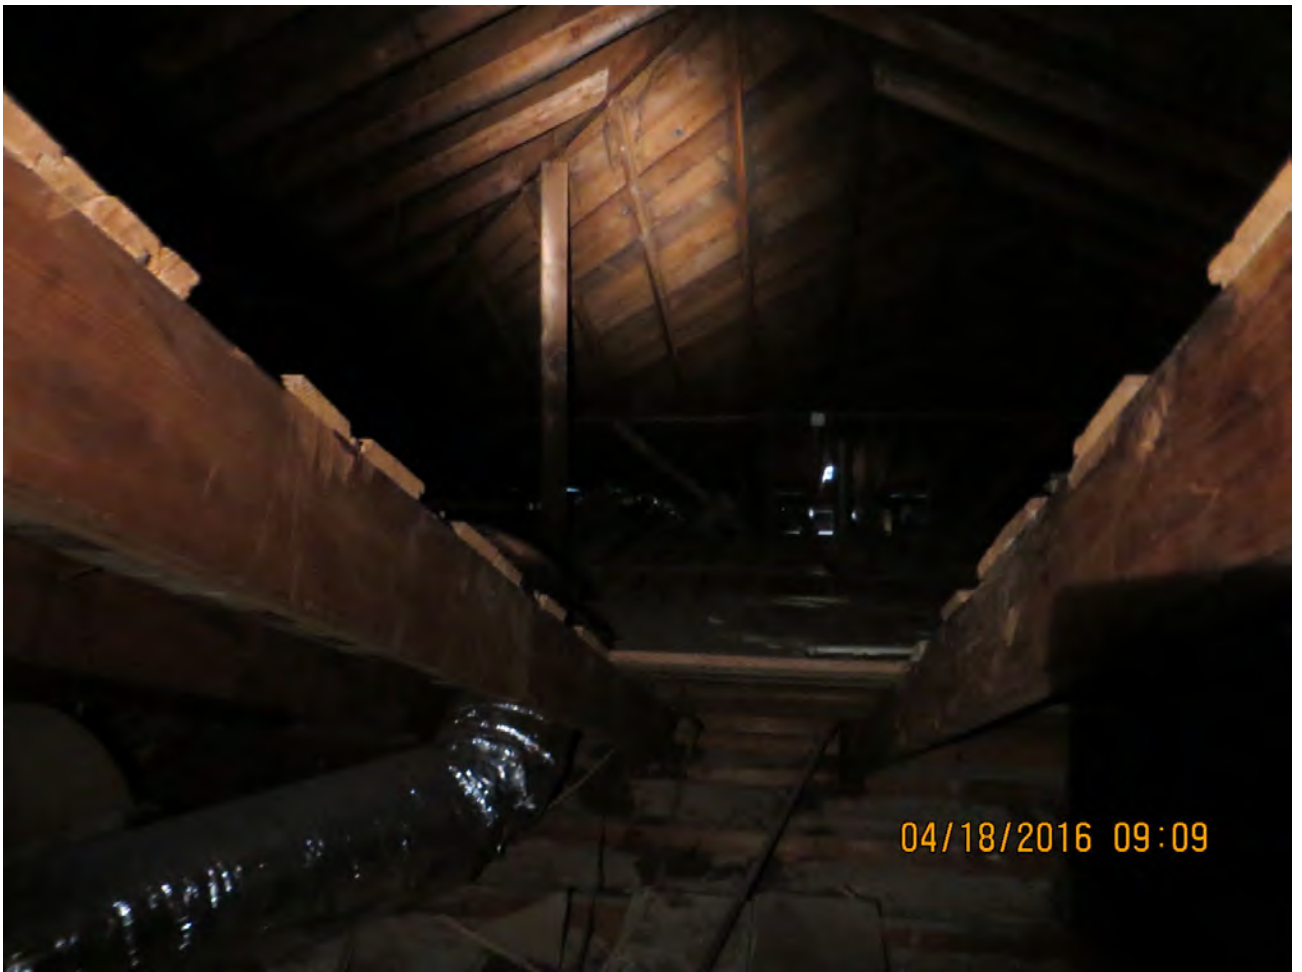
Photo 44: The attic of the right front addition connected to the original building attic

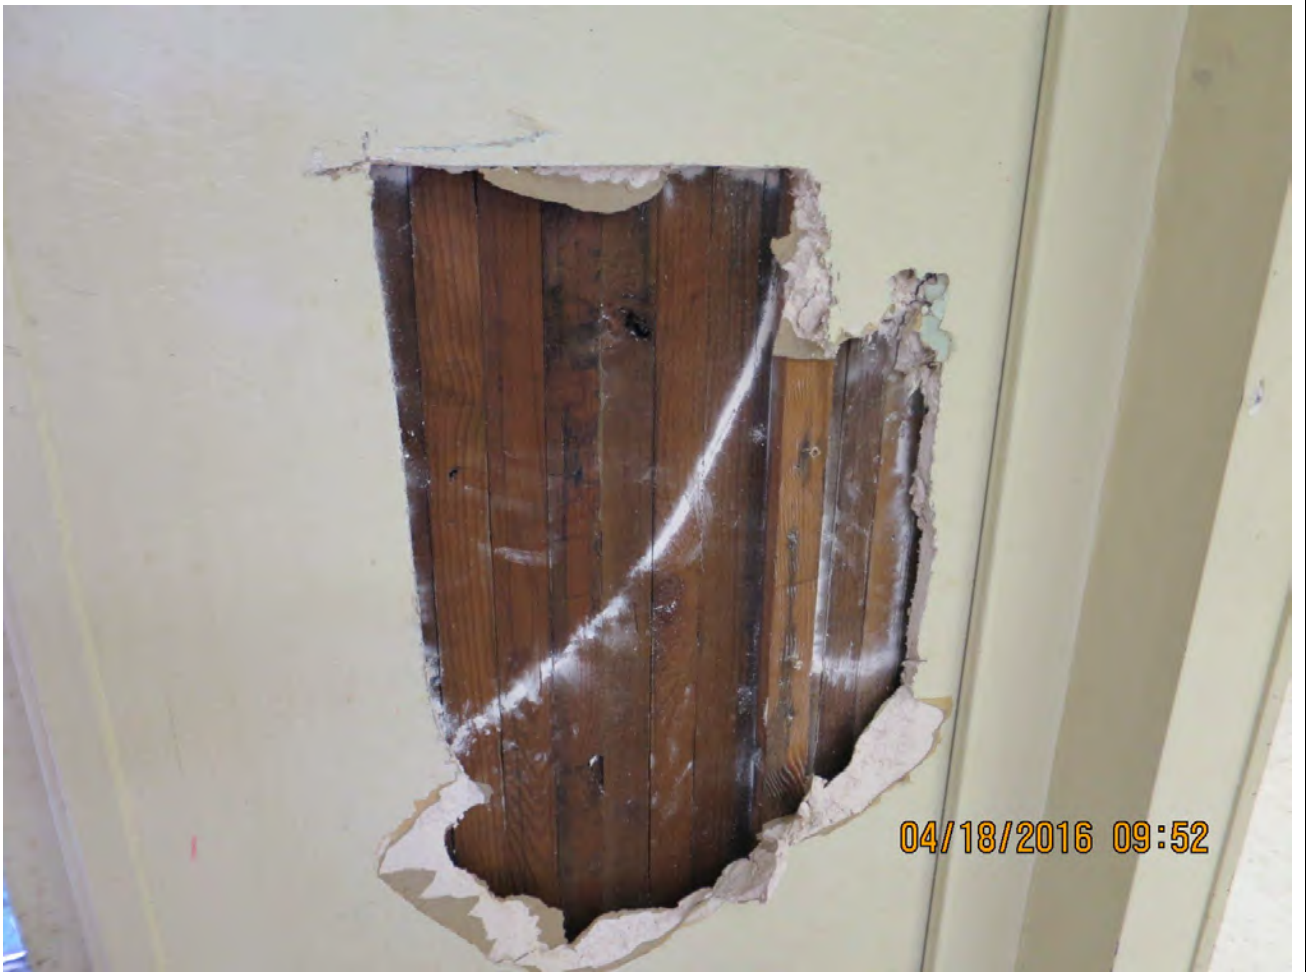
Photo 45: The exterior walls are solid wood, with 2x2 studs touching

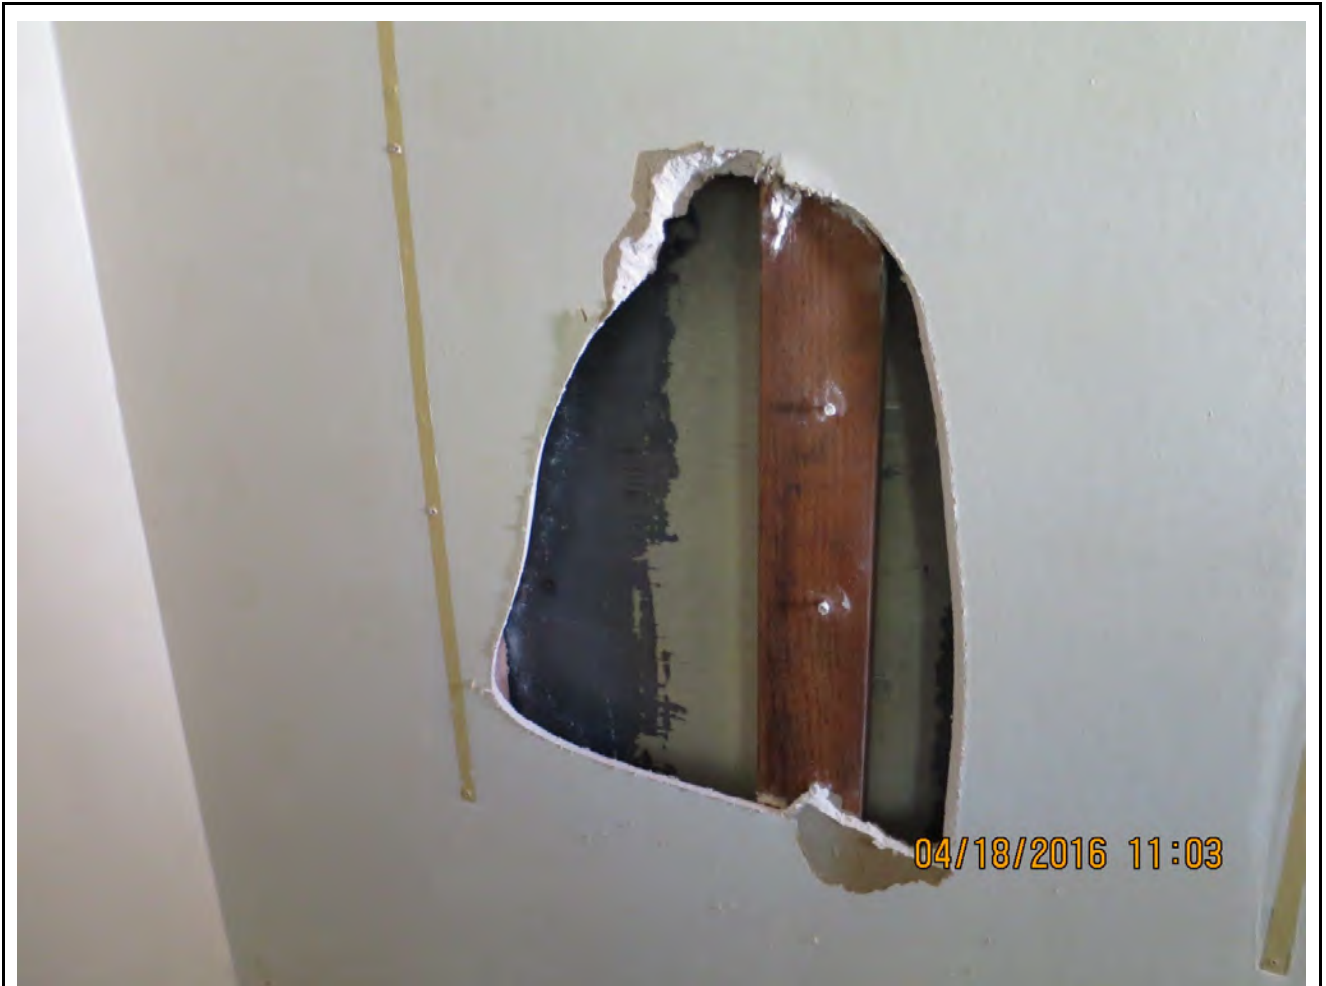
Photo 46: Sheet lead lining walls at the former X-Ray area in Room 120

Solid sheet lead lining the X Ray room walls in Room 120, Photo 46 .

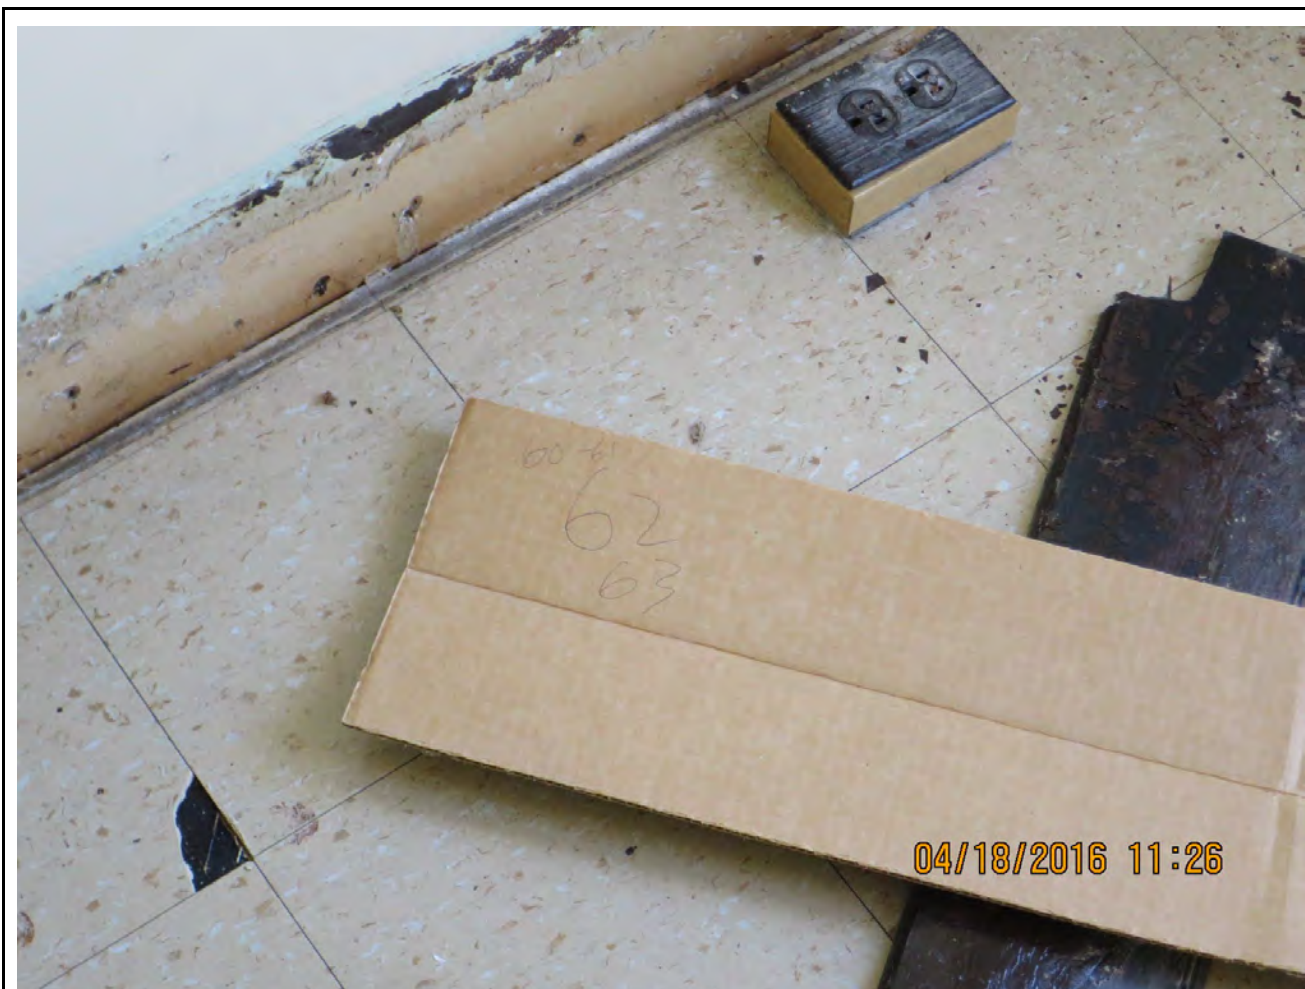
Photo 47: Vinyl floor tile in Room 135

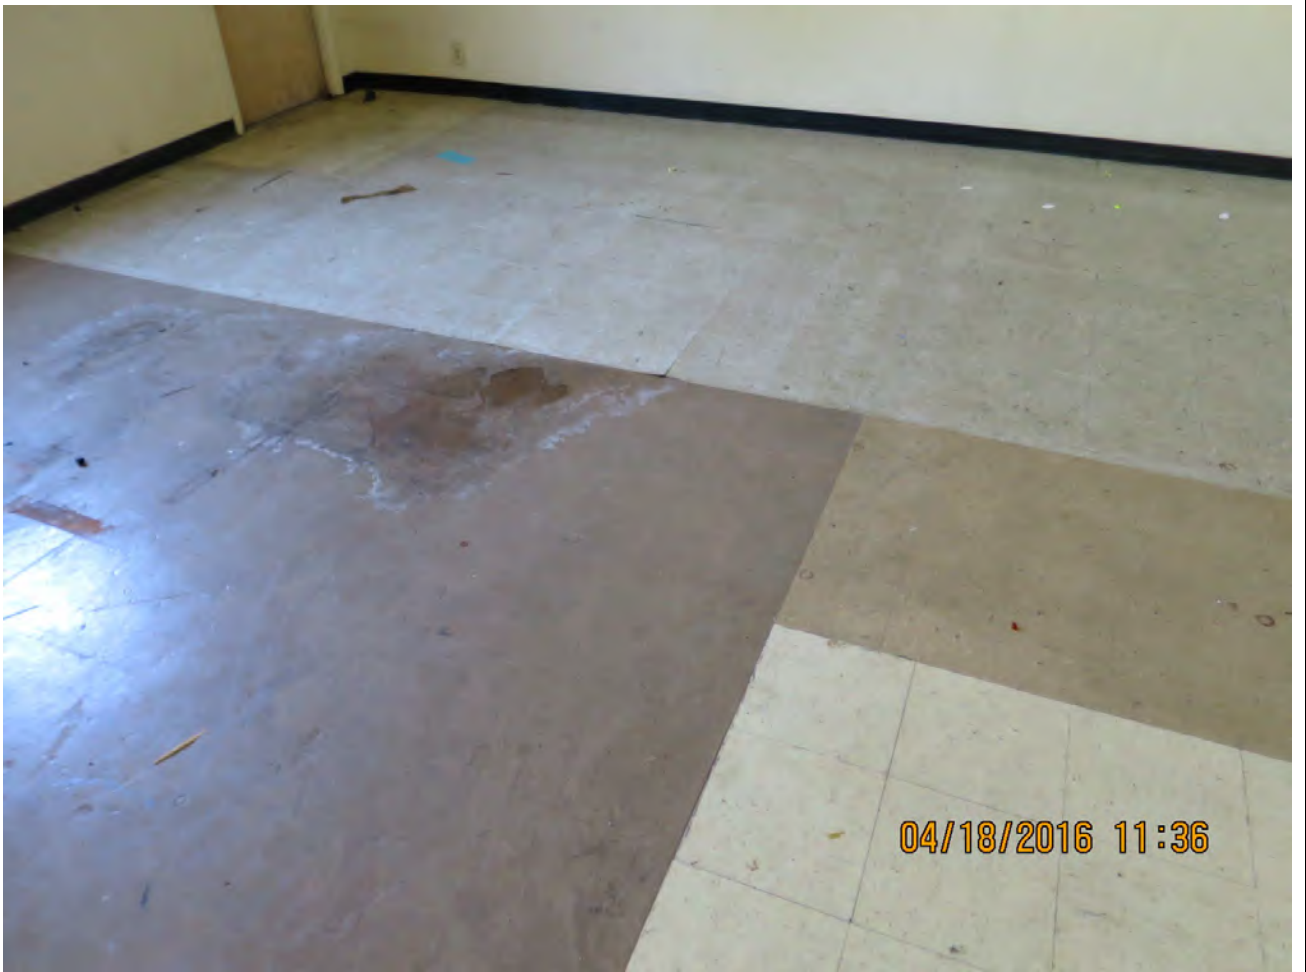
Photo 48: Brown burlap-backed linoleum and vinyl floor tiles in Room 150

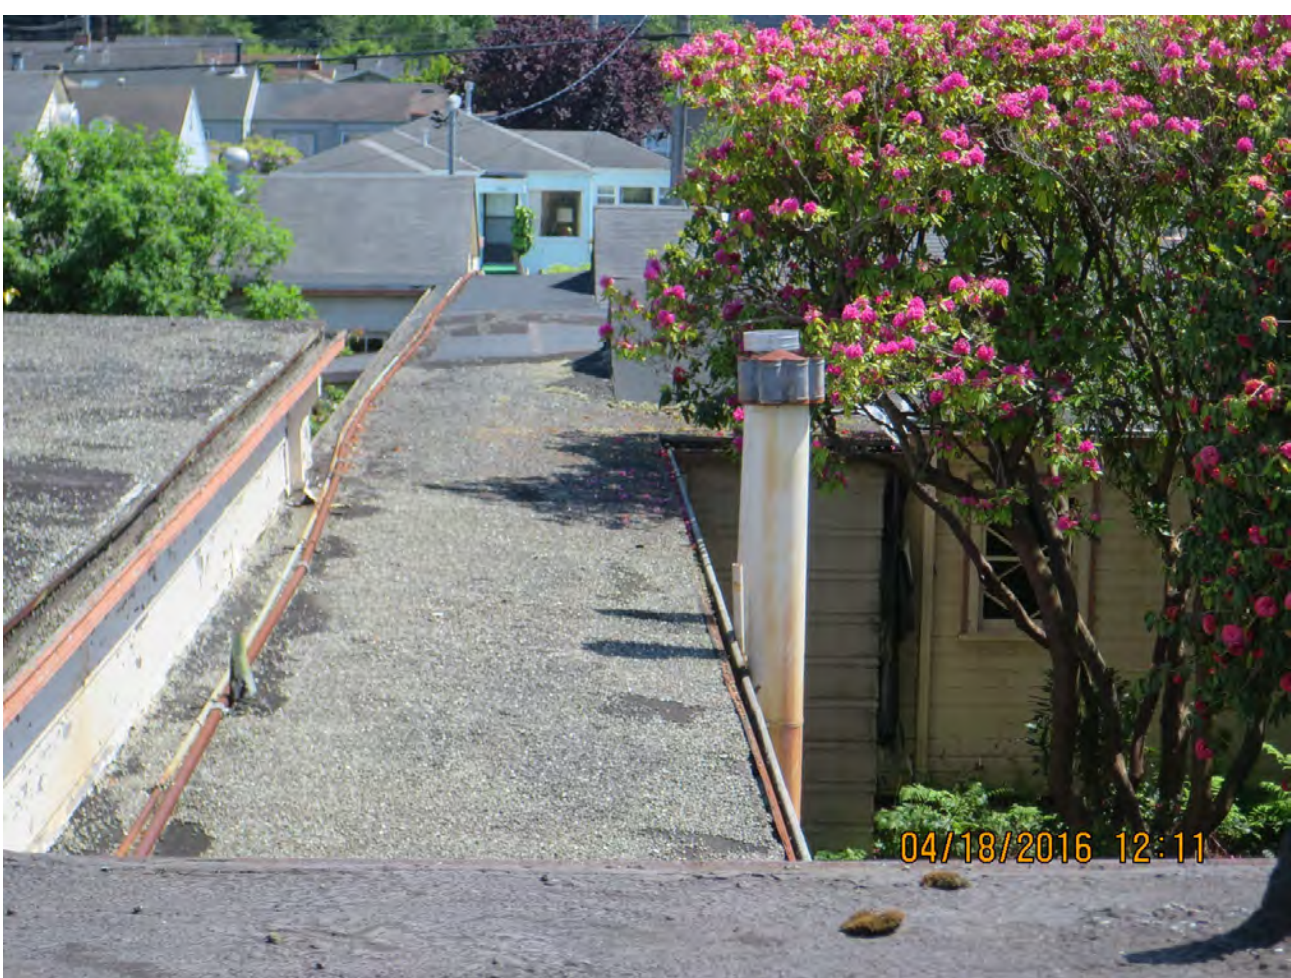
Photo 51: Two approximately 8" diameter asbestos-cement flue pipes

Homogeneous Area (an area of material uniform in color, texture, construction or application date and general appearance)	Sample Number	Specific Sample Location Please see the drawings If one or more samples contain asbestos, the entire homogeneous area must be treated as asbestos containing	Lab. Result % or None Detected	Asbestos Containing Materials	
				Hazard Rank	Waste
redwood insulation	TA-38	in the wall in Room 118	ND		
light fixture insulator in Room 105B, Photo 22, less than 1 square foot	TA-71	in Room 105 B, center	80	5d	F
insulation inside the metal cabinet of the sterilizer in Room 103A, roughly 40 square feet	TA-72	in Room 103A	80	3c	F
asbestos cement sheet on the door to Room 3, Photo 56, roughly 12 square feet	TA-90	on the door to Room 3	20	3c	NF
laboratory table top, roughly 50 square feet	TA-92	in Room 11	20		
wood fiber ceiling boards	TA-98	Room 151 ceiling	ND		
two approximately 8" diameter asbestos cement flue pipes from the water heater room, roughly 50 linear feet, Photo 51	n/a	n/a - assumed, identified visually	n/a	3c	NF

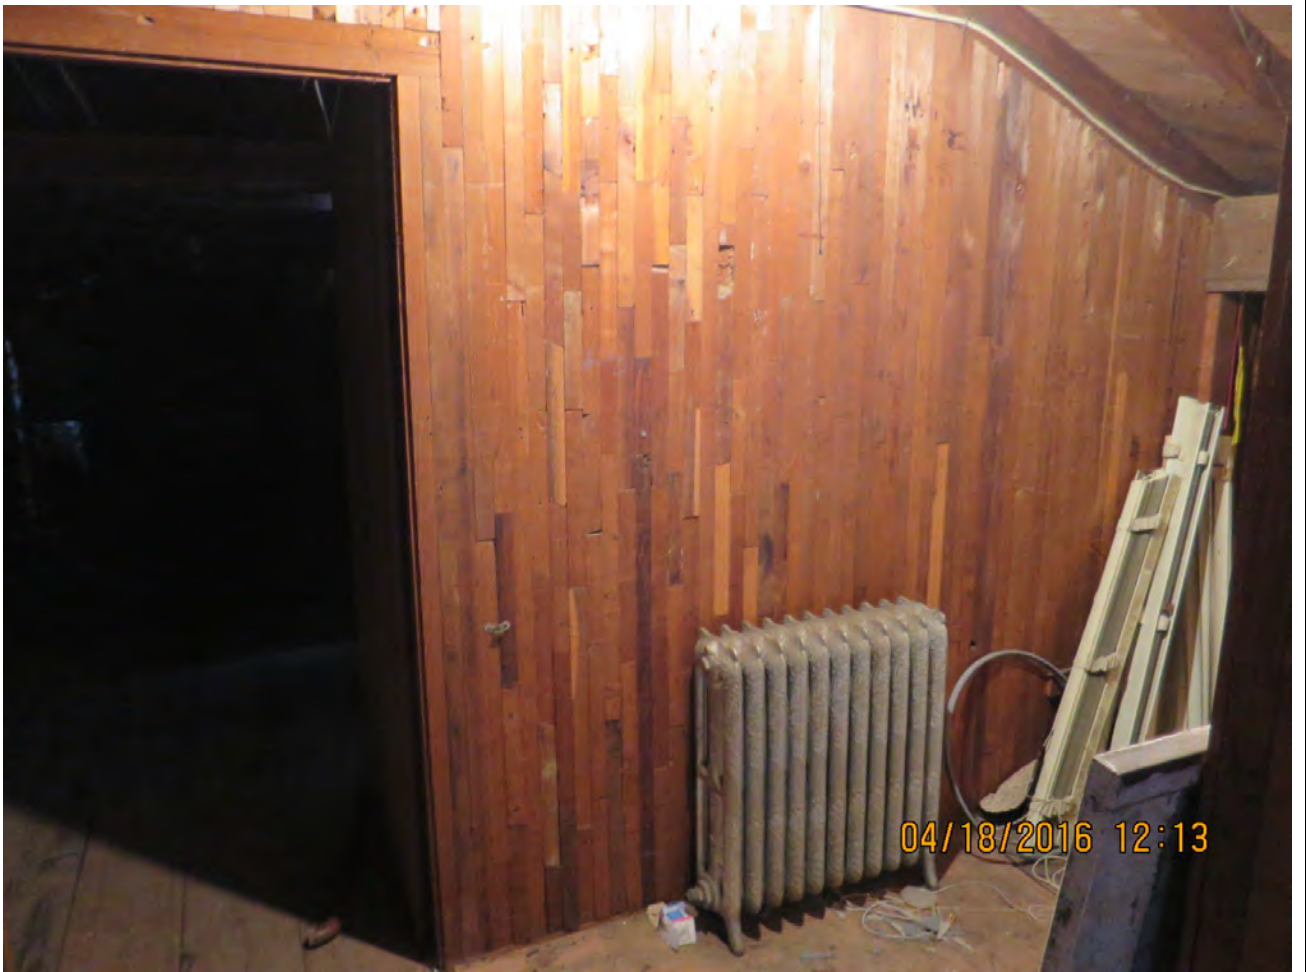
Photo 52: A wall in the attic is made of studs which touch, and an ornate old radiator

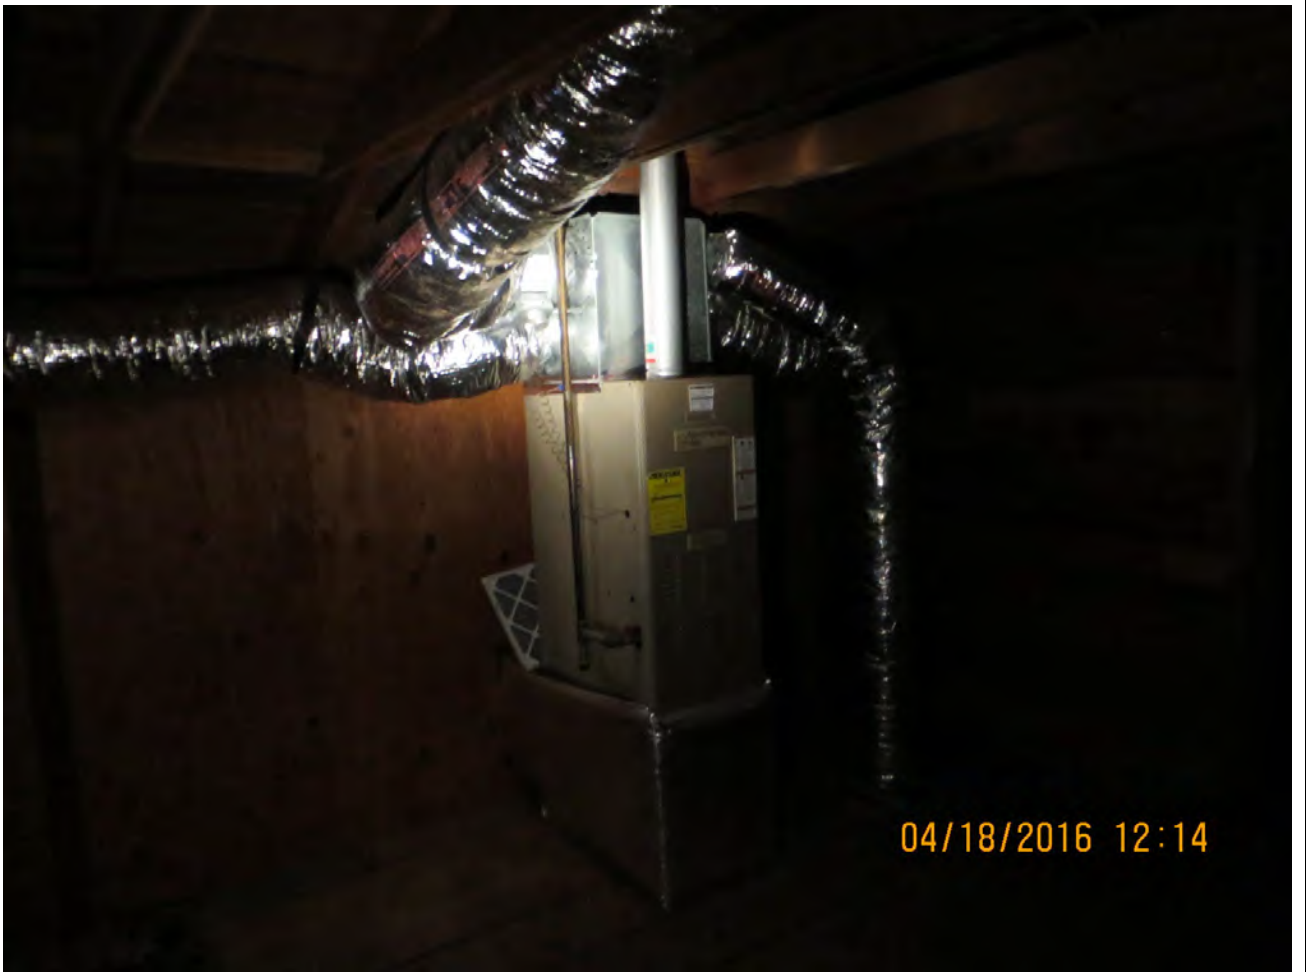
Photo 53: One of many typical new furnaces, here in the attic, all with fiberglass-insulated ducts

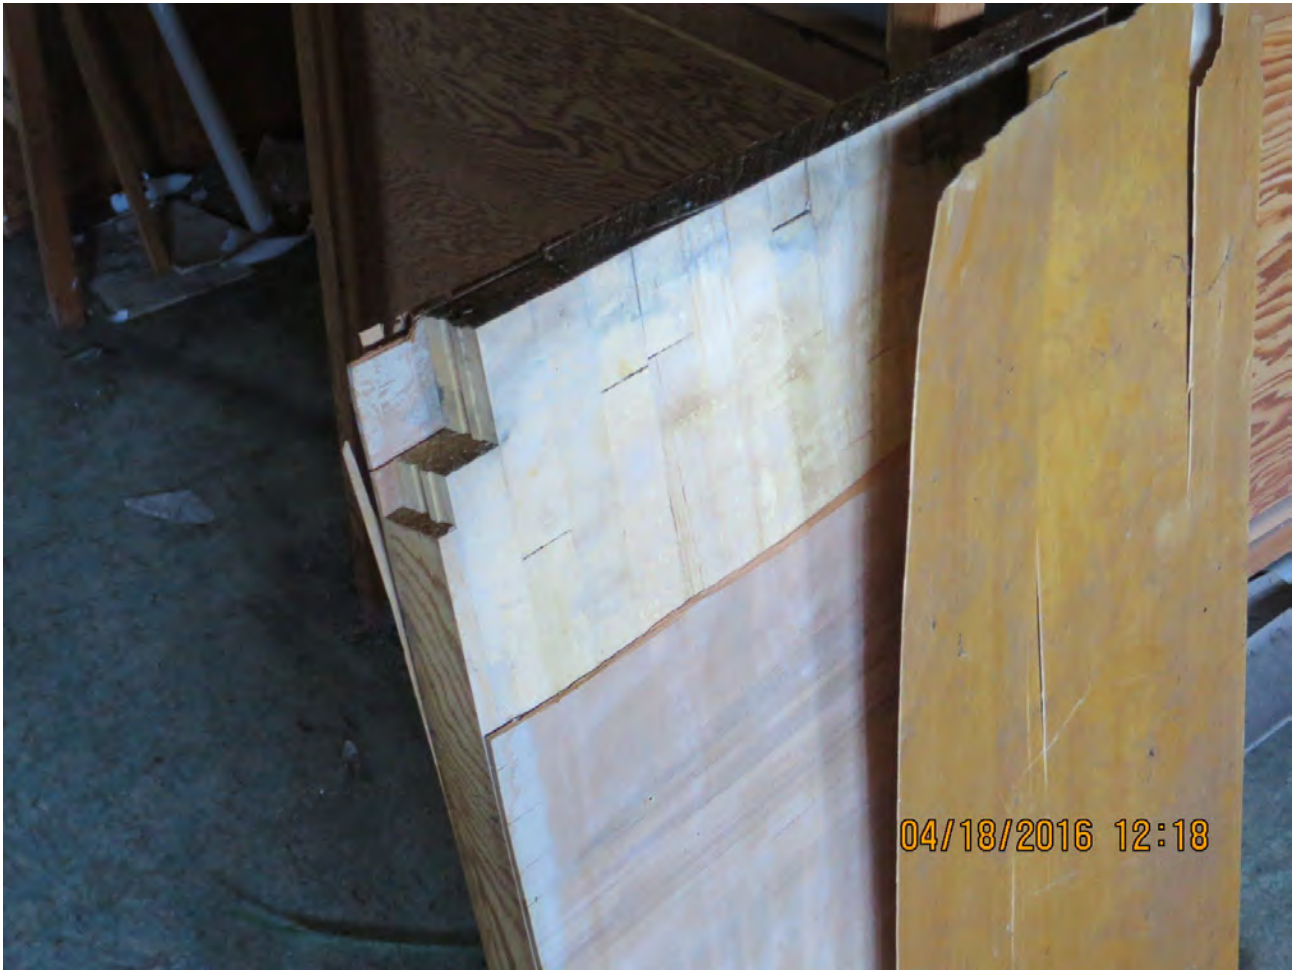
Photo 54: A typical door, made of solid wood

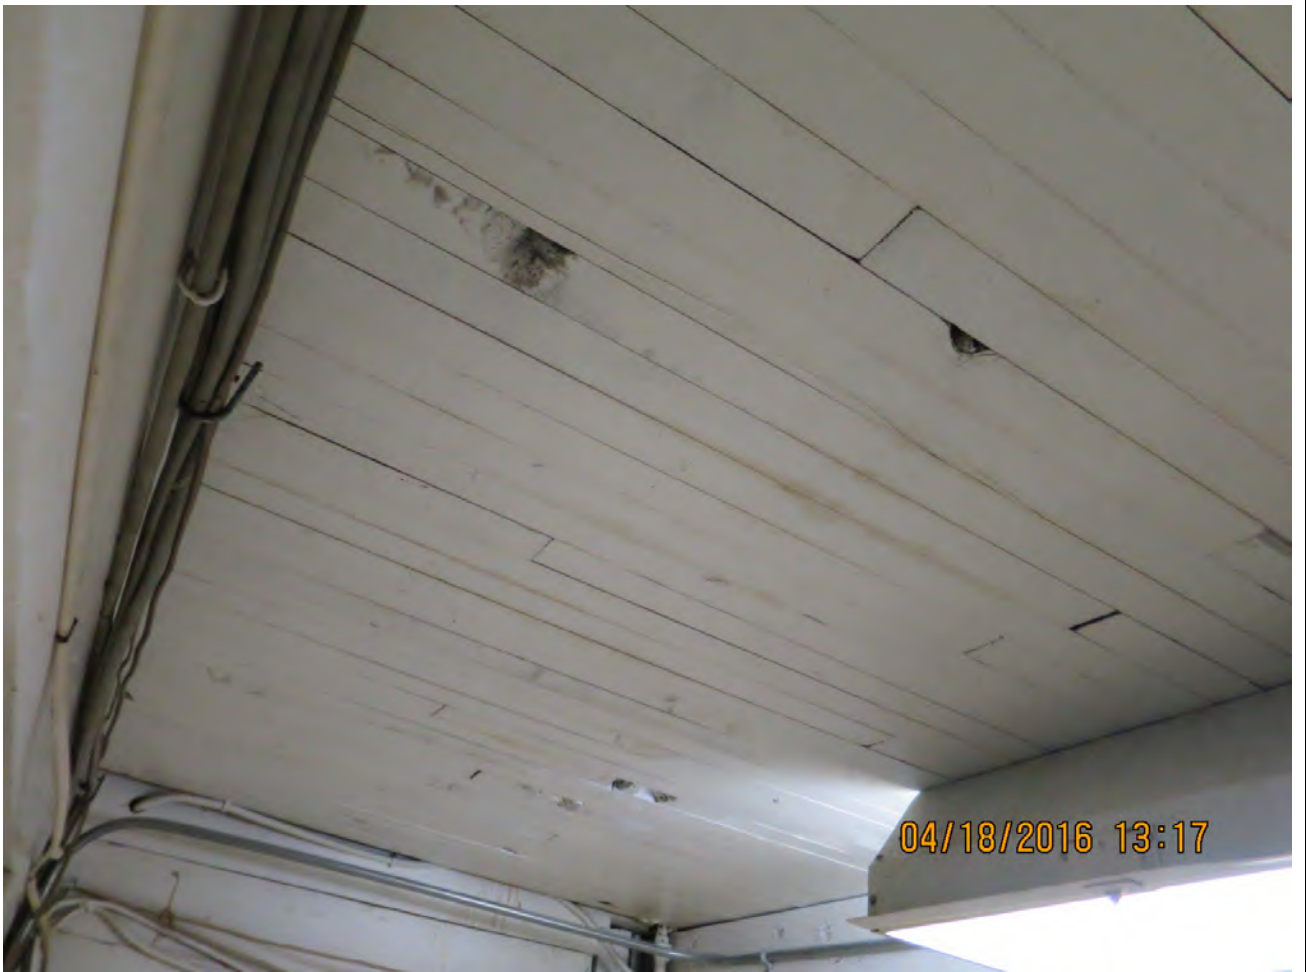
Photo 55: The basement ceiling is solid wood, as the floor joists touch
