HSU Trinity Children's Center and Child Development Lab Project

Initial Study-Mitigated Negative Declaration

November 2021

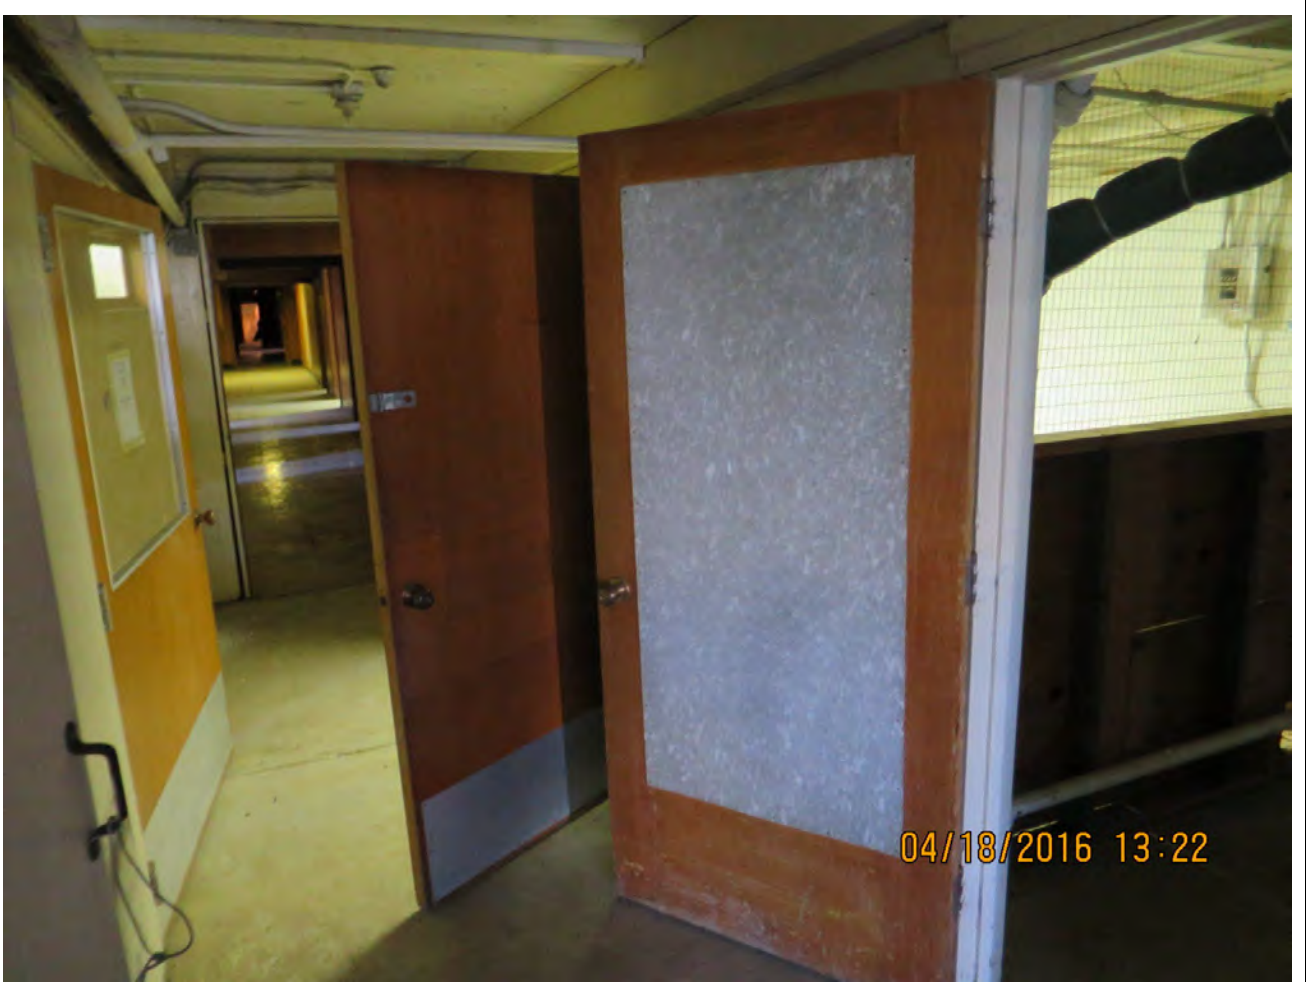
Photo 56: An asbestos-cement panel on the door to Room 3

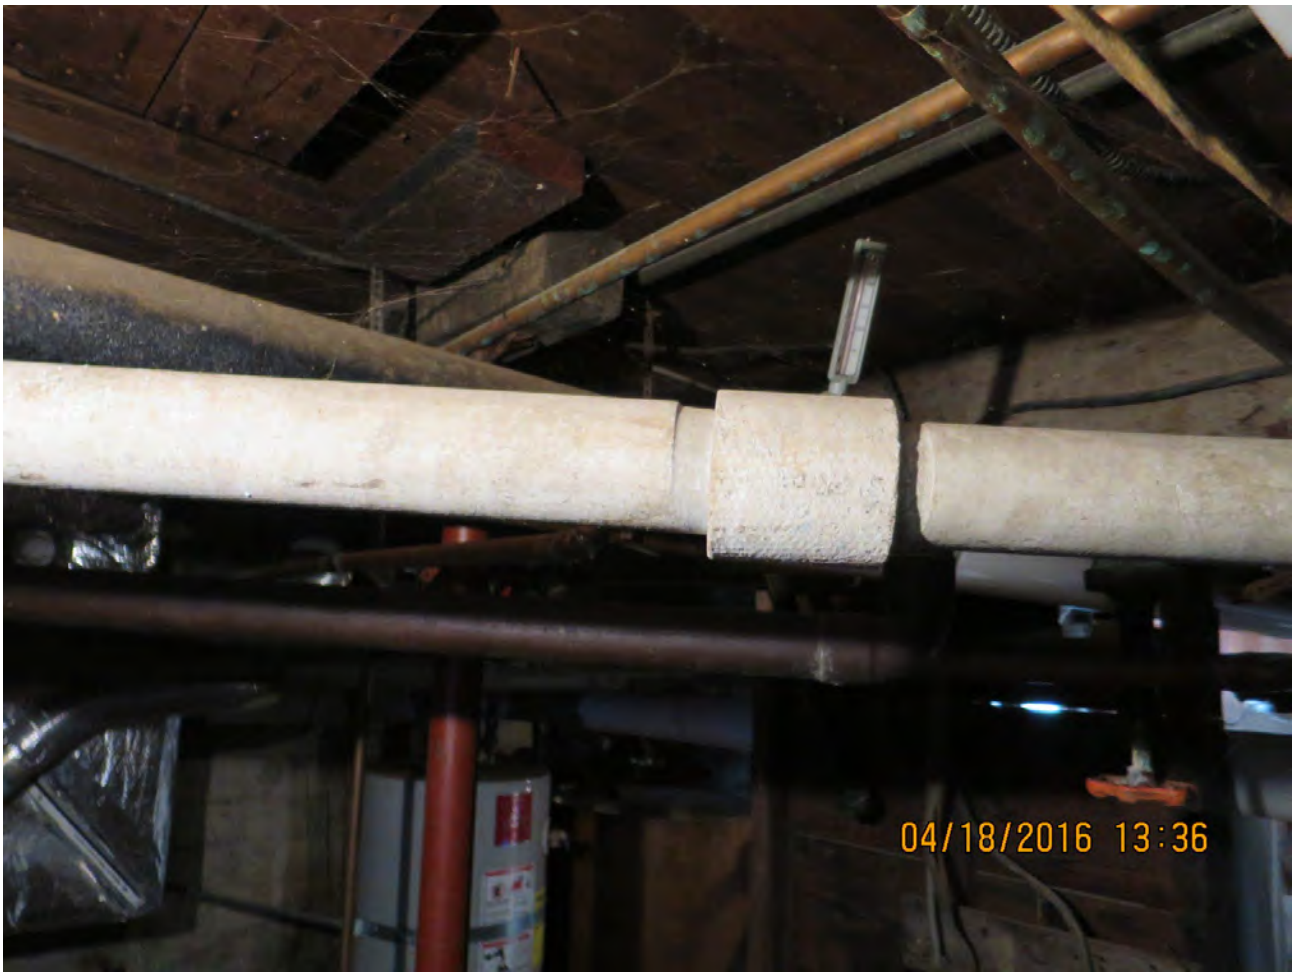
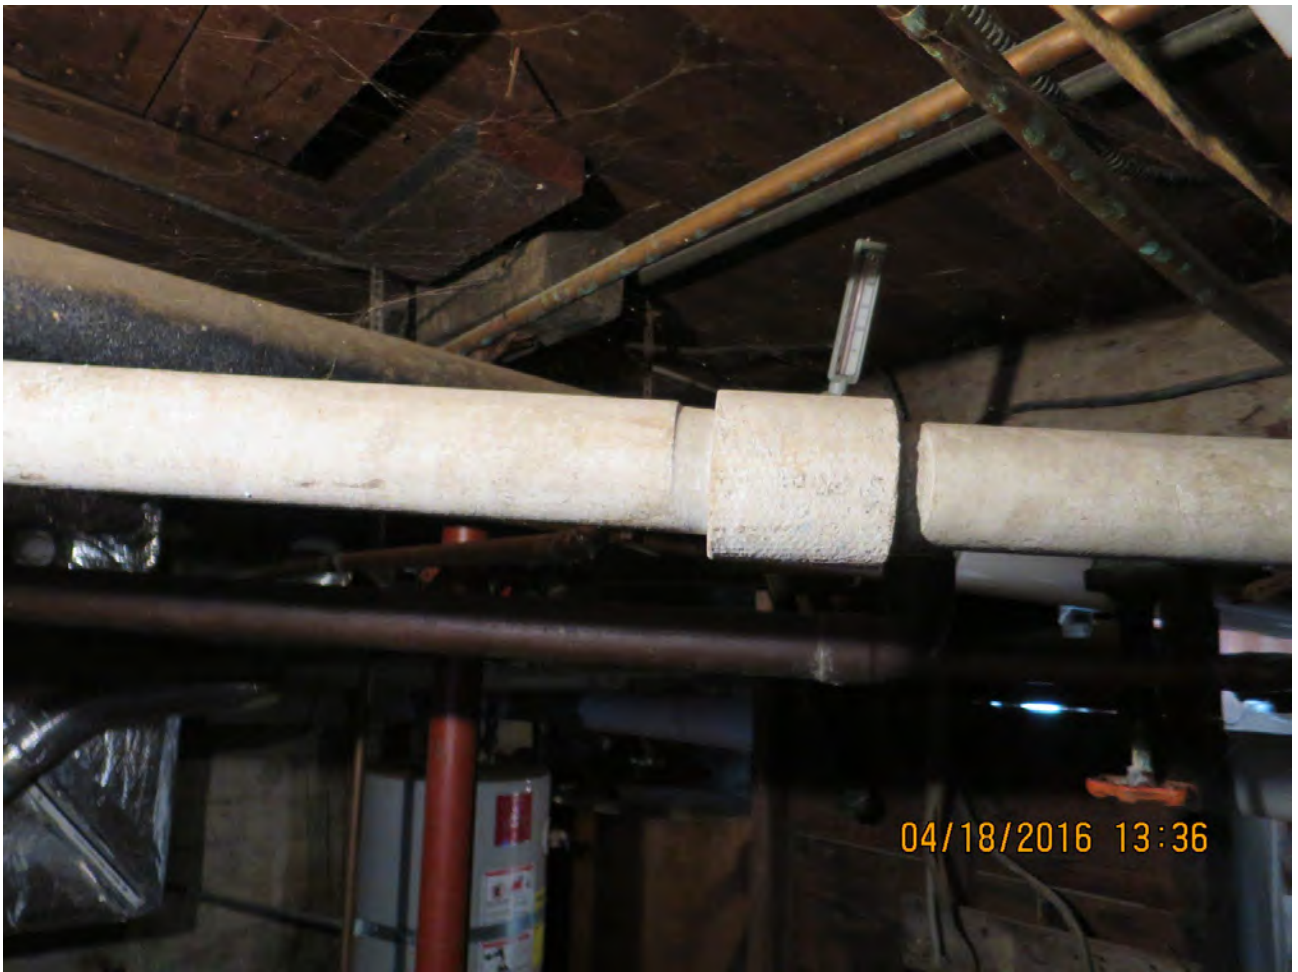
Photo 57: An un-insulated tank in the hot water heater room, and another of the newer furnaces

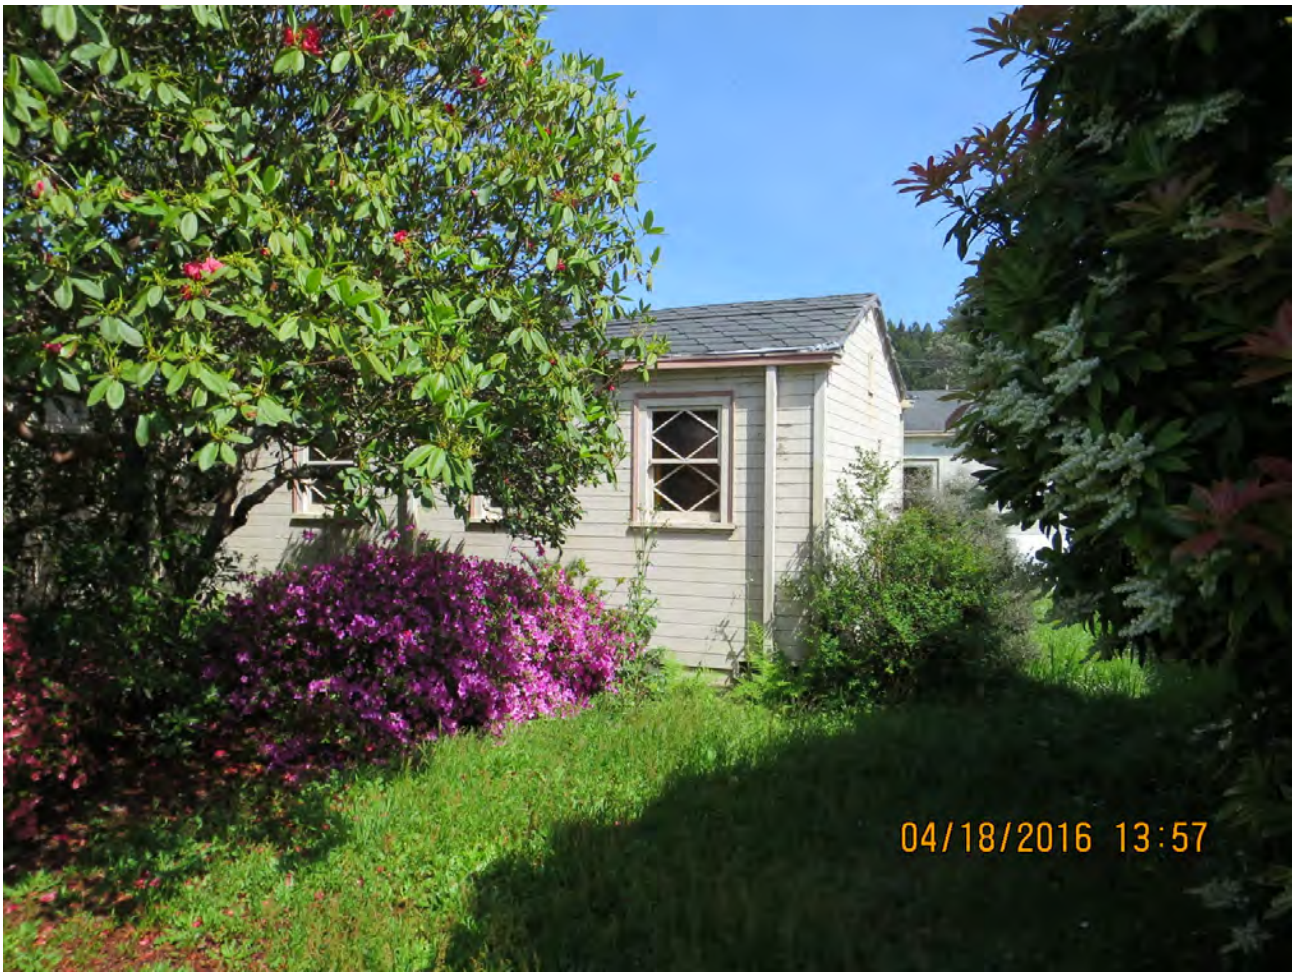
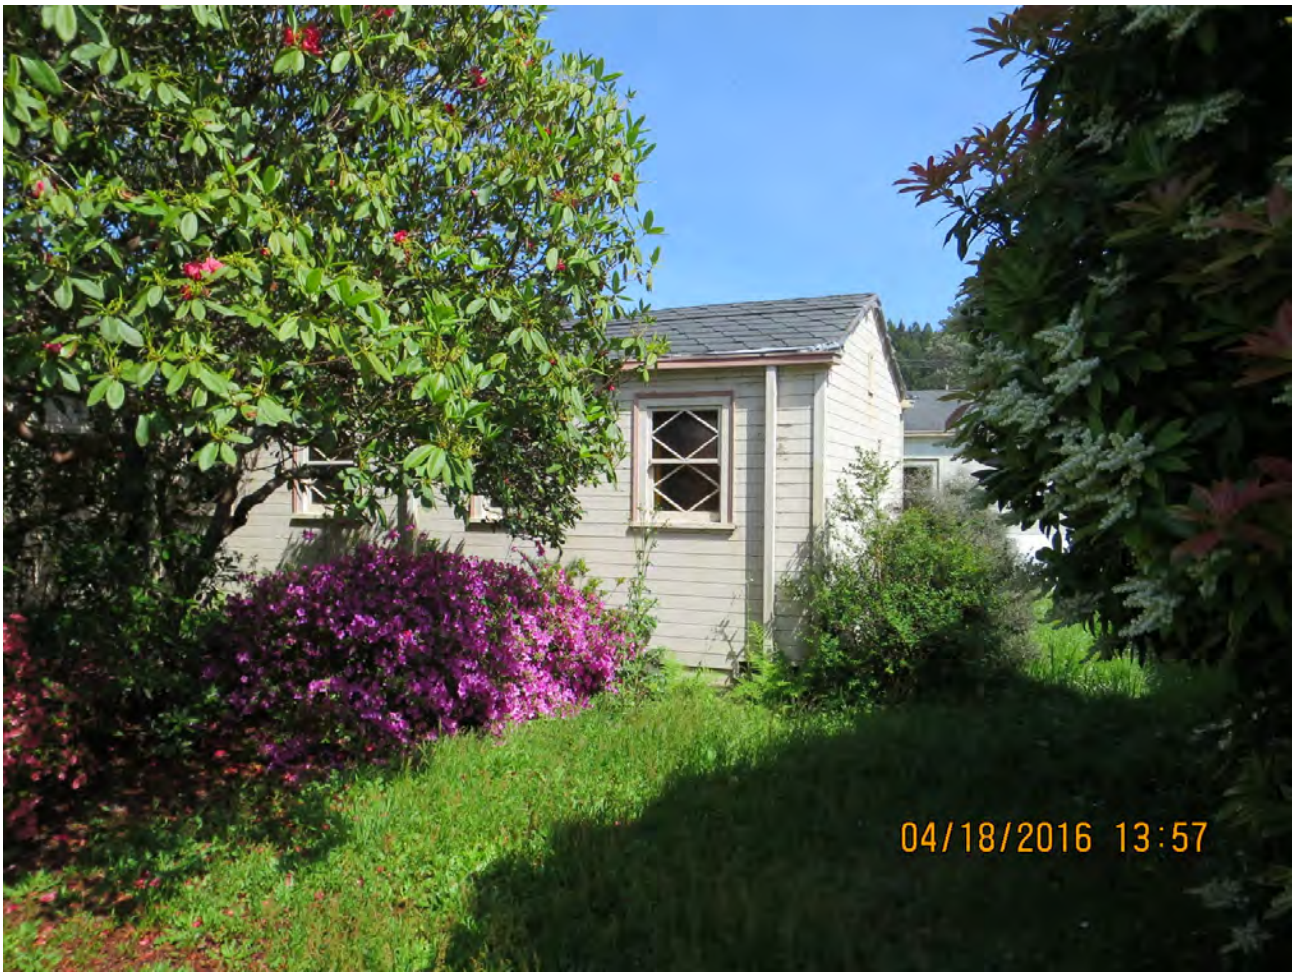
Photo 58: The approximately 2.5" diameter asbestos-cement conduit observed in Room 12 and in Room 156

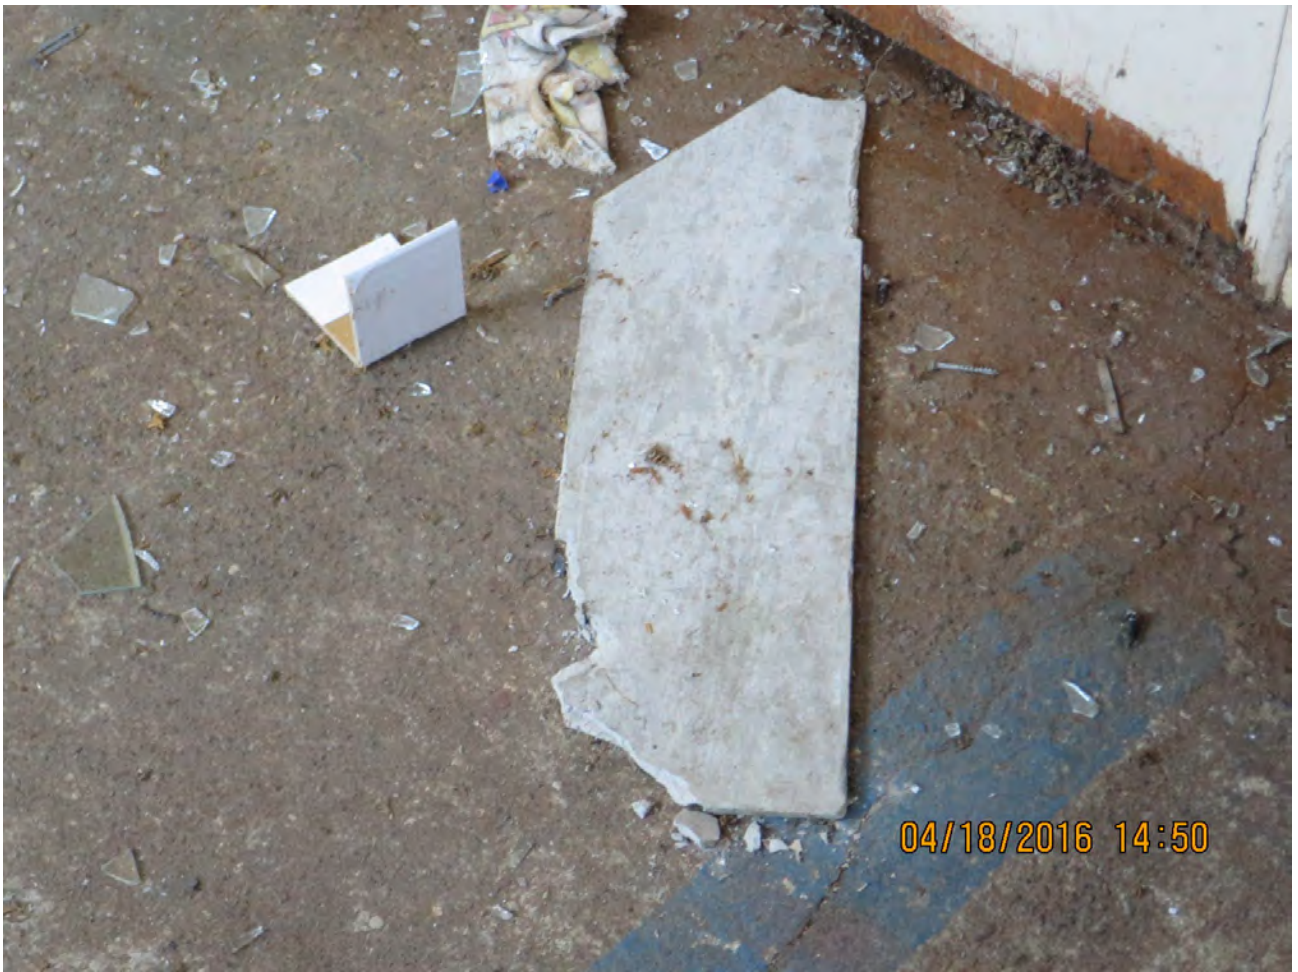
Photo 62: A piece of asbestos-cement sheet material laying on the floor in Room 156

Two pieces of asbestos-cement sheet material in Room, 156, roughly 3 square feet total, Photos 62, 63	n/a	n/a - assumed, identified visually	n/a	6b	NF
the main pattern of fiberglass composition shingles	149	rear slope of main roof above Room 110	ND		
tar paper under the fiberglass composition shingles	129	above the south end of Room 154D	ND		
	132	above Room 155	ND		
	150	rear slope of main roof above Room 110	ND

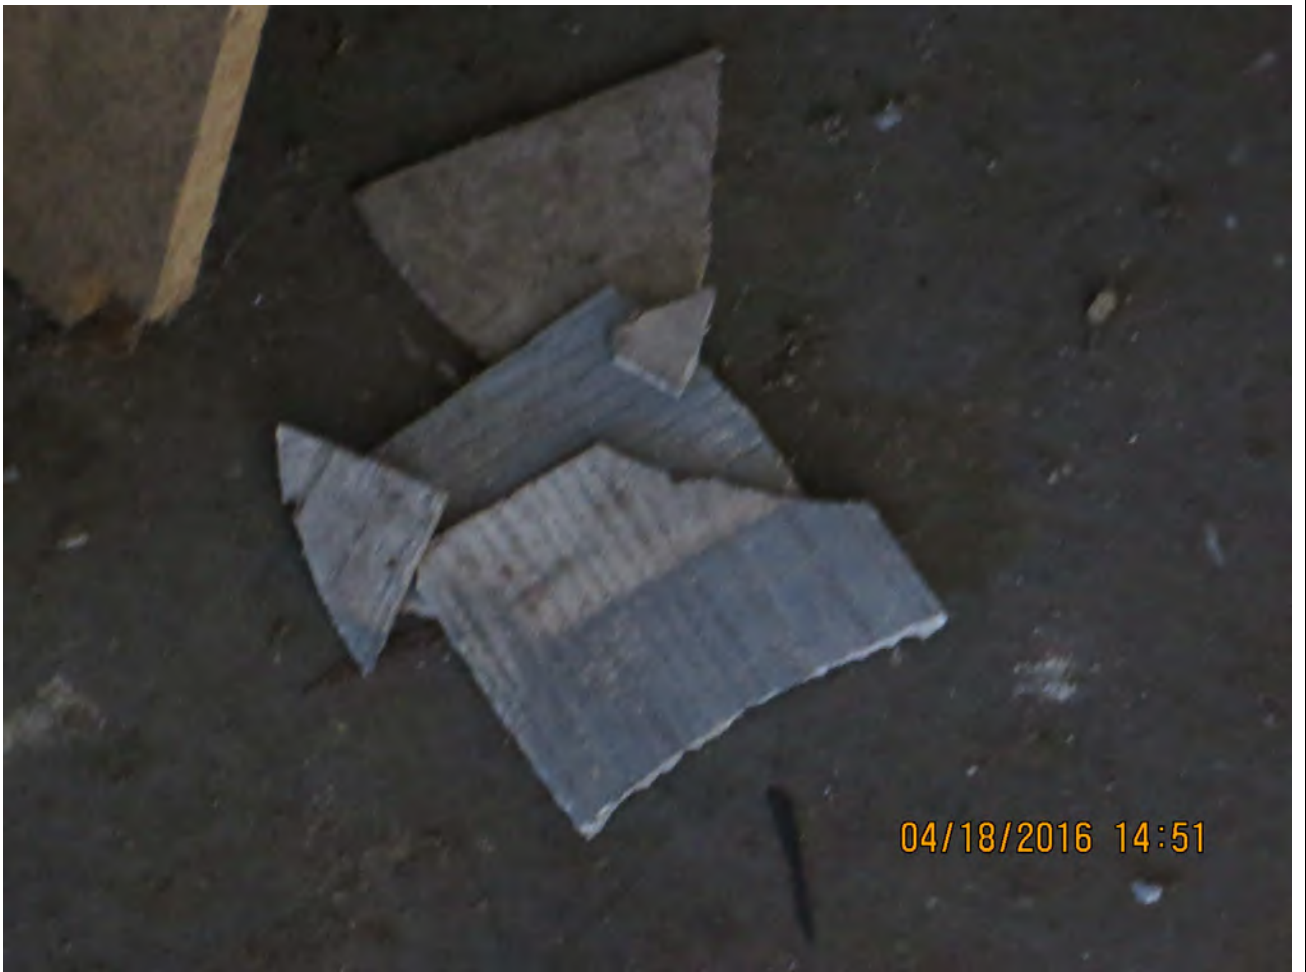
Photo 63: Another piece of asbestos-cement sheet material laying on the floor in Room 156

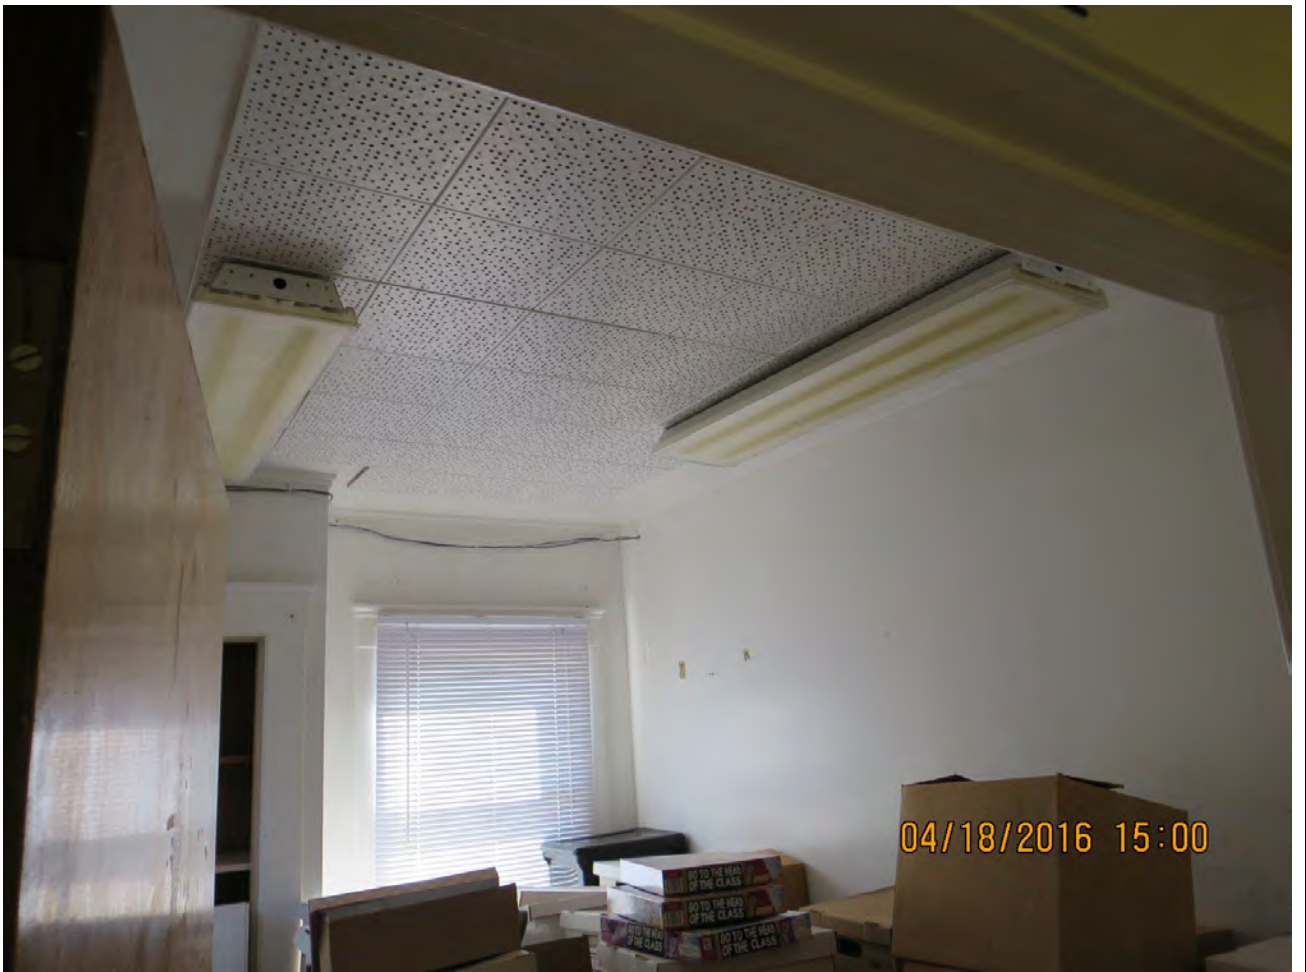
Photo 64: The 1' x 1' ceiling tile in Room 157

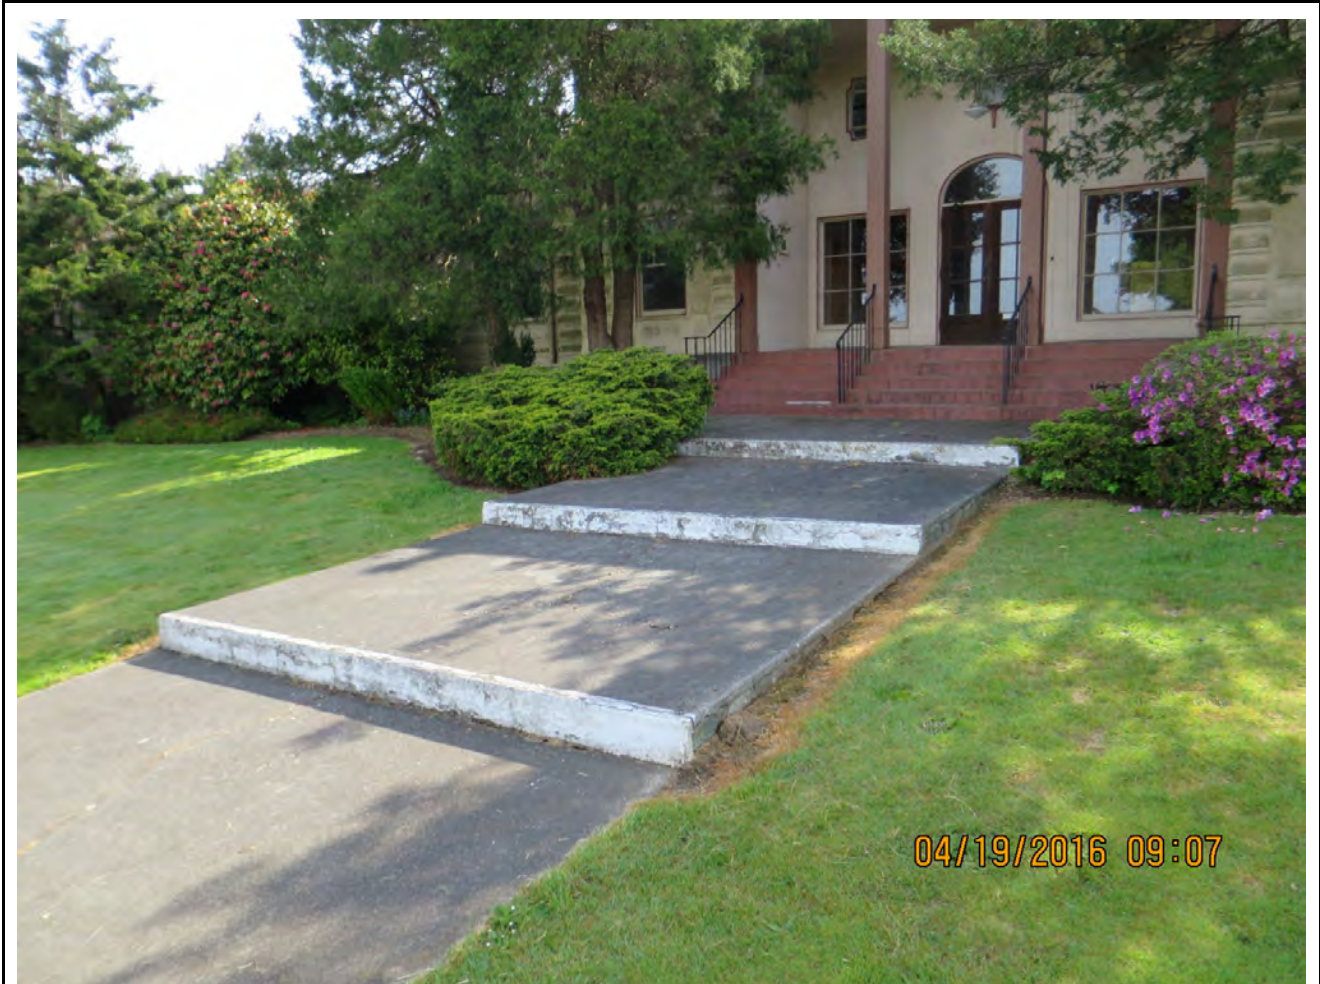
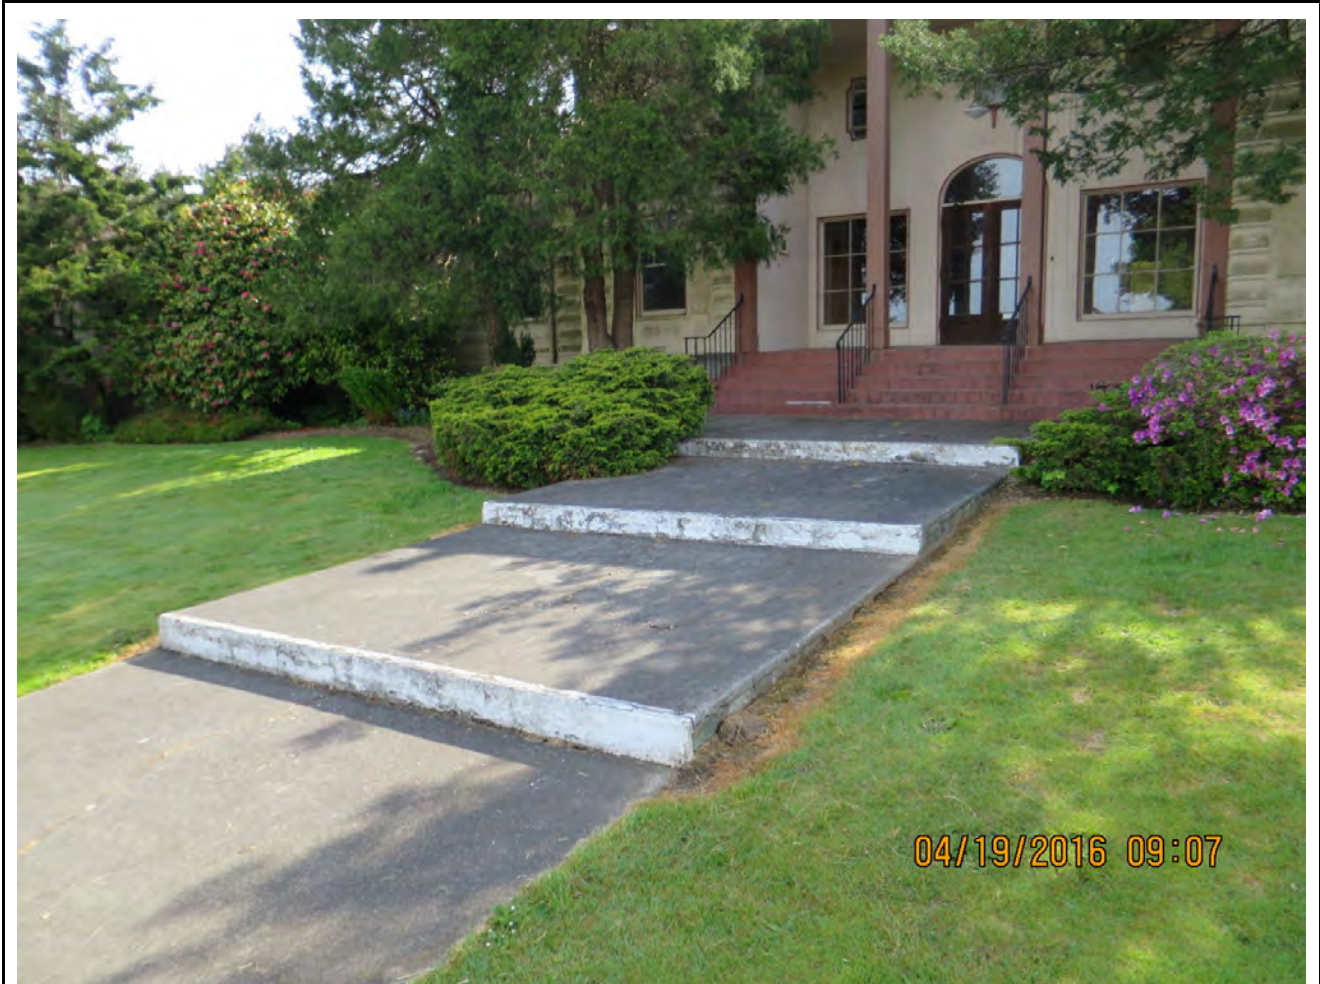
Photo 69: The roof of the larger addition on the right side

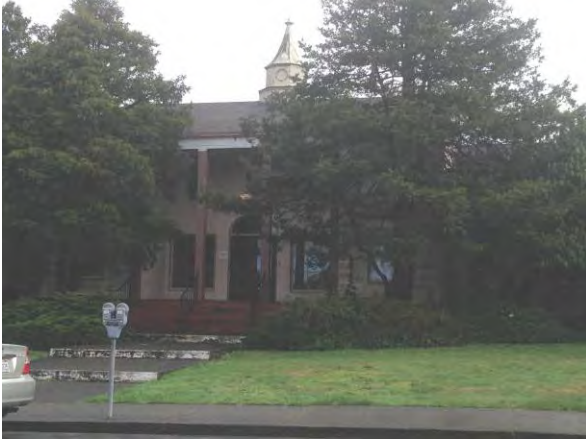
Photograph 2. View of deteriorated lead-based paint on the subject property building, from the north end of the parking lot facing west.

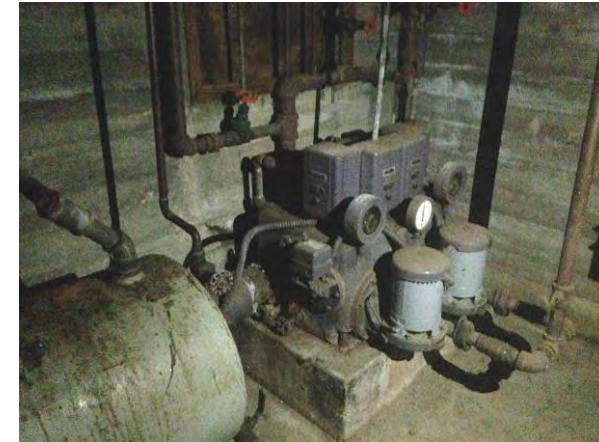
Photograph 7. View of rusted and corroded pipes in the basement of the subject property building.

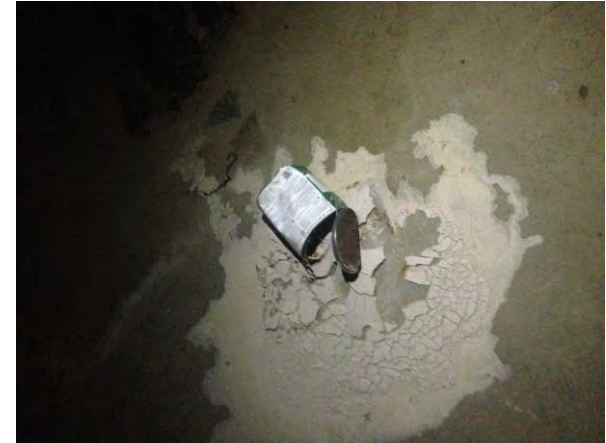
Photograph 9. View of one of multiple spilled paint containers located in the basement of the subject property building.

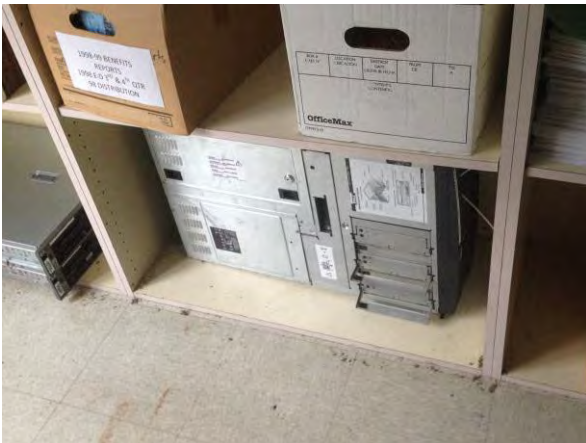
Photograph 10. View of typical subject property building storage material (computer equipment, files, theatre set materials, etc.).

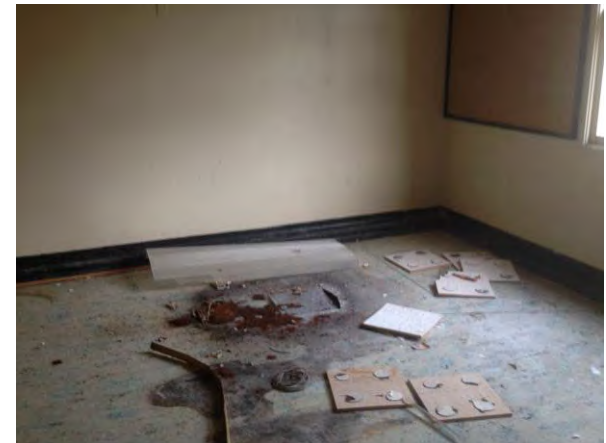
Photograph 11. View of the inside of one of the rooms with a caved-in ceiling and stained flooring.

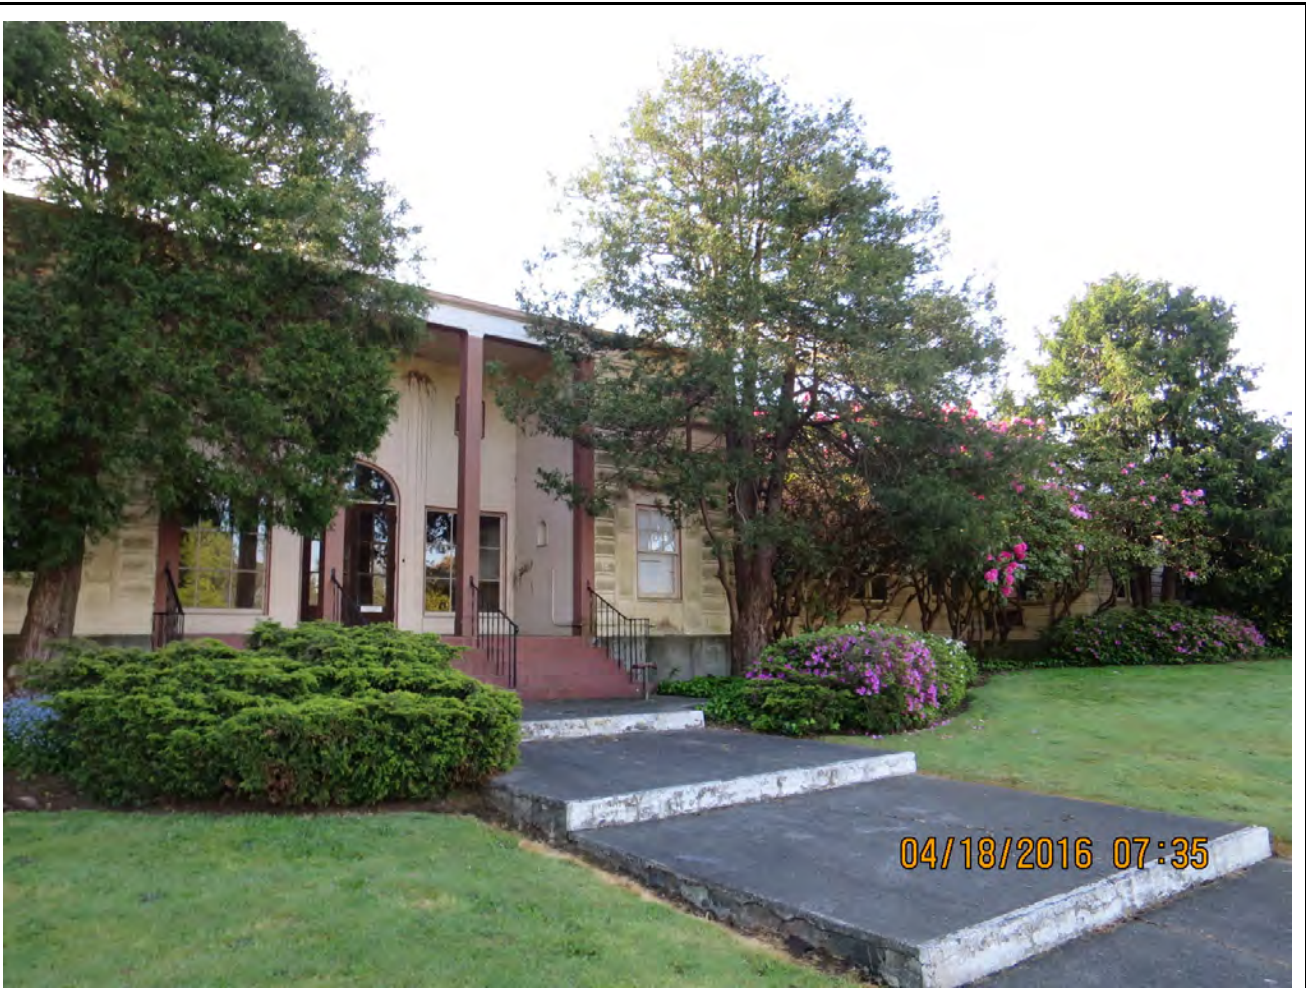
Photo 3: The main entrance

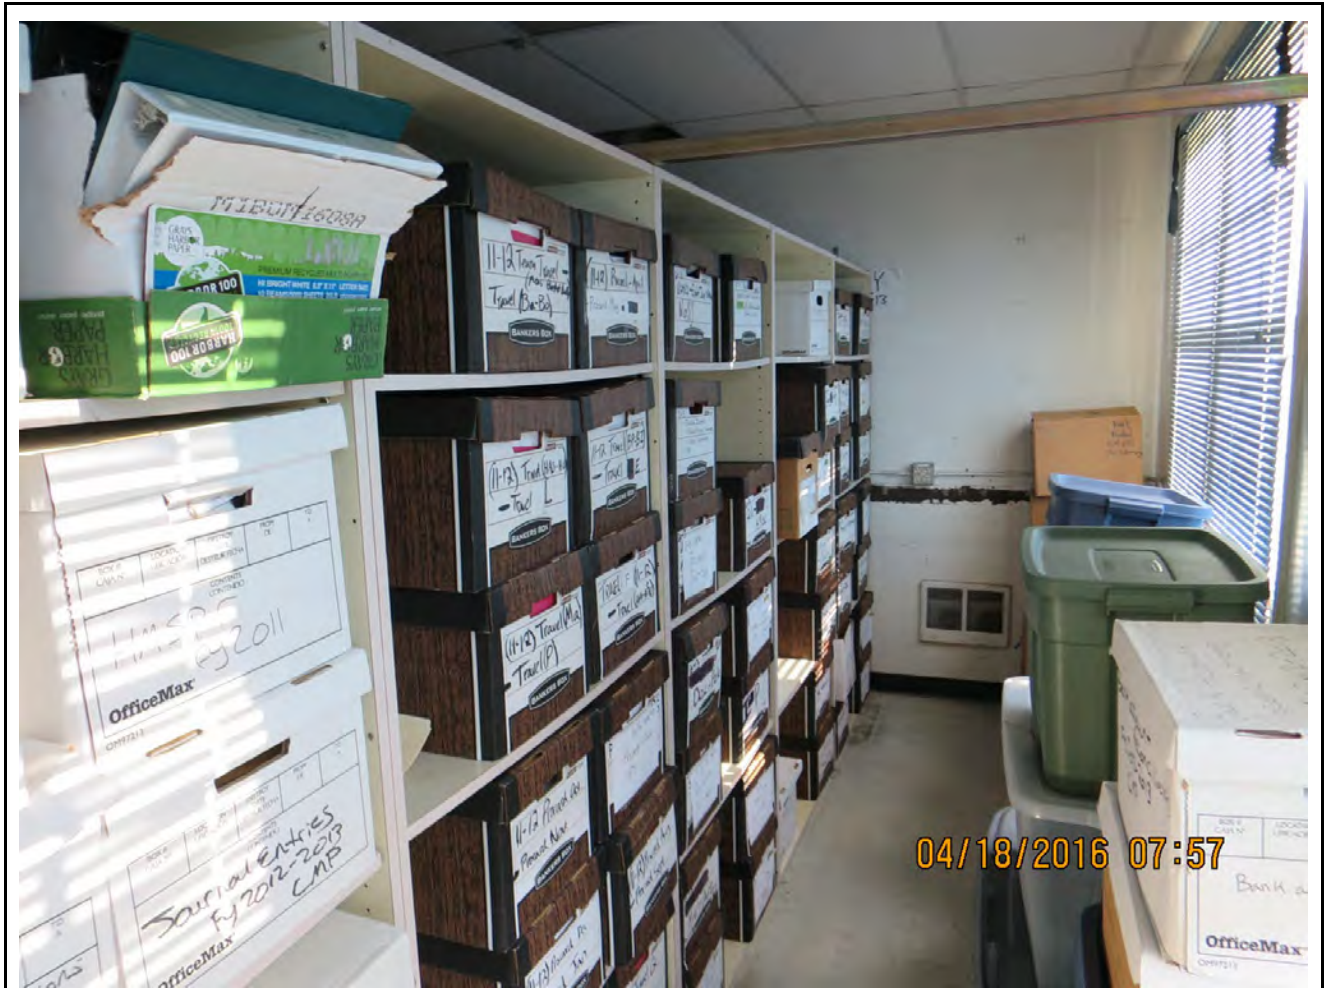
Photo 7: Room 154C

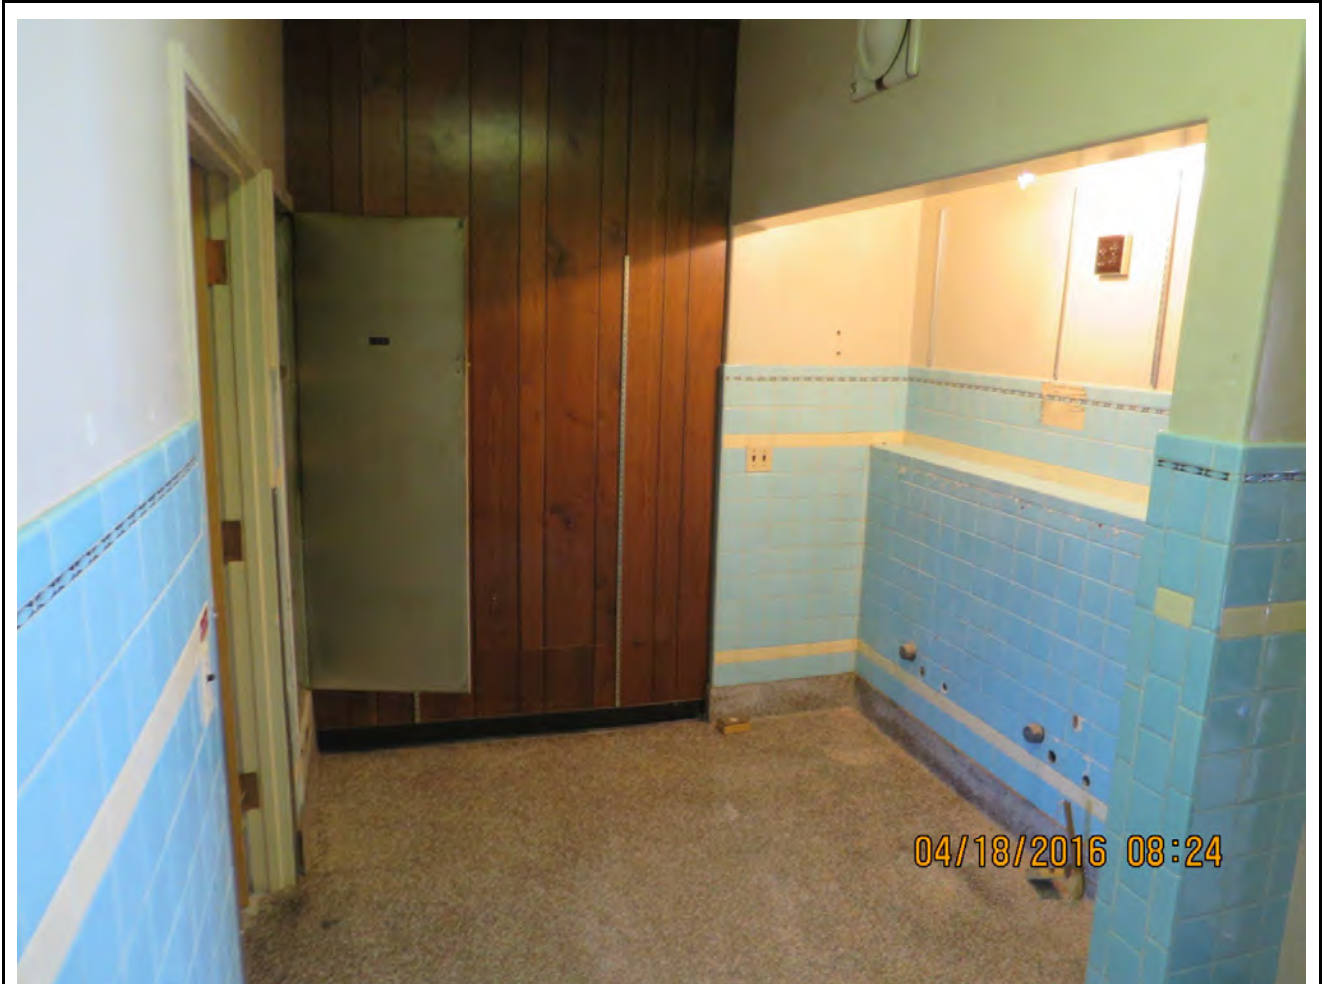
Photo 23: Room 105B

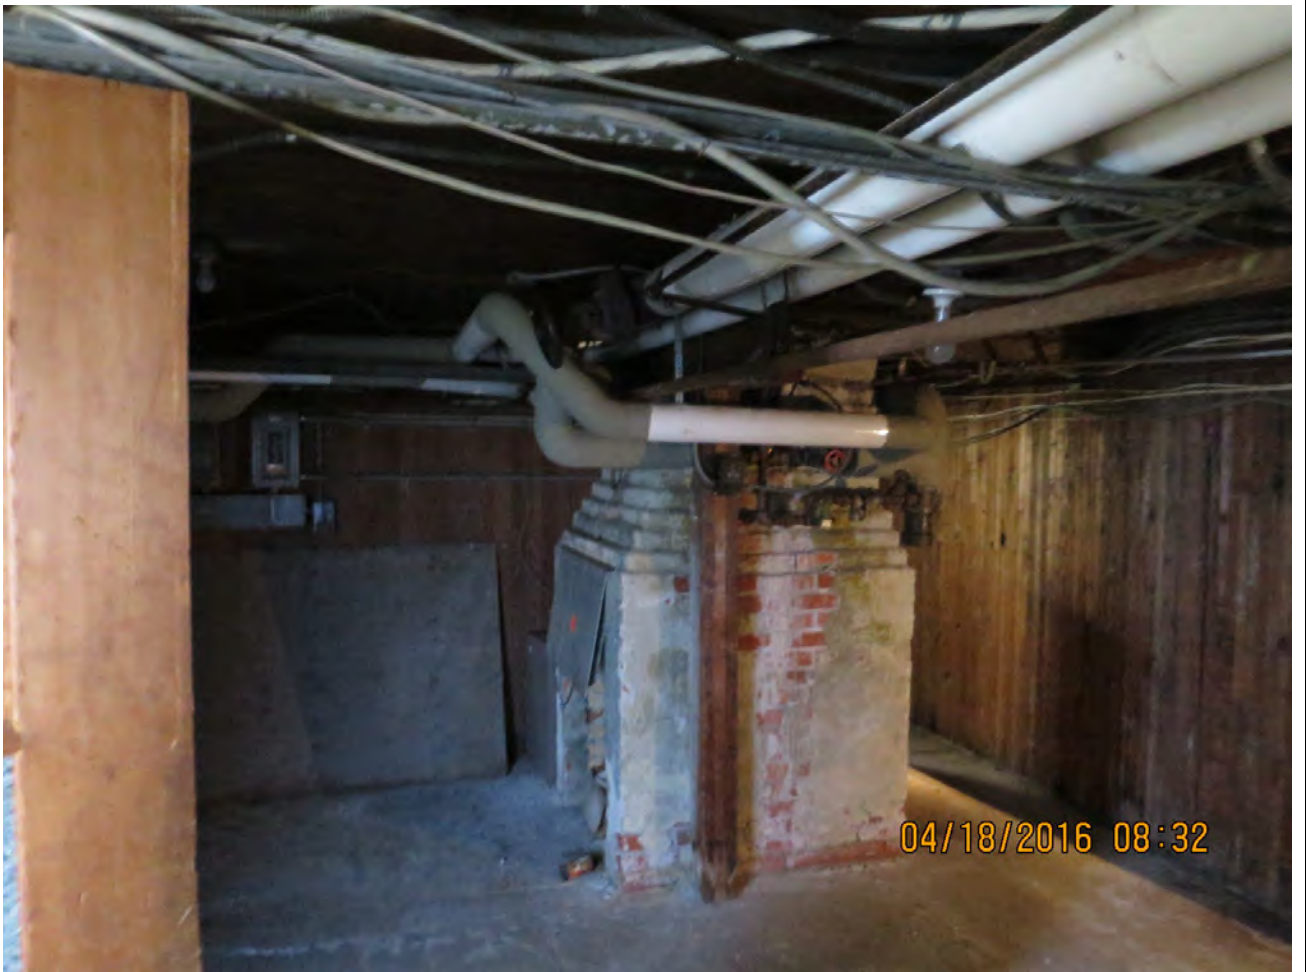
Photo 26: The incinerator and new coverings over pipes with old asbestos insulation

Photo 26: The incinerator and new coverings over pipes with old asbestos insulation

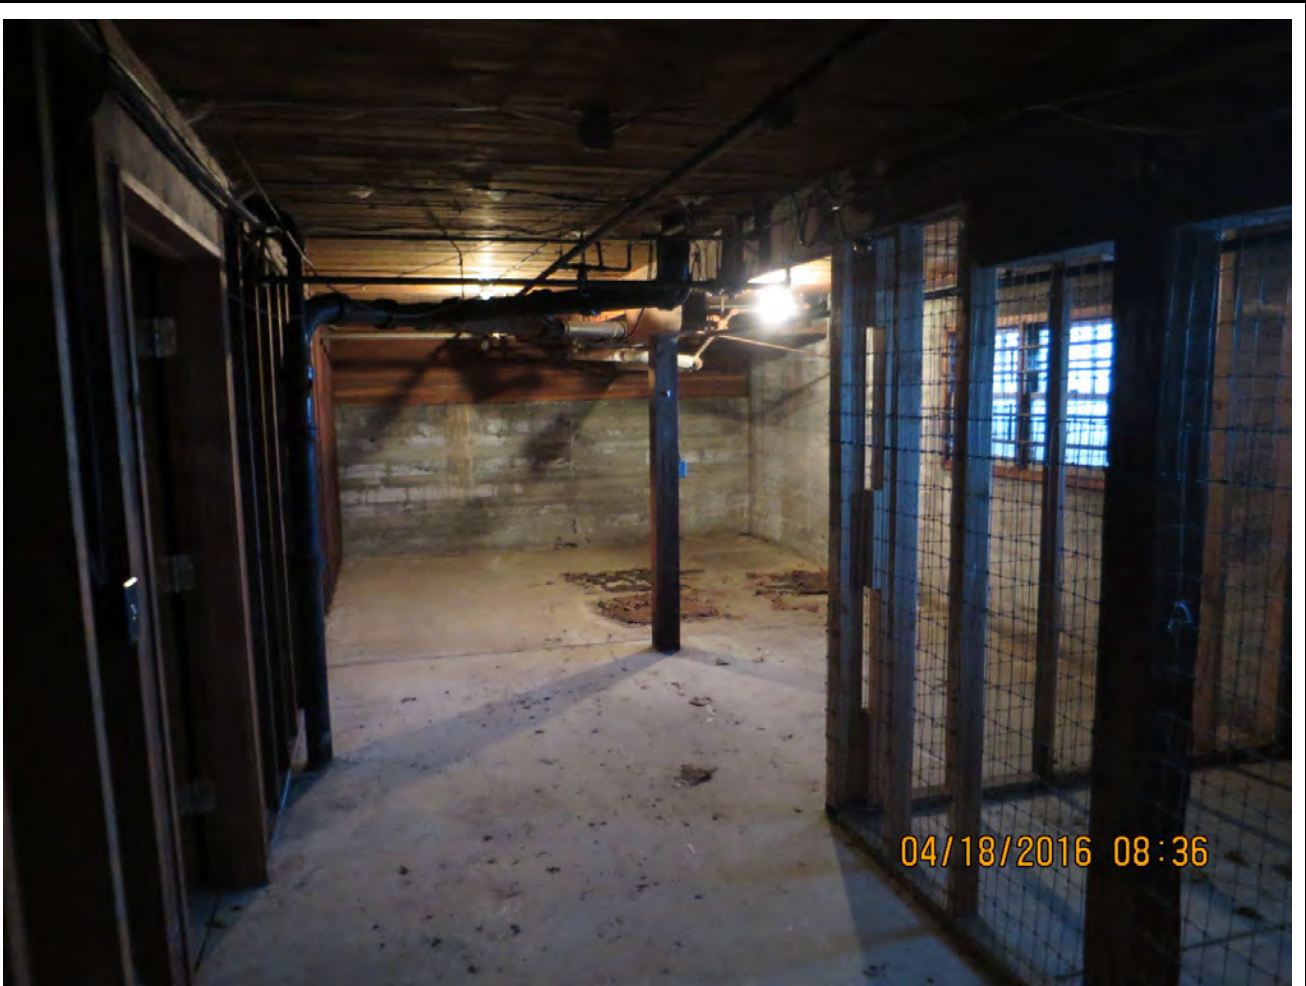
Photo 28: Room 15

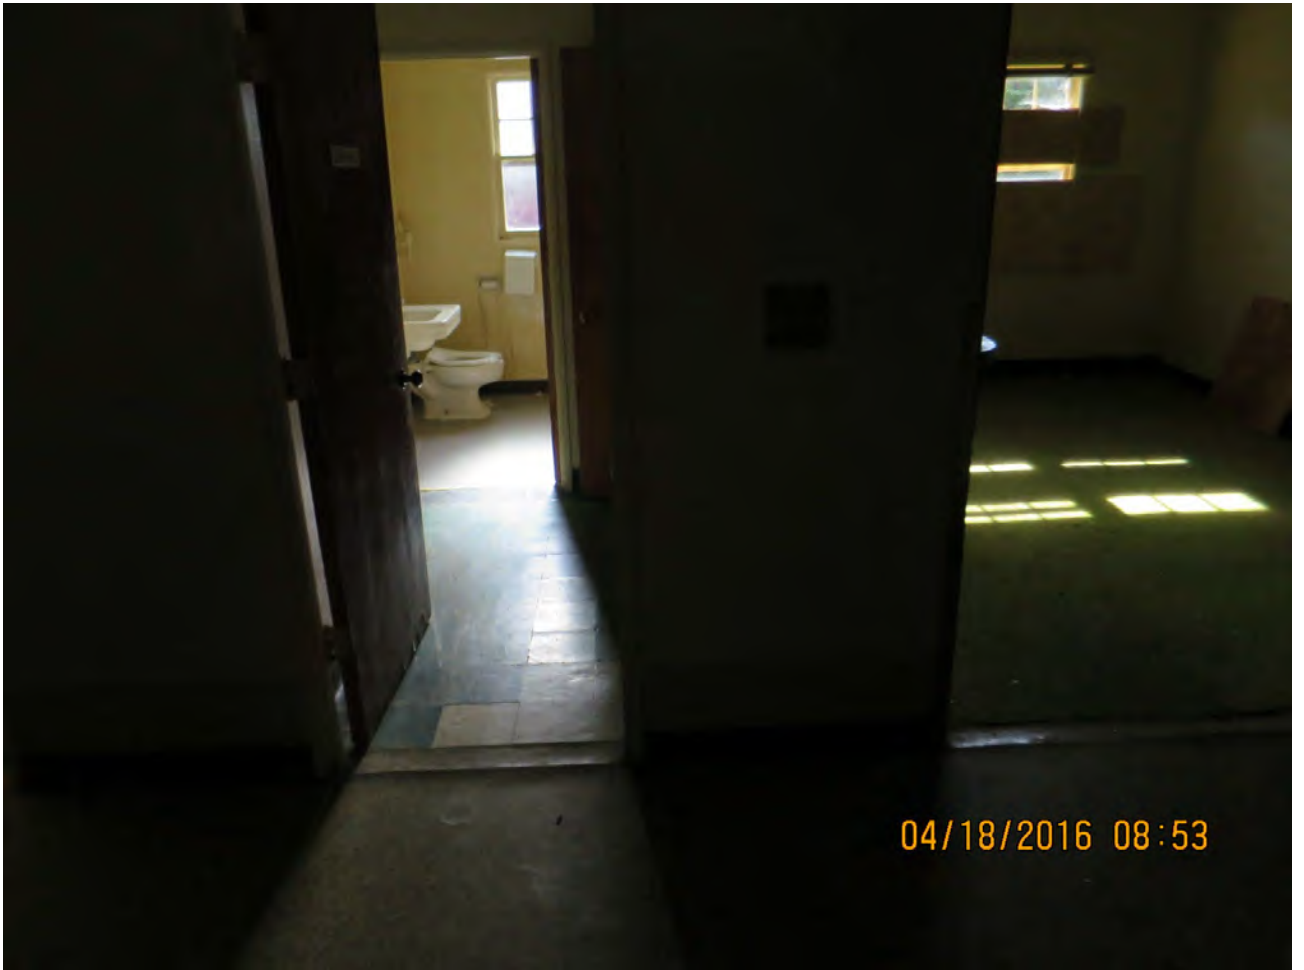
Photo 36: Looking into Rooms 114 with asbestos floor tile

Photo 36: Looking into Rooms 114 with asbestos floor tile
