HSU Trinity Children's Center and Child Development Lab Project

Initial Study-Mitigated Negative Declaration

November 2021

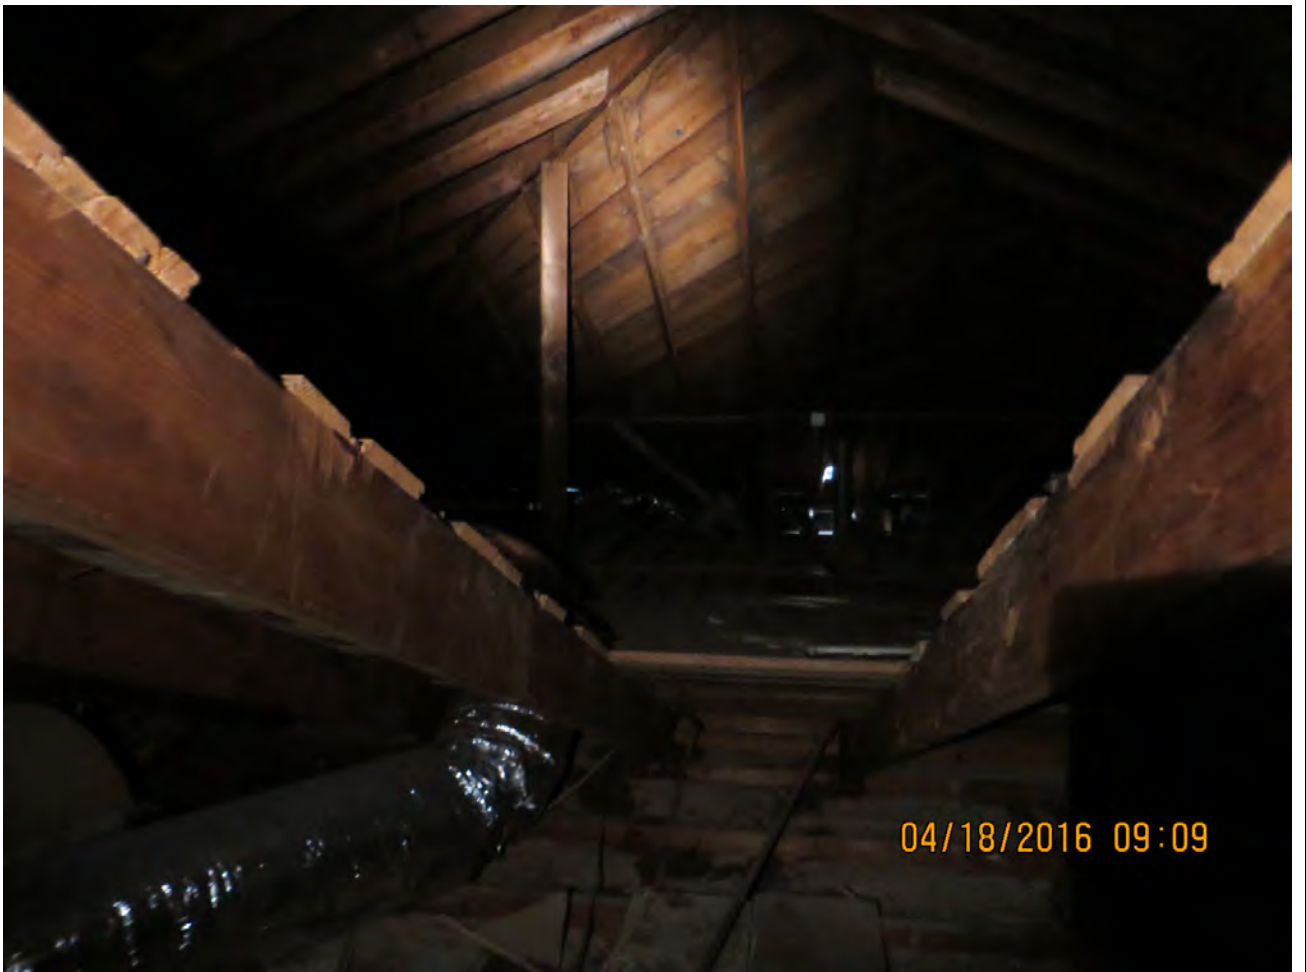
Photo 44: The attic of the right front addition connected to the original building attic

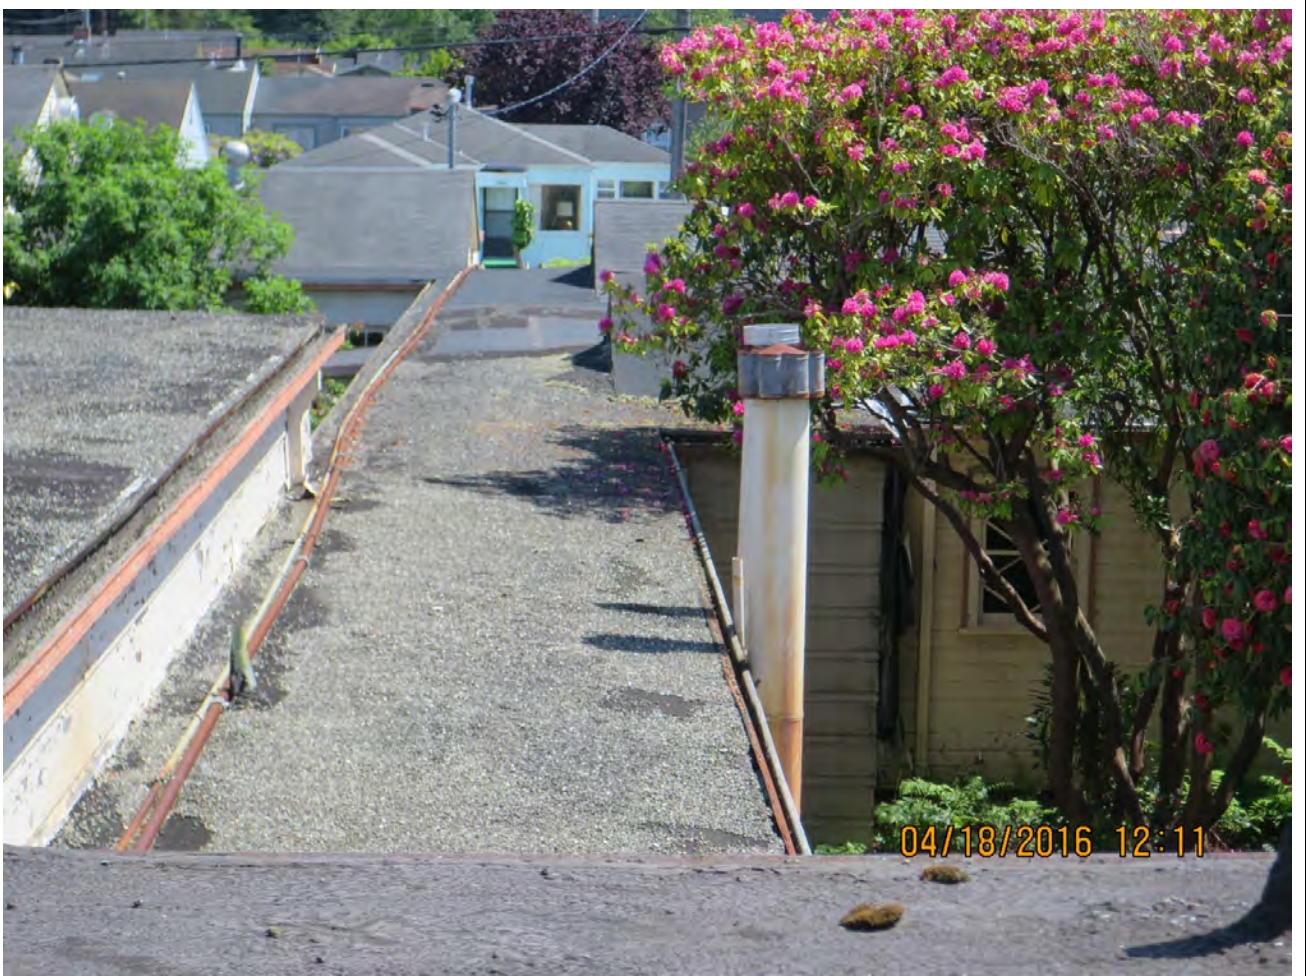
Photo 51: Two approximately 8" diameter asbestos-cement flue pipes

Photo 51: Two approximately 8" diameter asbestos-cement flue pipes

Homogeneous Area (an area of material uniform in color, texture, construction or application date and general appearance)	Sample Number	Specific Sample Location Please see the drawings If one or more samples contain asbestos, the entire homogeneous area must be treated as asbestos containing	Lab. Result % or None Detected	Asbestos Containing Materials	
				Hazard Rank	Waste
redwood insulation	TA-38	in the wall in Room 118	ND		
light fixture insulator in Room 105B, Photo 22, less than 1 square foot	TA-71	in Room 105 B, center	80	5d	F
insulation inside the metal cabinet of the sterilizer in Room 103A, roughly 40 square feet	TA-72	in Room 103A	80	3c	F
asbestos cement sheet on the door to Room 3, Photo 56, roughly 12 square feet	TA-90	on the door to Room 3	20	3c	NF
laboratory table top, roughly 50 square feet	TA-92	in Room 11	20		
wood fiber ceiling boards	TA-98	Room 151 ceiling	ND		
two approximately 8" diameter asbestos cement flue pipes from the water heater room, roughly 50 linear feet, Photo 51	n/a	n/a - assumed, identified visually	n/a	3c	NF

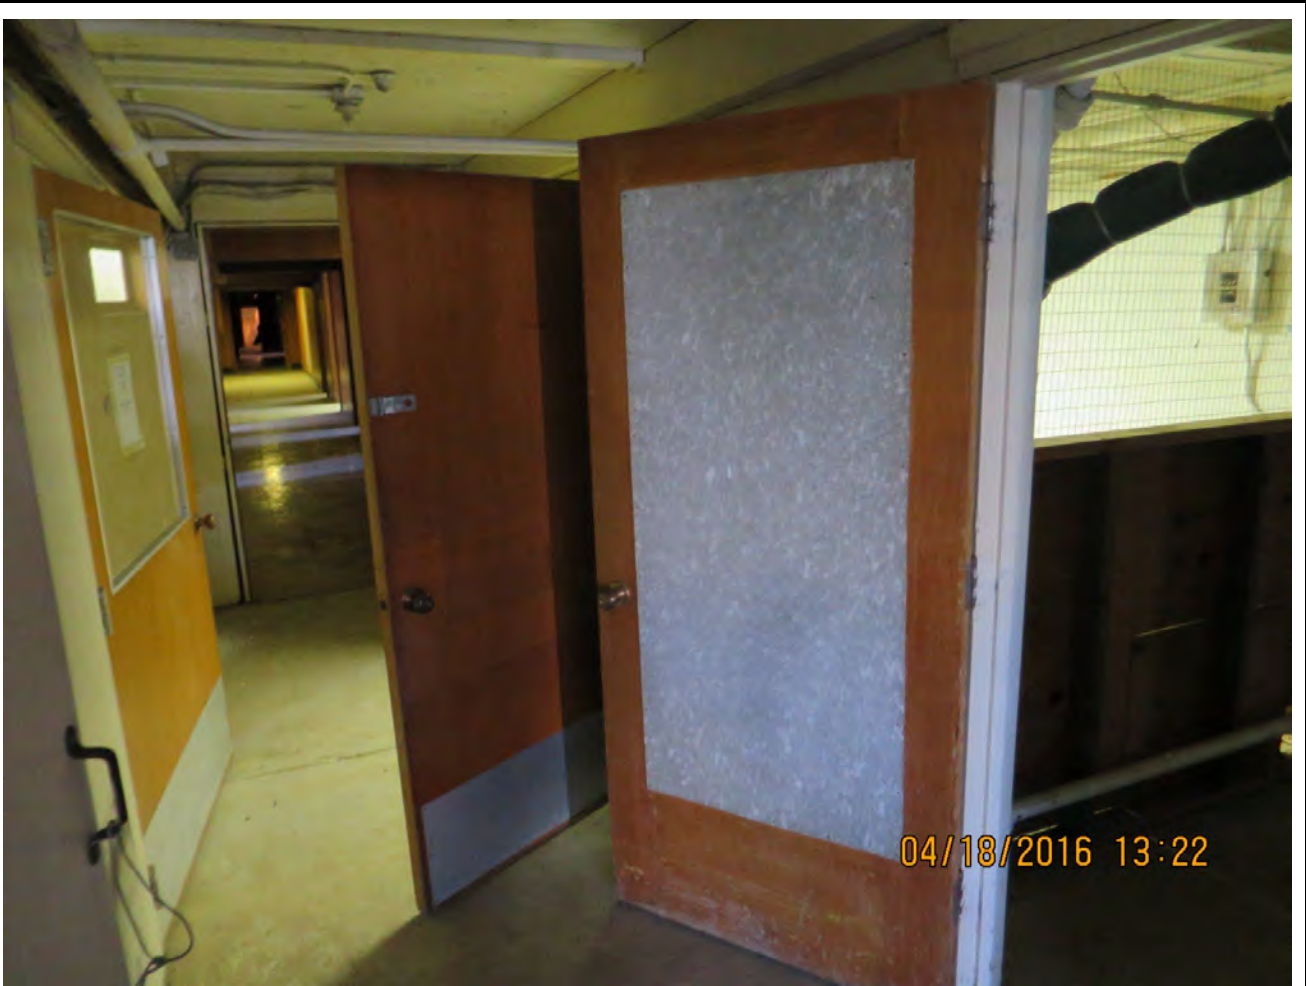
Photo 56: An asbestos-cement panel on the door to Room 3

Photo 56: An asbestos-cement panel on the door to Room 3

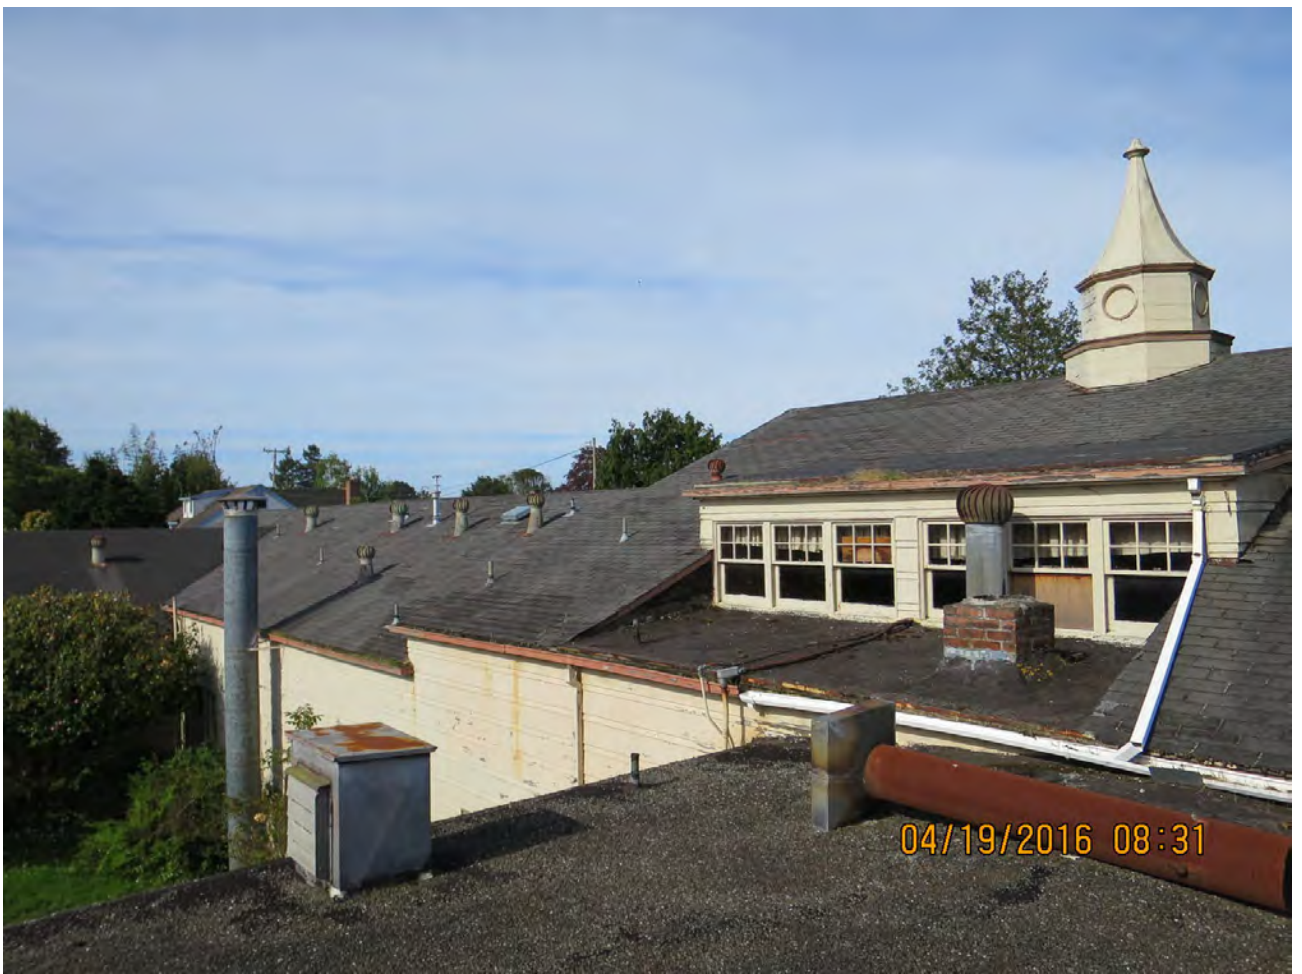
Photo 68: The small area of flat roofing outside of the Room 200 dormer, and the roof of the front portion of the building
