# Introduction

1. The objective of this project is to determine whether the construction of the Mill Creek Shopping Center complied with the settlement agreement and included the addition of sediment and grease traps on the property.
2. Within this objective we hope to locate the missing maintenance schedule for these traps, should it exist, and share it with the Department of Fish and Wildlife that was supposed to receive a copy once construction was completed.
3. Additionally, once potential runoff locations are found, water quality tests will be conducted to determine the types of contaminants that could flow into Mill Creek.
4. Based on the results, we will include recommendations for the Mill Creek shopping center to better mitigate for these contaminants into the creek in the future.

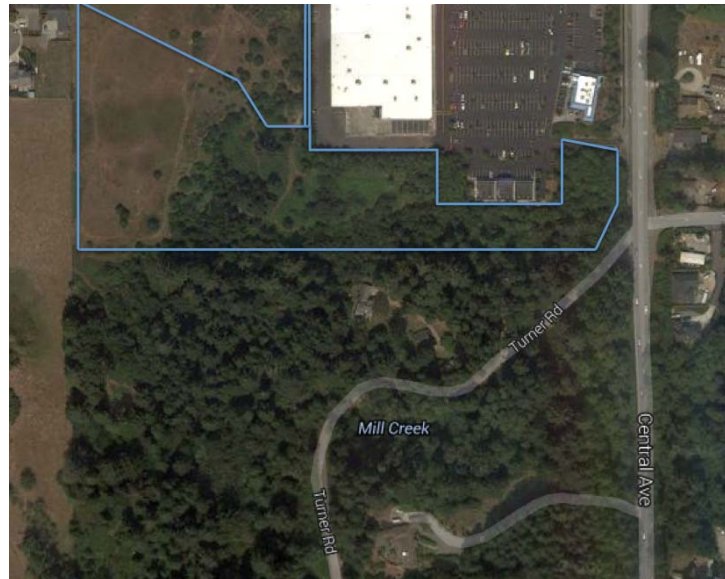
Figure 2. Chah-GAH-Cho Property boundary.

The Chah-GAH-Cho property is bound by Central Avenue to the east and Mill Creek Shopping Center and parcels set aside for future development to the north (Figure 3). Prior to construction of the shopping center, over eighty-five percent of the acreage

was used for pasture. Red alder (*Alnus rubra*), California blackberry (*Rubus ursinus*), and seedling Douglas fir (*Pseudotsuga menziesii*) are rapidly encroaching on the open grassland. Himalaya blackberry (*Rubus discolor*), an aggressive invasive, is also established and spreading in disturbed areas, notably in the southeast quarter of the site (Chah-GAH-Cho Plan). In the southeast corner of the Chah-GAH-Cho property (Figure 2) there is a small spring-fed wetland. South of the wetland, a gully drains water into a drainage ditch, which runs parallel to Turner Road and ultimately empties into Mill Creek.

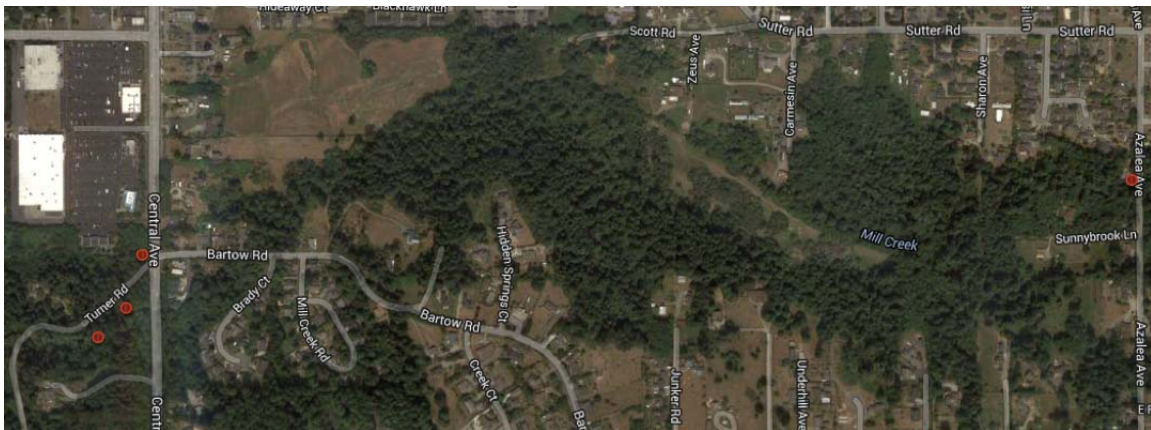
Figure 3. Map of McKinleyville, California. Solid circles indicate sampling locations.

Sampling was conducted within three locations along Mill Creek (Figure 1). The upstream site was located a few miles upstream on Azalea Road (40.931902,-124.081738). This region had with limited development compared with the downstream location. The transect began at the culvert on the west side of Azalea Road. The stream depth at the deepest point was about 12 inches with a low gradient and flow.

Our second site, called our “midpoint” (40.930208,-124.10146) is located west of Central Avenue upstream of the discharge pipe outlet on Turner Road. This site was sampled due to

assess potential impacts from Central Avenue that may affect the stream. The water sampled is still upstream from where the discharge pipe discharges into Mill Creek. The downstream site (40.929759,-124.102055) is 400 feet further west from the midpoint location, downstream of discharge pipe . Both site's water depths were between 8 to 24" inches, with a low gradient and flow. Samples from all three sites were taken about 10 feet apart in oxygenated, rocky areas.

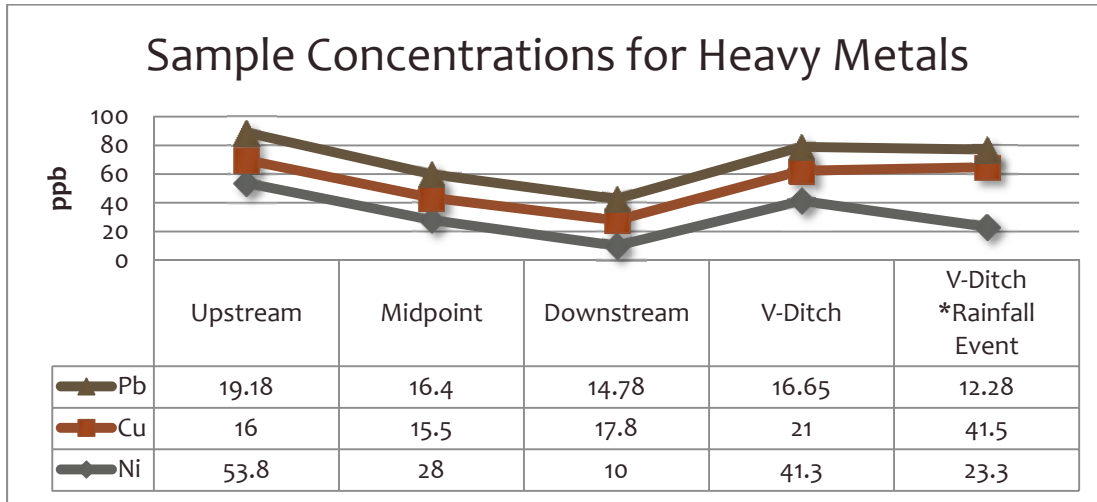
Figure 4. Concentrations of Nickel (Ni), Copper (Cu), and Lead (Pb) taken at Mill Creek, measured in ppb

Results from the Ni testing yielded the highest concentrations within the control site and the V-ditch at 53.8 parts per billion (ppb) and 41.3 ppb. Due to the unusually high amounts of Ni within the control site we have determined that an error occurred during testing. The control site was tested last and we hypothesize that the results drifted causing an error in the results. Otherwise as we expected the V-ditch contained the highest amounts of Ni at 41.3 ppb. With sites 2 and 3 yielding results of .028 ppm and .01 ppm.

Results from the copper testing yielded traces of copper (Cu) throughout all sites. Concentrations within Sites 1-3 were within the range of 15-17 ppb, with higher concentrations within the V-ditch at 21 ppb and .42 ppb.

Results from the Pb testing yielded the highest concentration at the upstream site (191.8 ppb) and decreased progressively in both downstream sites 147.8 ppb. The V-ditch site yielded lower Pb results during both sampling periods (16.65 ppb and 12.28 ppb).

The results from water testing of heavy metals yielded concentrations of Nickel (Ni), Copper (Cu), and Lead (Pb) within each site (Table 3). Cadmium (Cd) was found to be absent from each site and therefore excluded as a probable pollutant.

Based on our results contamination levels have been found to be very low. Nickel has an LC50 (Lethal Concentrations to 50% of population) for most fish species at contamination levels of 4-14 parts per million (ppm) with a duration of 96 hours within soft water and an LC50 of 24-44 ppm for a duration of 96 hours in hard water (Eisler 1998). Based on the lethal nickel levels stated, nickel concentrations currently in Mill Creek are within safe levels and will have no adverse effect on aquatic organism. The toxic effects of nickel are influenced by pH. Nickel has been determined at being most lethal at pH of 8.3 and having the lowest impact at a pH of 6.3 (Eisler 1998).

Cu contamination can have multiple effects on salmonids. Contamination can affect salmonids sensory abilities leading to an interruption of spawning migrations, can affect growth, and can be lethal depending on the dose and duration of exposure. The LC50 of dissolved copper, above a background concentration of led set at 3 ppb for the study we used, for adult Coho salmon are 46 ppb and 57 ppb for adult Steelhead, both at a 96 hour exposure (Hecht et al 2007). The dissolved copper LC50 for Chinook salmon fry is 19 ppb, for Coho salmon fry is 28-38 ppb, and Steelhead and Rainbow trout fry is 9-17 ppb, all at an exposures of 96 hours (Hecht et al 2007). Given these levels of lethality copper levels within Mill Creek are likely not be

The Pb results yielded may not have an effect on certain aquatic organism, such as mayflies (Ephemeroptera). Studies have shown that mayfly molting rates can be affected when exposed to lead rates of 664 ppb for a duration of 96 hours (Mebane et al 2008). With rainbow trout, effects have been observed during constant exposure to lead within the early life stages at concentrations of 12-384 ppb (Mebane et al 2008). This effect was caused by constant exposure and water hardness of 20 ppm. Lead contamination can have increasing effects depending on pH, water temperature, and hardness of water (Eisler 1988). Given these factors effects may increase or decrease throughout the year as water temperature and pH fluctuate. This factor illustrates the importance of baseline data and testing throughout the year. Given that results were found to be relatively low when compared to concentration effects stated above it is not likely that aquatic organisms will be affected by the levels found during testing.

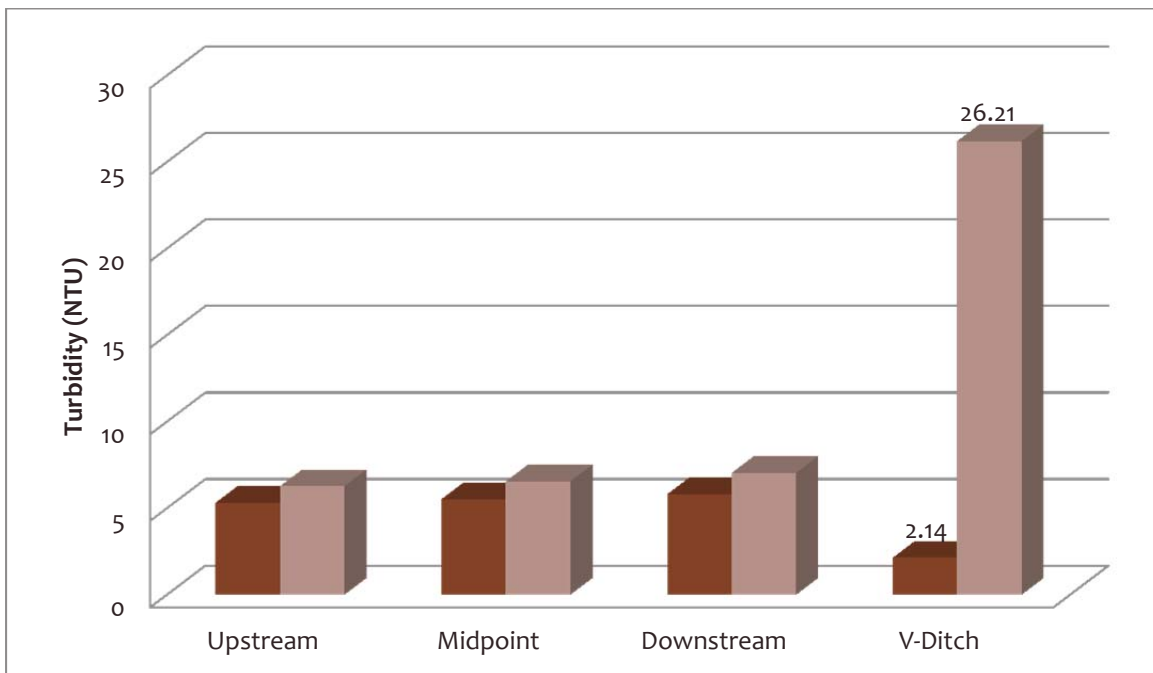
Figure 5. Turbidity comparisons between rainfall and dry event.

Turbidity measurements slightly increased downstream from our control (Site 1). The control site measured at 5.31 NTU. The Mid-Point (Site 2) measured at 5.52 NTU and Downstream (Site 3) at 5.81 NTU. The V-Ditch had the lowest turbidity readings at 2.14 NTU. Rainfall turbidity measurements increased in all locations. The V-Ditch measurement increased the most from 2.14 NTU to 26.21 NTU.

Turbidity readings indicate that Mill Creek may have increased turbidity and Total suspended solids (TSS). Reducing potential inputs that affect turbidity will: increase water clarity and provide better fish visibility, increase aquatic plant presence with greater light penetration, increase oxygen concentrations, and reduce sedimentation and stress on benthic stream biota. It has been shown that higher turbidity can indicate fecal bacteria presence. California forested lands has requirements that vary from a 1 NTU increase from background data to a 20% NTU above background data. Unfortunately, there has not been consistent testing at this location to determine background data for this assessment.

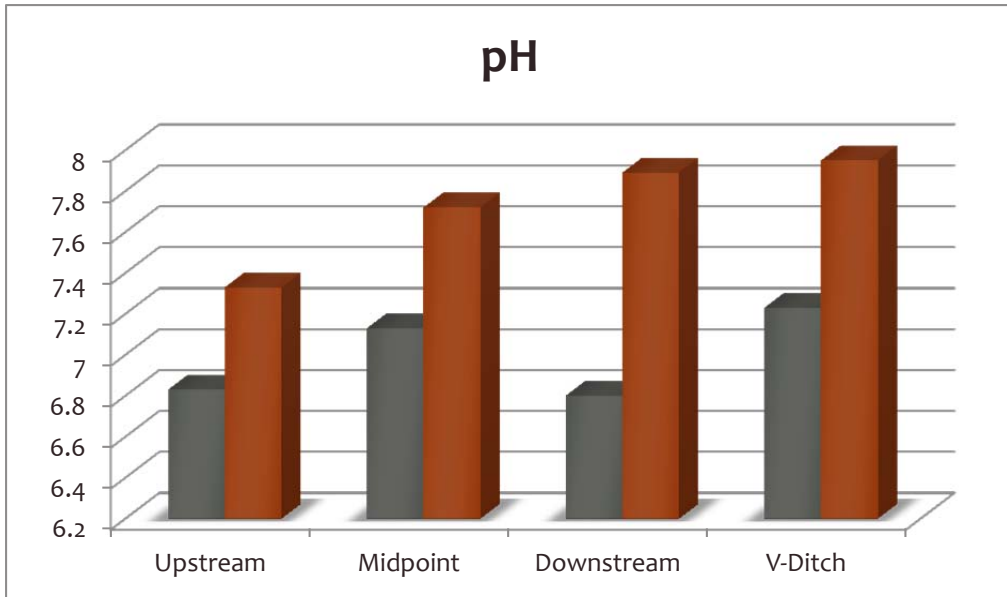
Figure 5. pH comparison between sites before and after a rainfall event.

Initial pH testing showed variability between site locations in pH. The control (Upstream) measured with a pH of 6.83. Our downstream site (Site 3) had a lower pH of 6.8. Midpoint site (site 2) and the V-ditch were more alkaline. Following a rainfall event, the results from pH testing show increases in all other sites when compared with control (Upstream).

Our pH readings at our sampling locations did not show any substantive adverse impacts from contaminants. While a pH of 7 is considered to be neutral, most natural waters have pH values that fall between 6.5 and 8.5 (Dave 2005). None of our samples fell outside of this range. pH was tested twice in the study, secondly after a rainfall event. Results indicate that pH increased after a rainfall event.

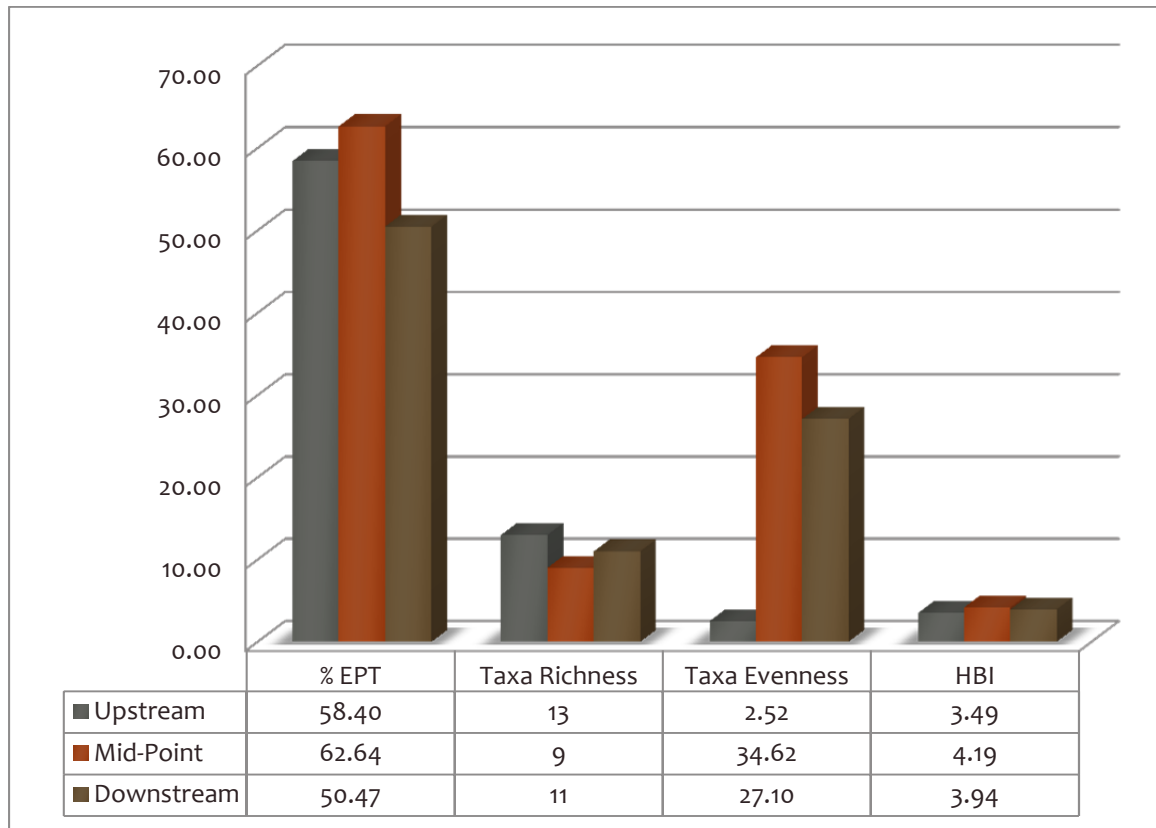
Figure 6. Biodiversity comparison between site locations.

Results for all three sites showed that water quality in Mill Creek is fell within the “excellent” category in the Hilsenhoff Biotic Index. Taxa richness was most reduced at the Mid-Point. Surprisingly, Taxa evenness was lowest at the Upstream location, but we believe this is likely due to the abundance of one single species, and biased the sample.
